LICENSEE EVENT REPORT (LER)

FACILITY NAME (1) POINT BEACH NUCLEAR PLANT UNIT 1	DOCKET NUMBER (2) 05000266	PAGE (3) 1 OF 6
---	-------------------------------	--------------------

TITLE (4)
PRA Assessment of Auxiliary Feedwater System Reveals Procedural Vulnerability Related to Loss of Instrument Air

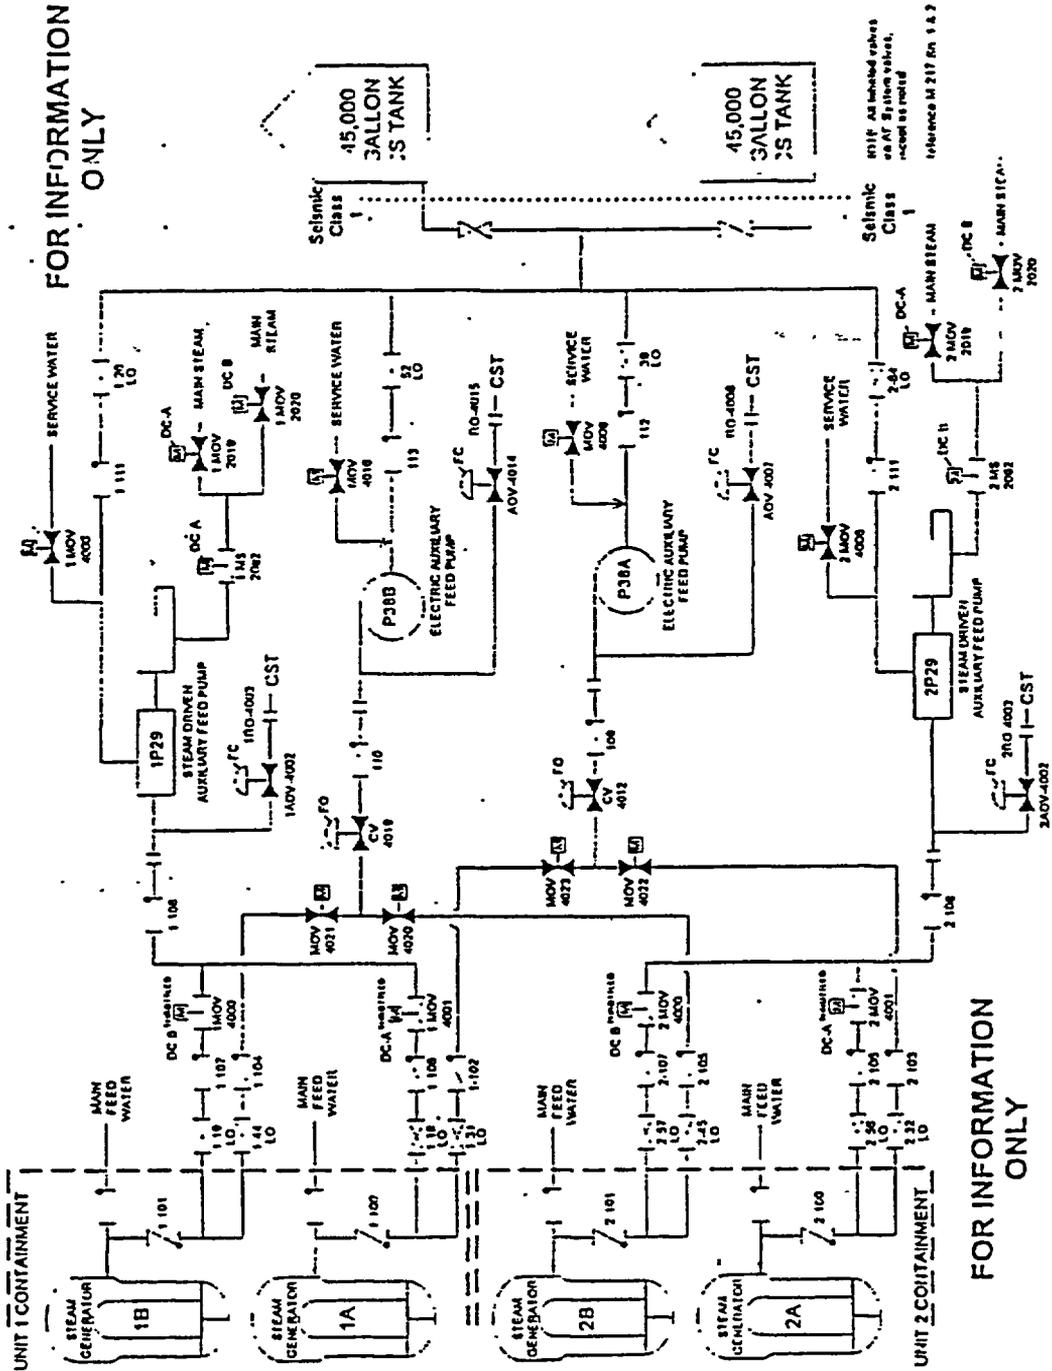
AFW System - Major Flow Paths

The following component and system description comes from Section 10.2 of the PBNP FSAR. A diagram of the major AFWS flowpaths is provided on the last page of this LER.
