Re: Turkey Point Unit 3
Docket No. 50-250
Order (EA-03-009) Relaxation Request
Examination Coverage of Reactor Pressure Vessel Head
Penetration Nozzles

**TURKEY POINT UNIT 3 RELAXATION REQUEST
FROM US NRC Order EA-03-009**

**“Hardship or Unusual Difficulty without Compensating Increase in
Level of Quality or Safety”**

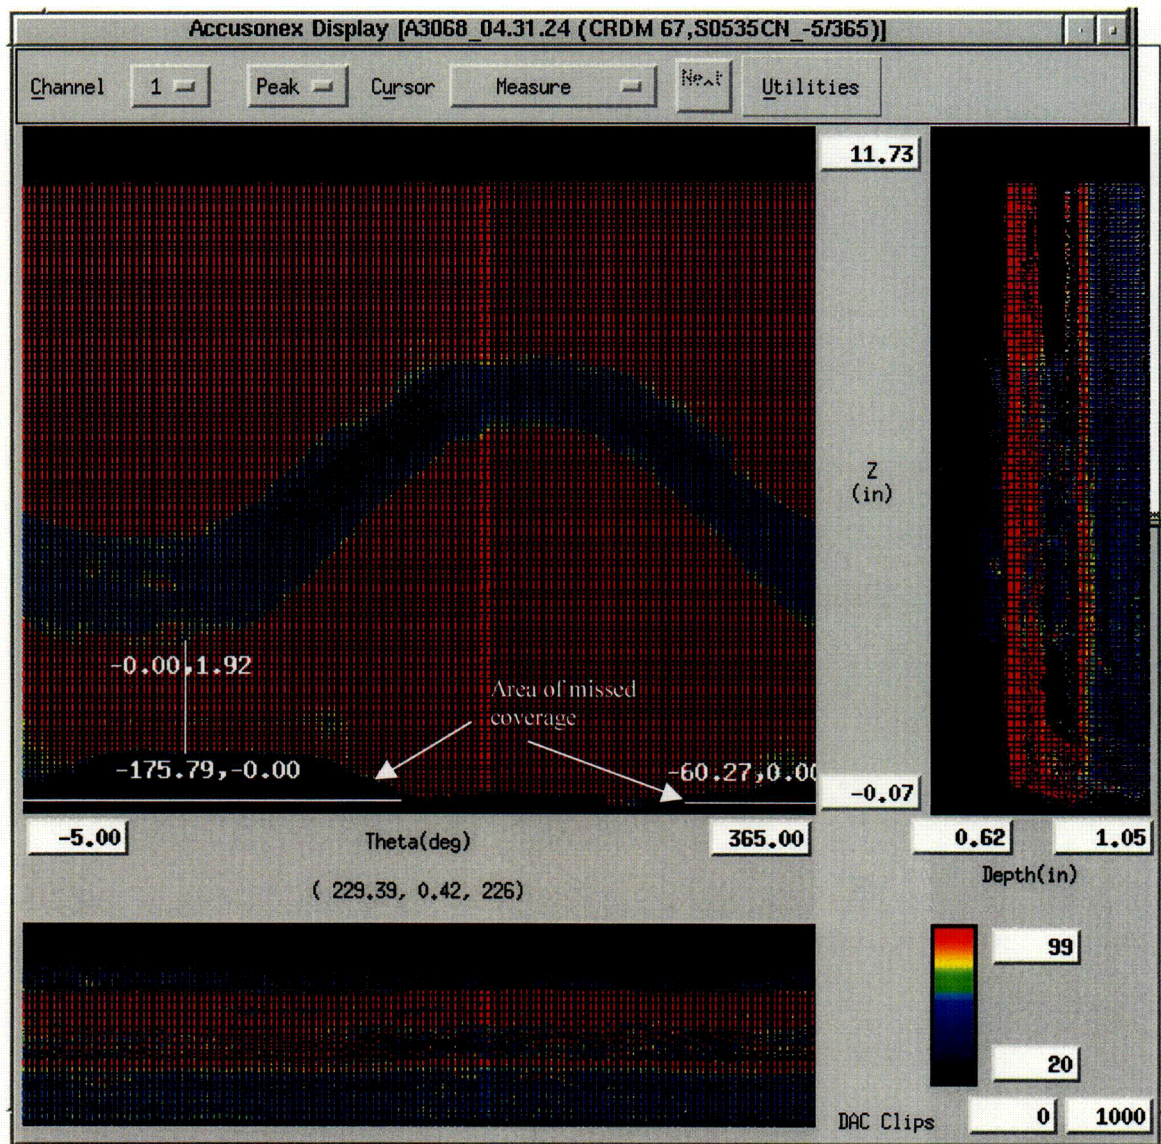
Pursuant to Order Section IV.F.(2) "Compliance with the Order for specific nozzles would result in hardship or unusual difficulty, without a compensating increase in the level of quality and safety", FPL is requesting this relaxation for Turkey Point Unit 3. Currently, with 48 of 66 RPV nozzle penetrations examined, there are 6 RPV head penetrations that contain areas of coverage less than that required by the NRC Order. The Order requires examination from 2 inches above the J-groove weld to the bottom of the RPV head penetration nozzle. The reduced coverage is caused by nozzle configuration, and limitations of the probe design used for the Ultrasonic (UT) examination. Specifically, actual coverage below the weld, in the non-pressure boundary portion of the nozzle, did not in all cases, extend to the "bottom of the nozzle." A typical example of the UT cover area, with the area of missed coverage identified, is shown in Figure 1.

Figure 1: Typical RPV Nozzle UT Inspection "C" Scan with area of missed coverage identified by arrows and above the white horizontal line.

The proposed alternative is to perform the UT examination to the extent practical. This is defined as "the examination shall be performed to include 2 inches above the weld to \geq 1 inch below the weld." This relaxation request documents and submits to the NRC, deviations from the NRC Order required inspection coverage area along with a justification as to their acceptability.

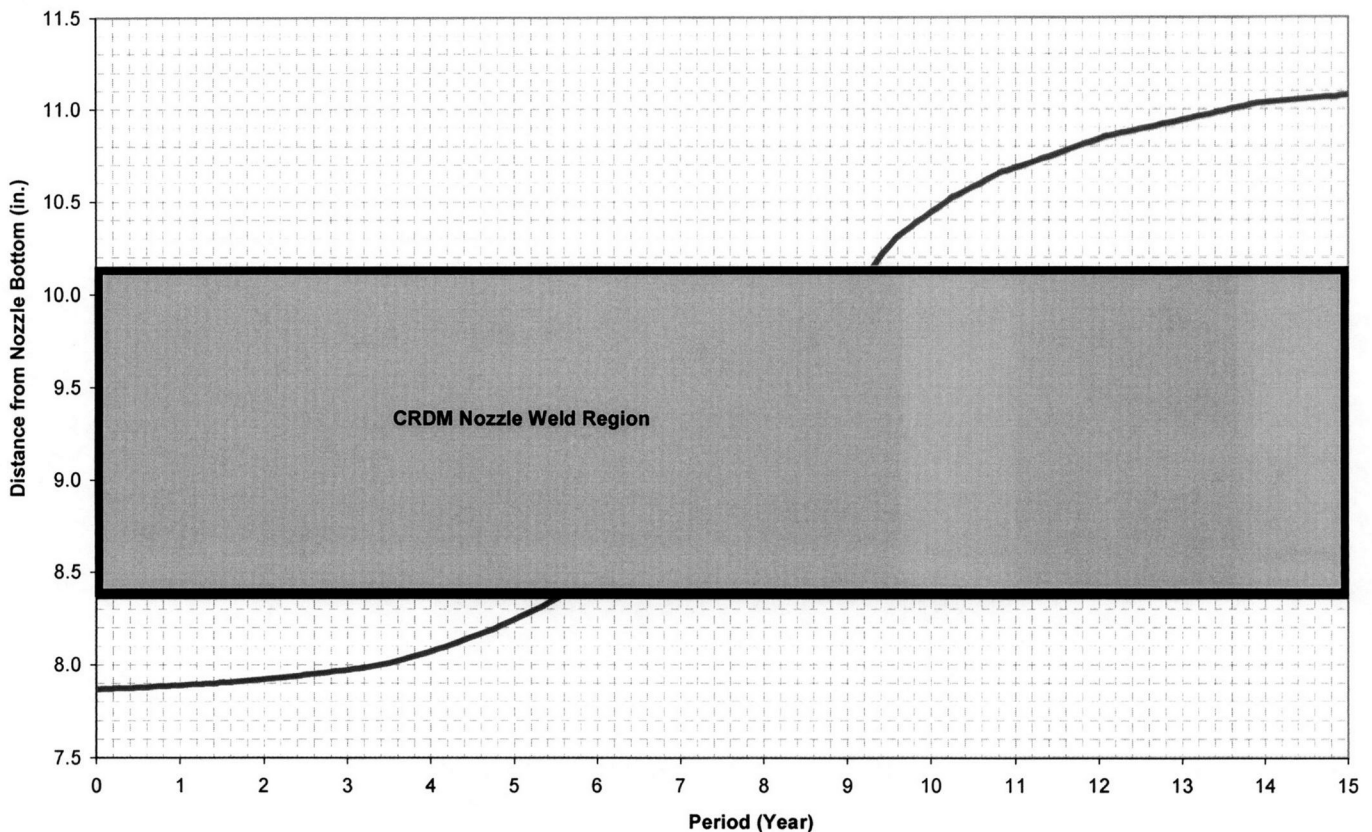
To determine the significance of an axial flaw that is contained in the non-pressure boundary nozzle material in the un-inspected region >1 inch below the weld, a flaw tolerance approach is used. A flaw evaluation was performed postulating an axial flaw in the area of missed coverage below the weld using WCAP-16027-P³. A through wall flaw is postulated in the nozzle material from the bottom of the penetration to 1" from the bottom of the weld. The flaw evaluation in WCAP-16027-P is based on Turkey Point Unit 3 and 4 specific stresses in the nozzle penetrations. Since the stresses >1" below the weld are too low to propagate an axial flaw, the WCAP-16027-P flaw evaluations start at ½" below the weld, and evaluate the time to propagate the flaw in the nozzle to the bottom of the weld (start of the pressure boundary portion of the nozzle material or toe of the J-groove weld). Assuming a through wall flaw below the weld, with the flaw end located at ½" below the weld (which is in the area of complete UT examination coverage), an axial flaw would take greater than 5 years of operation (Figures 6-12 through 6-20 in WCAP-16027-P) in any nozzle location to grow to the point of contact with the weld. This time period is significantly greater than the current inspection frequency of every refueling cycle (18 months for Turkey Point Unit 3) identified in NRC Order EA-03-009. As an added conservatism, this evaluation does not attempt to evaluate the time for the axial flaw to grow from the bottom of the weld through the pressure boundary. Figure 2 provides a graphical presentation of the above flaw evaluation discussion for the outer most penetration location.

Figure 2: Through-Wall Axial Flaws Located in the 42.6 Degree Row of Penetrations, Uphill Side - Crack Growth Predictions (From Figure 6-19, WCAP-16027-P)

Therefore, there are no concerns with the structural integrity of the RPV penetration nozzles that could be caused by axial cracking in the missed coverage areas in the non-pressure boundary portion of the nozzle material > 1" below the weld for a period of > 5 years of operation.
