Re: Turkey Point Unit 3
Docket No. 50-250
Order (EA-03-009) Relaxation Request
Examination Coverage of Reactor Pressure Vessel Head
Penetration Nozzles – Supplemental Data

**TURKEY POINT UNIT 3 RELAXATION REQUEST
FROM US NRC Order EA-03-009**

**“Hardship or Unusual Difficulty without Compensating Increase in
Level of Quality or Safety”**

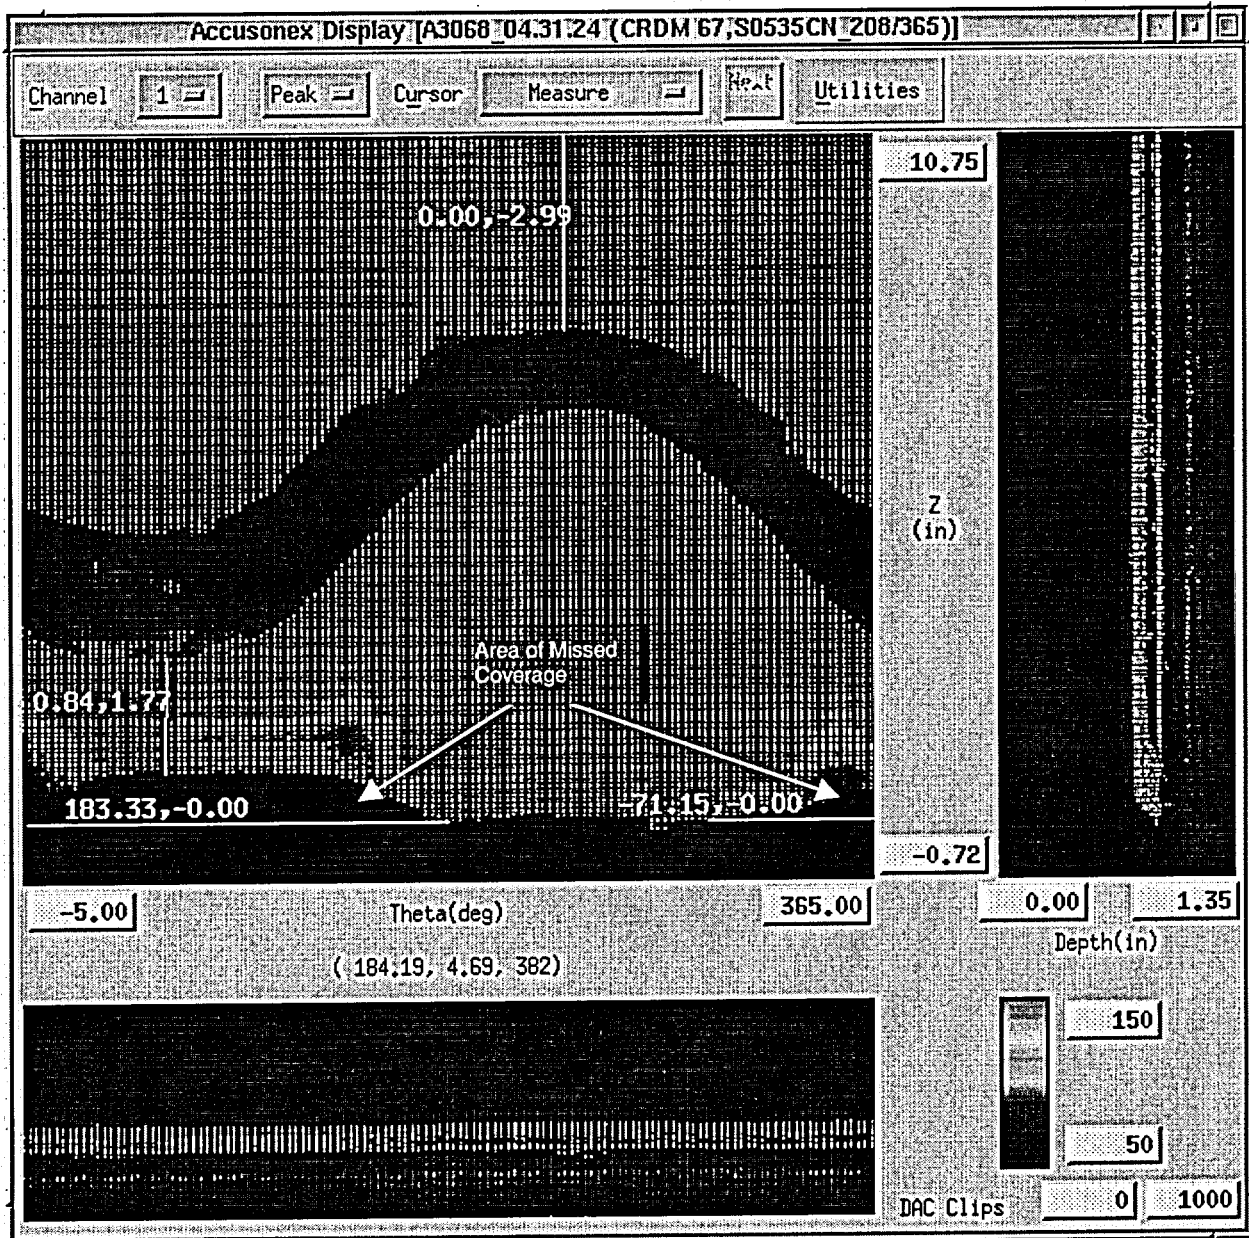
Pursuant to Order Section IV.F.(2) "Compliance with the Order for specific nozzles would result in hardship or unusual difficulty, without a compensating increase in the level of quality and safety", FPL is requesting this relaxation for Turkey Point Unit 3. There are 9 RPV head penetrations that contain areas of coverage less than that required by the NRC Order. The Order requires examination from 2 inches above the J-groove weld to the bottom of the RPV head penetration nozzle. The reduced coverage is caused by nozzle configuration, and limitations of the probe design used for the Ultrasonic (UT) examination. Specifically, actual coverage below the weld, in the non-pressure boundary portion of the nozzle, did not in all cases, extend to the "bottom of the nozzle." A typical example of the UT coverage area, with the area of missed coverage identified, is shown in Figure 1.

Figure 1: Typical RPV Nozzle UT Inspection "C" Scan with area of missed coverage identified by arrows and above the white horizontal line.

Previously, Figure 1 was included to depict a "typical" example for nozzle #67. The figure 1 that is included in the supplemented request is the actual C-scan for nozzle #67 that illustrates the circumferential extent of missed coverage. The extent of missed coverage at the bottom of the nozzle is determined by, in this case, adding the two numbers. Additionally, the total circumferential extent of missed coverage, in degrees, is now shown in Table 2 for every nozzle where coverage was less than 100%.

The proposed alternative is to perform the UT examination to the extent practical. This is defined as "the examination shall be performed to include 2 inches above the weld to ≥ 1 inch below the weld." This relaxation request documents and submits to the NRC, deviations from the NRC Order required inspection coverage area along with a justification as to their acceptability.

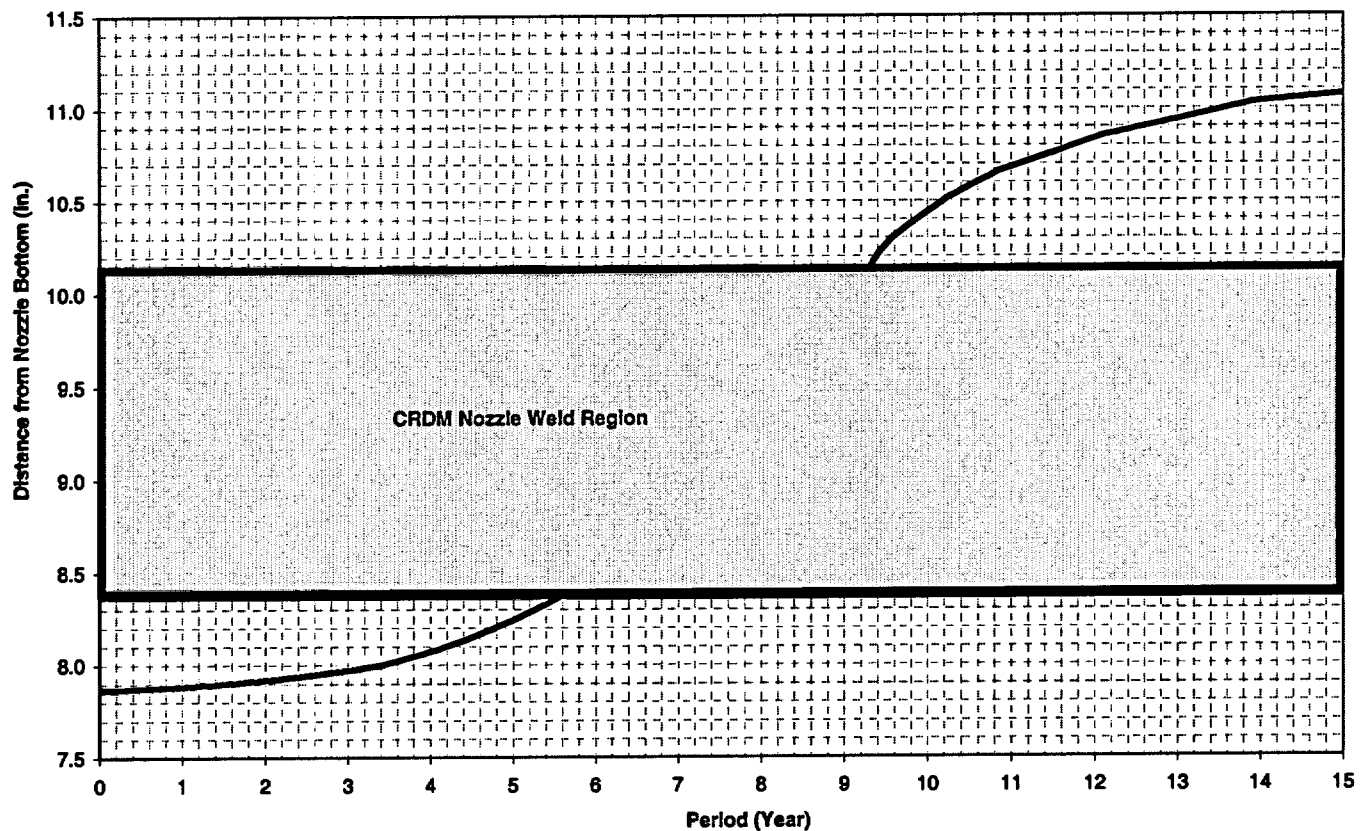
Figure 2 provides a graphical presentation of the above flaw evaluation discussion for the outer most penetration location.

Figure 2: Through-Wall Axial Flaws Located in the 42.6 Degree Row of Penetrations, Uphill Side - Crack Growth Predictions (From Figure 6-19, WCAP-16027-P)

Therefore, there are no concerns with the structural integrity of the RPV penetration nozzles that could be caused by axial cracking in the missed coverage areas in the non-pressure boundary portion of the nozzle material > 1" below the weld for a period of > 5 years of operation.
