**TENNESSEE VALLEY AUTHORITY - SEQUOYAH NUCLEAR PLANT UNIT 2 -  
DOCKET NO. 50-328 - FACILITY OPERATING LICENSE DPR-79 - LICENSEE  
EVENT REPORT (LER) 50-328/2003-002-00**

**4. TITLE**  
Limiting Condition for Operation 3.0.3 was entered when two refueling water storage tank level transmitters failed during cold weather conditions.

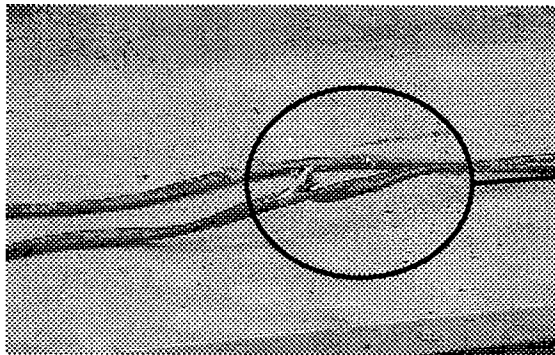
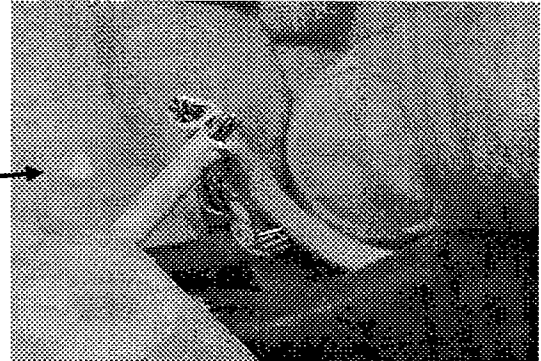
The two RWST level transmitters malfunctioned because the heater circuits designed to prevent freezing in the junction boxes in which they are located did not operate properly. The malfunctions of the heater circuits were the result of damaged cables supplying power to the heater strips. Evaluation of the cables determined that the root cause of the damage to both cables was excessive pull tension, during installation in December 1982. This was verified by a microscopic examination of the ends of the conductor strands at the damaged spots. The evidence suggests that the excess tension resulted from an attempt to pull in kinked cables.

The malfunctions of the heater circuits were the result of cables damaged during installation, supplying power to the heater strips. The cables are: 2/c, 12 AWG, seven strands, manufactured by American Insulated Wire (AIW), TVA type PXMJ, mark letter WGB, no separator tape over the conductor, paper separator tape over the non-twisted conductors (the cable was assembled in a "twin-flat" arrangement).

Temporary heat was placed around the area of the junction boxes. After adding temporary heat, the two transmitters returned to scale. One transmitter was calibrated and returned to operable status that same day. The other transmitter had to be replaced because it could not be calibrated. The new transmitter was installed, calibrated, and determined operable the following day. The damaged cables were replaced.

The other RWST junction box heater cables are being replaced, to ensure that a similar problem does not exist.
