**SG-SGDA-02-43-NP
Comanche Peak Steam Electric Station
1RF09 Outage Condition Monitoring Report and
Preliminary Cycle 10 Operational Assessment**

SG-SGDA-02-43-NP

October 2002

Westinghouse Electric Company LLC

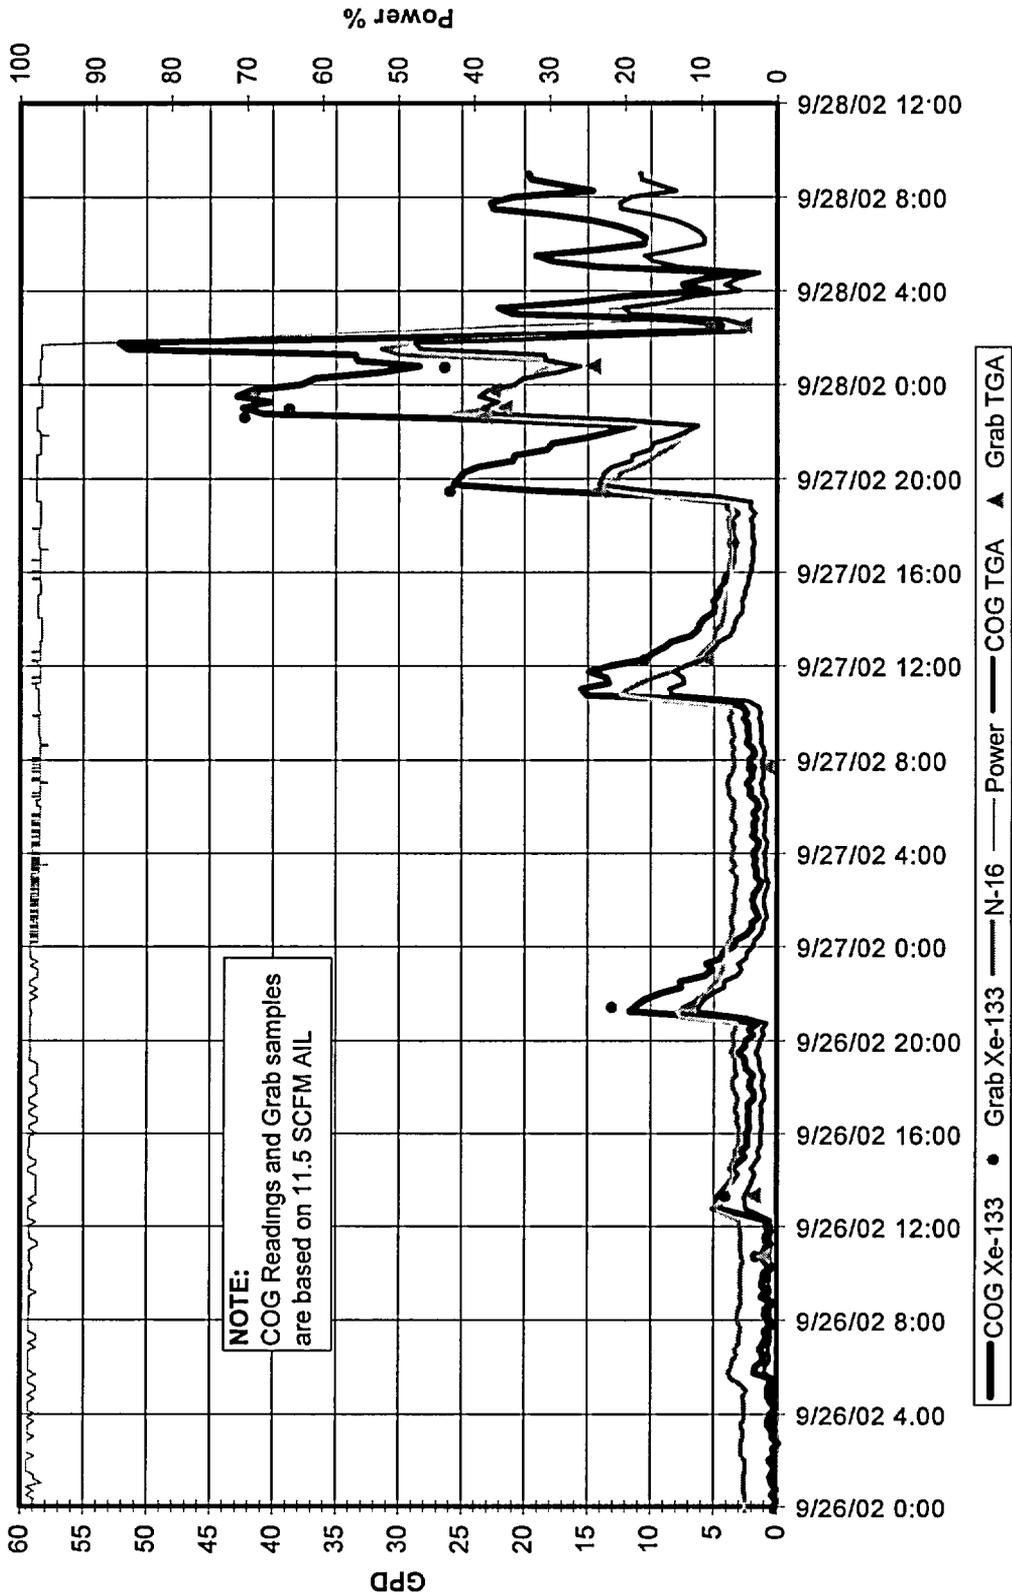
Figure 1

Approximately 1 week prior to the planned shutdown for the 1RF09 outage, primary to secondary leakage was reported from SG 2. Over an approximate 2 day period, the leakage trending showed 6 spikes, with decaying leak rate following the spike. For the first 3 spikes of 5, 12, and 15 gpd, the leak rate decayed following the spike to less than 5 gpd. For the next 3 spikes of 25, 42, and 52 gpd, the leak rate began to decay but the duration between the spikes was reduced and the decay was not complete. The unit was taken off-line on September 28, 2002, prior to the primary to secondary leak rate reaching the EPRI Primary to Secondary Leakage Guideline limit of 75 gpd. The leak rate trending curve is provided in Figure 1.

Unit 1 PSL from COG Readings and N-16 Monitors
 COG Readings are Correlated to Off-Gas Grab Samples (TGA and Xe-133)

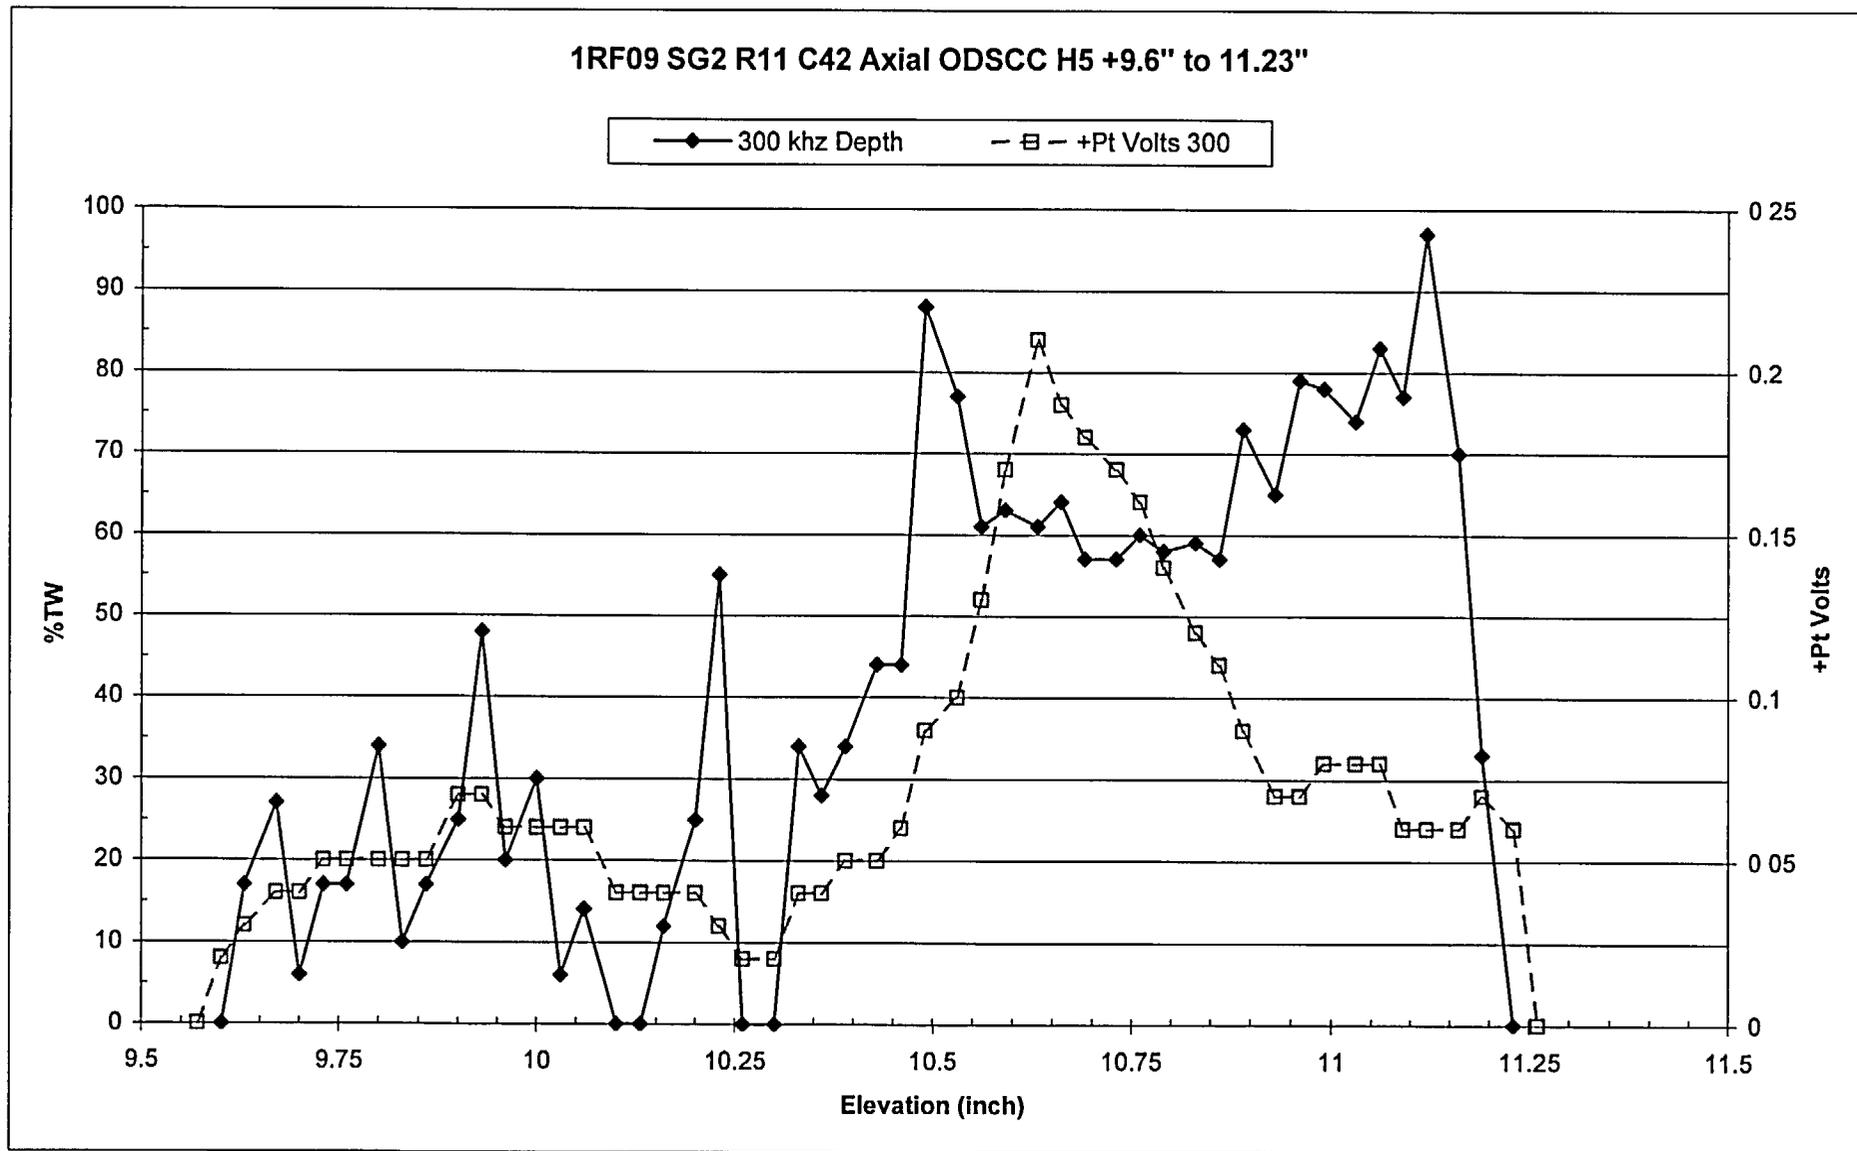
Figure 5 presents the pre in situ +Pt depth profile for R11 C42. As seen from Figure 5, the voltage response is low, but the depth from response is uncharacteristically high. It is believed that this profile is a gross overestimate of truth. The post in situ depth profile shows *shallower* depths compared to the pre in situ profile. This phenomenon was also observed for R7 C17. Signal amplitude for these indications was only marginally increased following pressure testing. The observation of shallower depth responses from phase analysis suggests that the pre in situ depth profile is unreliable. To qualitatively assess the validity of the 300 kHz +Pt profile, the 150 kHz channel was also used for profiling. The 150 kHz responses resulted in flaw amplitudes slightly larger than obtained from the 300 kHz channel, which is expected, but the depth profile resulted in depths of nearly 100%TW over significant lengths. The 150 kHz depth profile shows no relation between depth and amplitude, whereas the 300 kHz profile shows some relation between depth and amplitude for the flaw lengths near the center of the profile. Based on the 150 kHz profile, and using the actual material properties of this tube, leakage should have been experienced at approximately 2000 psi. No leakage was reported at 2841 psi. This evaluation suggests that neither of the phase based depth profiles for R11 C42 is representative of the true depth profile. Additionally, the bobbin coil prime:quarter mix amplitudes for the confirmed flaws are bounded by 0.41 volts for R11 C42 and 0.33 volts for R7 C17. Based on a regression line using the TSP ODSCC pulled tube data for ¾" OD tubing, a mix channel response of 0.41 volts suggests a maximum depth of 48%TW. Therefore, the bobbin amplitudes are inconsistent with the reported depths from phase, and the +Pt amplitudes are inconsistent with the reported depths from phase. As stated above, the post in situ depths from phase are shallower than the pre in situ depths. The post in situ depths from phase begin to approach the depth profile for depths associated with the +Pt amplitude.
