Attached is an update of the lab work associated with Sample Plan Phase 3. This update describes the cracking discovered in the exposed cladding in the Nozzle 3 cavity, and provides a recommendation for further investigation of the cracking. We plan to discuss this recommendation during the conference call scheduled for 10am on Sept 11.

Davis-Besse Reactor Head Sample Characterization

Phase 3

Status Report, 09/10/02

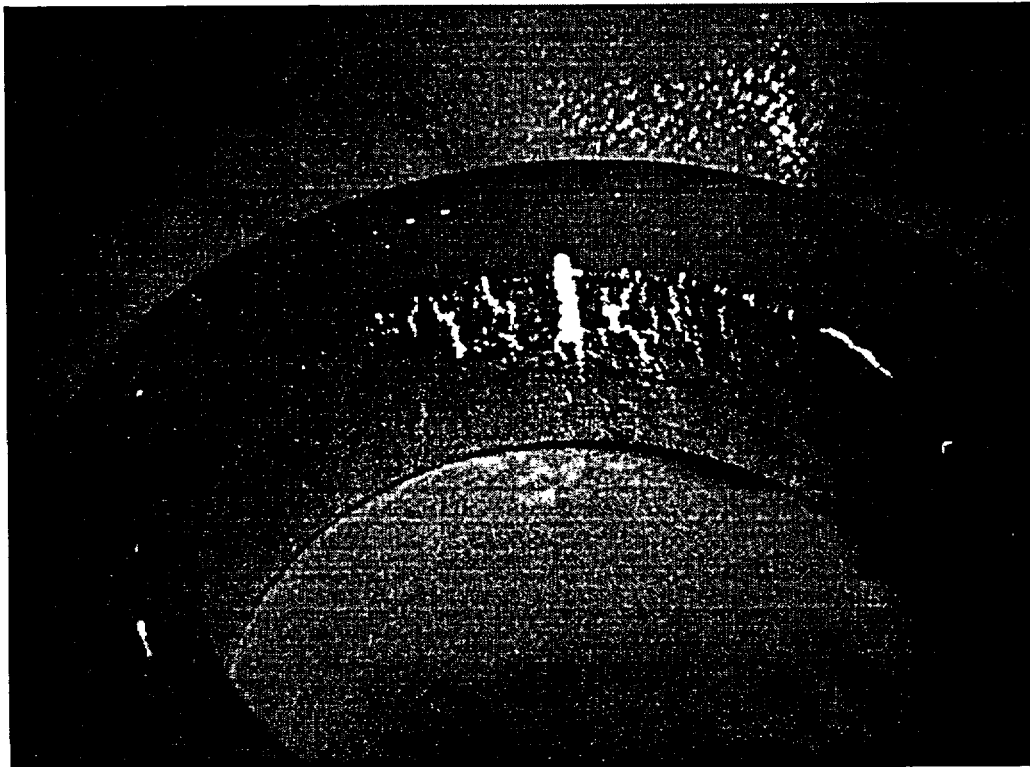
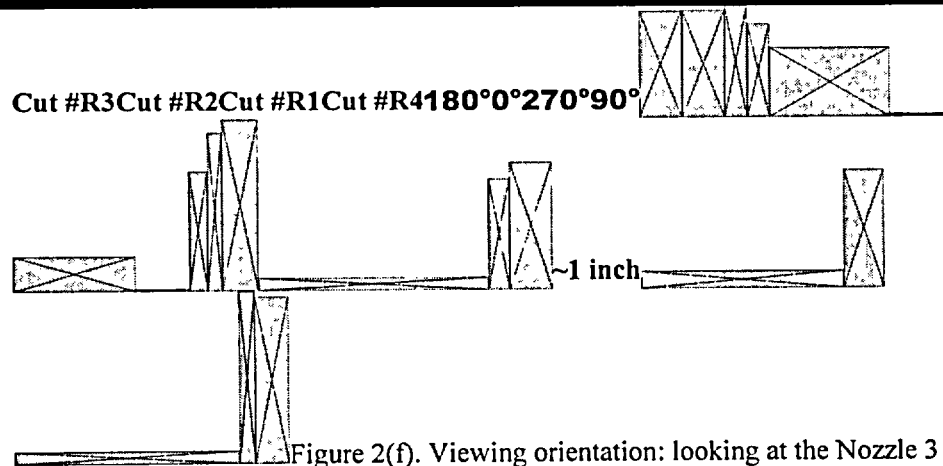
Figure 2(f). Viewing orientation: looking at the Nozzle 3

Completed on 8/26/02; a patch of axial crack-like indications was observed on the lower end of the nozzle OD. The largest indication extended ~0.5" axially and ~1/8" into the nozzle wall. These indications were located on the uphill side of the nozzle (i.e., 180° or the side facing toward nozzle #1).

Proposed sectioning plan for 1" ring from end of nozzle #3 (Dated 09/03/02).

The majority of cracks will be sectioned out of the ring (cuts #R1-3). Also, after Cuts #R1-2, the I.D. surface of the nozzle segment will be examined under SEM. Cut #R4, which is parallel to Cut #3, will be made transverse through the cracks (red line) and the two mirror surfaces will be mounted. This will permit observation of the cracks in two directions with further progressive grinding.

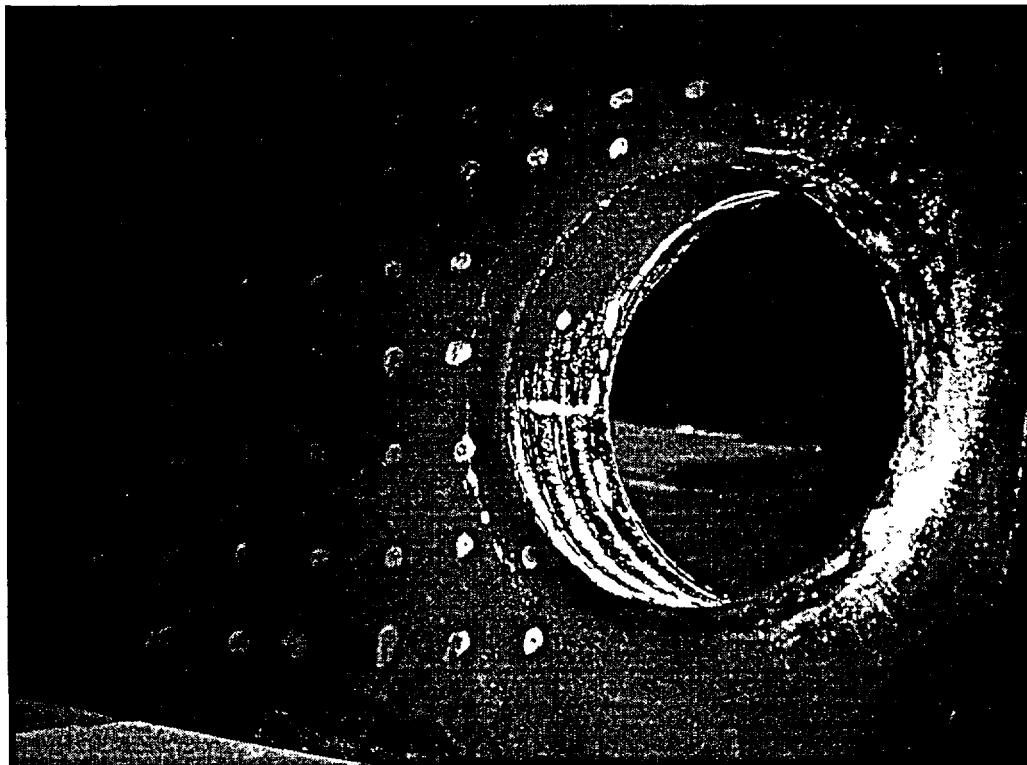
Completed on 8/28/02; linear crack-like indication present on ID surface; circumferential cracking present on the J-groove weld's underside surface (RSC side, the same as stainless steel cladding surface); linear voids present in J-groove weld. See the following three photos.

Figure 3(i)-1. PT results for nozzle #3 J-groove weld. Orientation: looking at stainless steel clad surface (or underside, i.e., RCS side). 0° is downhill side facing the cavity, and 180° is uphill side. A crack-like indication measuring ~1.4" long was present at ~10 degrees on the J-groove weld bore (arrow). This crack was visible on the top of the J-groove weld and was aligned with the deepest portion of the cavity. Circumferential cracking was observed on the J-groove weld's underside surface (same as stainless steel cladding surface). These circumferential cracks are located ~3/4" radially from the penetration bore and between 0° and 45° (higher magnification photos follow). Linearly aligned voids were also present on the J-groove weld bore

~0.3" below the top surface of the J-groove weld. These voids extended from 240 degrees to 30 degrees (through 0 degrees) and measured a maximum ~0.1" wide and ~1.4" in length. These voids likely formed during original welding.

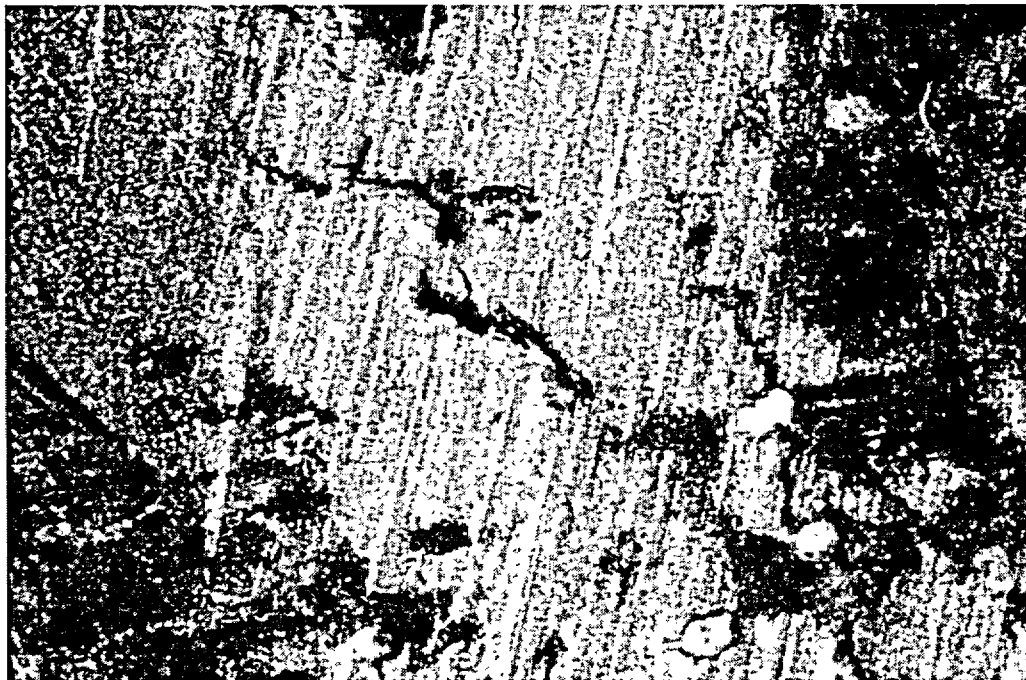
Figure 3(i)-3. Detail of circumferential cracking (40X).

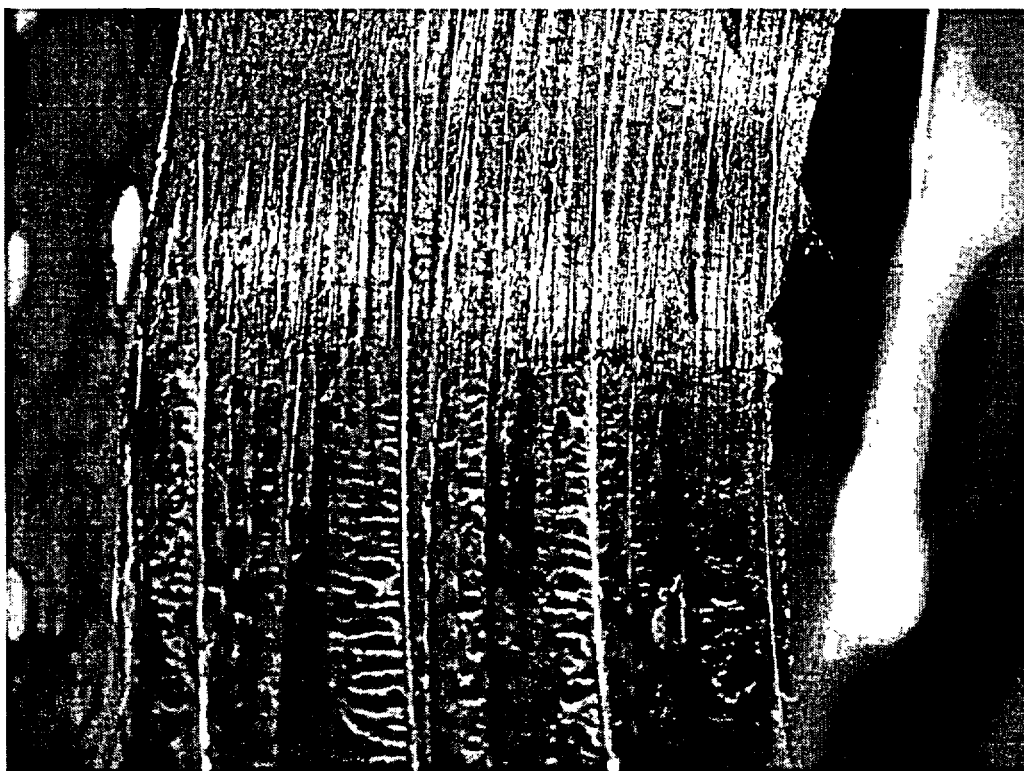
The PT performed did reveal one axial crack indication on the J-groove weld bore surface (180°) and some circumferential crack indications on the J-groove weld un-machined undersurface (0-45°) see above. However, the surface condition of the J-groove weld, especially the upper surface and the machined bore of the J-groove weld are not conducive to PT. Hence, it was decided to use the stereo microscope (up to X50) to completely scan the J-groove weld area. This led to the following new information to the PT indication, cracking indications not revealed by the PT, and cracking in the exposed stainless steel cladding top surface.

Figure 3(i)-4. Looking at J-groove weld underface (bored surface). Crack indication corresponds to axial crack (near 0°) indication in Figure 3(i)-1.

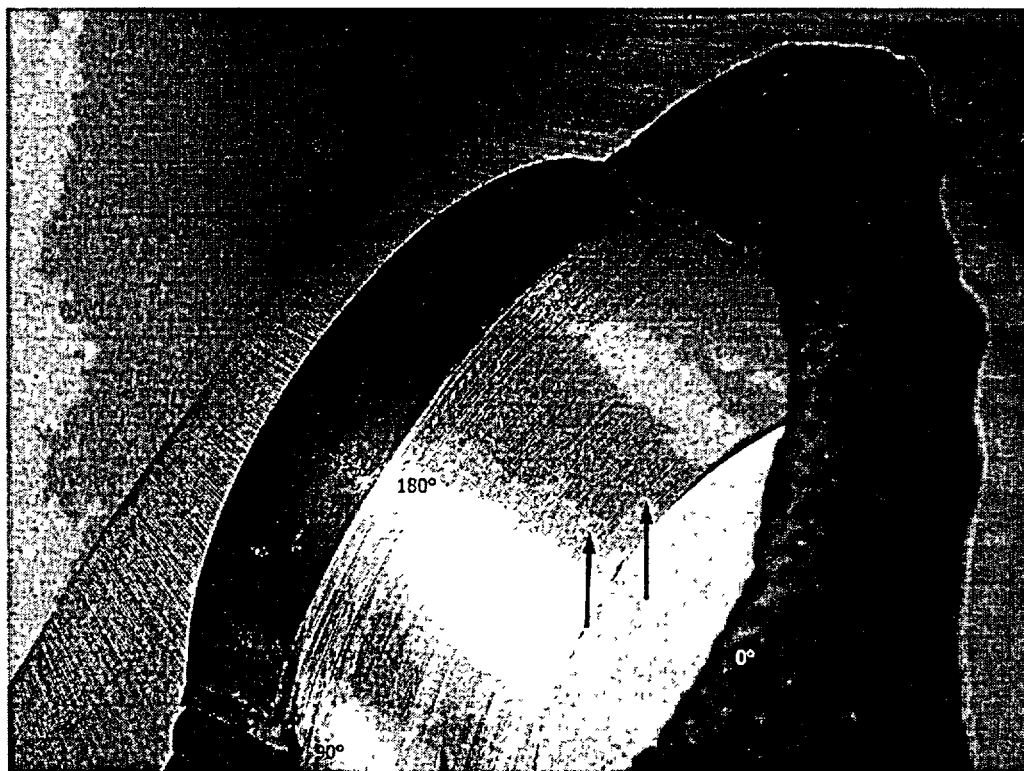
Figure 3(i)-5. Looking from the J-groove weld upper face (the J-groove beads exposed due to the removal of low alloy steel by boric acid corrosion can be seen near the 0°). Axial crack near 180° indications (not revealed by PT). Also see Figure 2(f) of 1" ring of Nozzle 3 axial cracking near 180°. These results suggest that axial cracking near 180° on the Nozzle 3 may be only through the nozzle wall within the length covered by J-groove weld (It is also possible for axial crack to be through the nozzle wall below the J-weld).

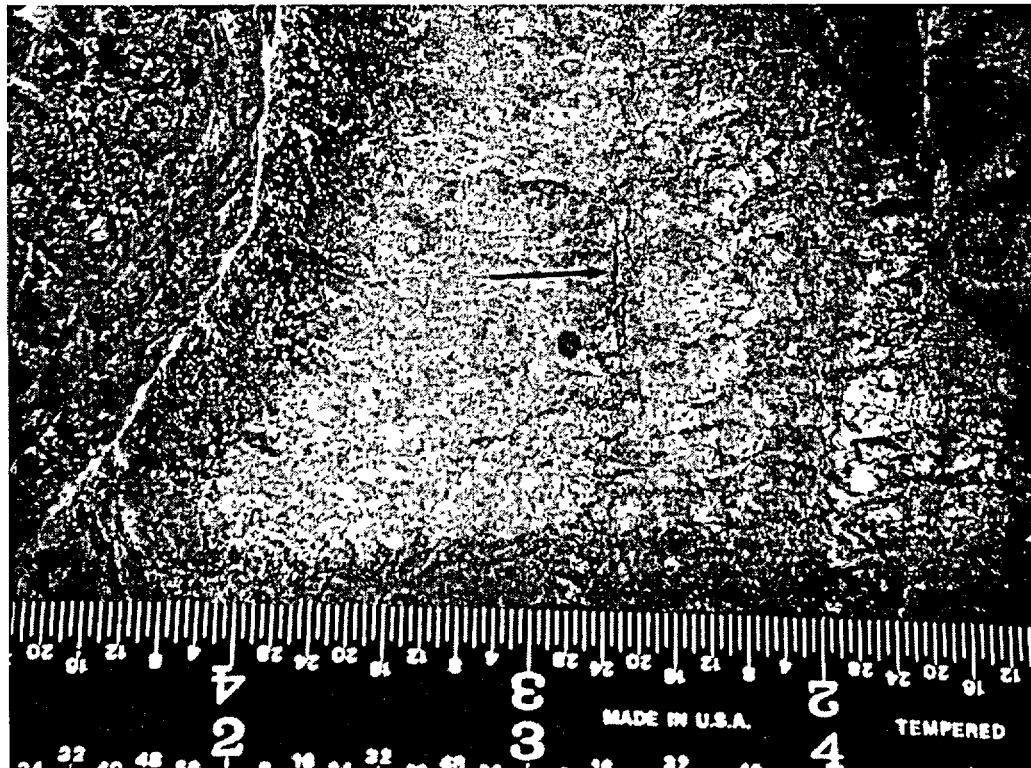
Figure 3(i)-6, crack indications in the upper stainless steel clad surface in the area of maximum upward deflection (also see Figure 3(f) below for orientation). These indications were mostly about 1.25" from the J-groove weld edge and do not appear to be associated with the circumferential cracking in the J-groove weld underface in Figure 3(i)-1.

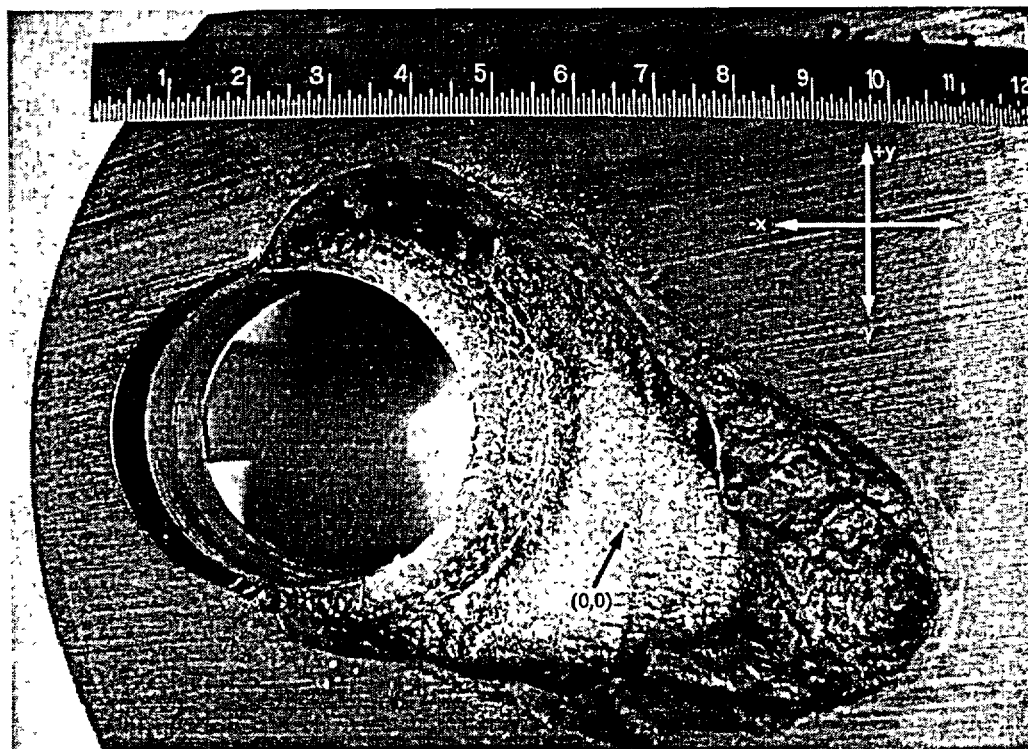
Figure 3(i)-7. Top view of the corrosion cavity after Cut #5. This lower part of Block A is designated "Block A2". The crack indications on the cladding surface, by coincident, are near the red dot (0,0) pointed by the arrow. The red dot (0, 0) was previously used for establishing the Cartesian coordinates for the exposed cladding thickness measurements shown in Figure 3(j).

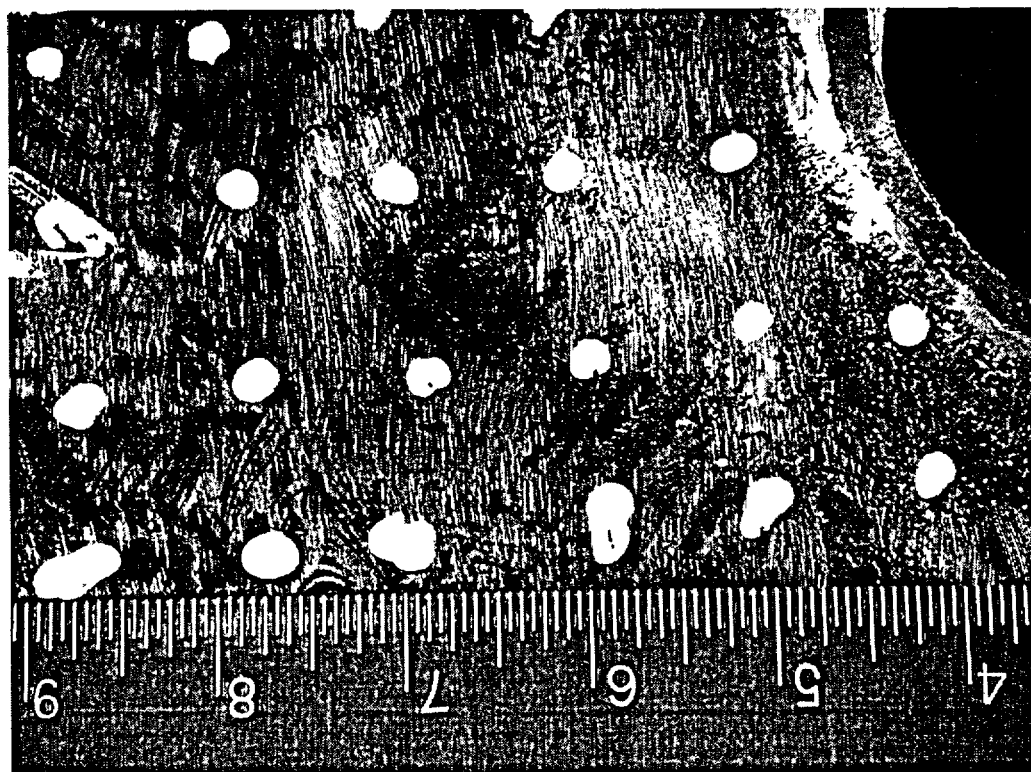
Figure 3(i)-10. Underside (RCS side) of the corrosion cavity, area around maximum deflection (bulging). No indication of cracking is found on the underside with stereomicroscope scanning.

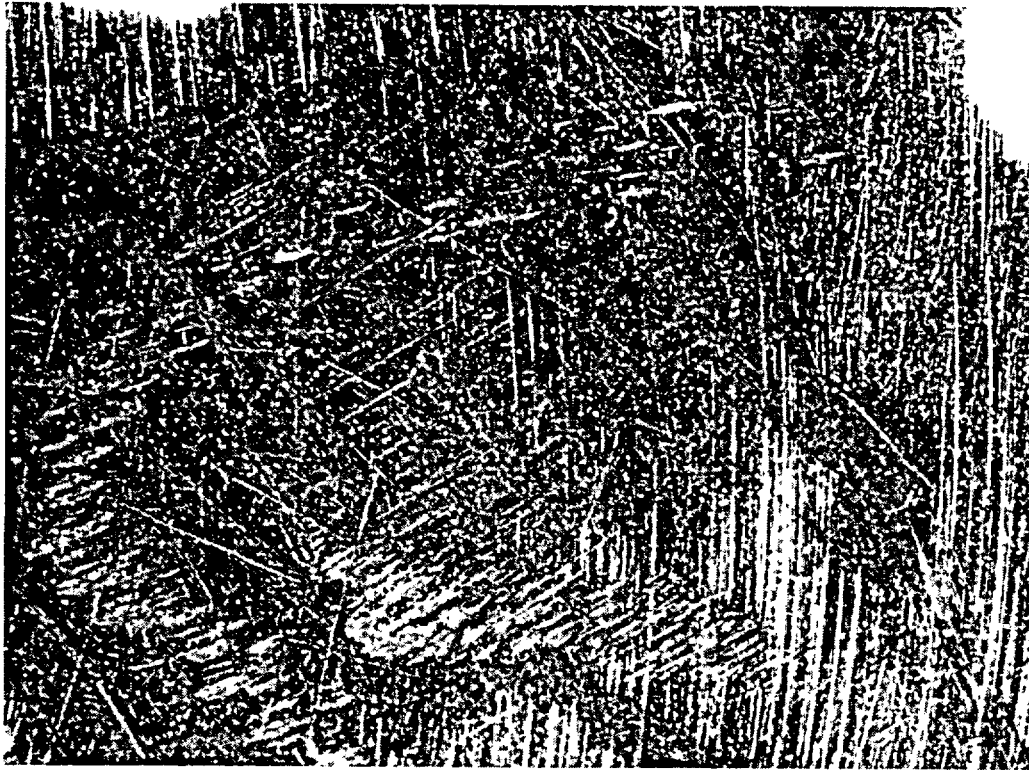
Figure 3(i)-11. Close-up of underside (RCS side) of the corrosion cavity, inside the maximum deflection 6X. No indication of cracking is found on the underside with stereomicroscope scanning.

- (1) PT the cladding underside (RCS side), covering the entire underside area corresponding to the exposed cladding on the upperside. This will look for signs of any cracking on the underside or if any cracks on the upperside extending to the underside, creating a leak path. The attempt will be made to remove the white dots/markings with chemical solvent. Mechanical means of removing these dots or surface preparation will Not be used.
- (2) PT the upperside of the cladding around the area of maximum deflection and to PT as much area as possible. However, the cavity edge will be excluded due to remaining overhang. This is to capture the extent of the cracking on the top side. However, substantial PT background noise due to the surface condition is expected based on prior experience with the J-groove weld PT. No surface preparation by mechanical means will be performed prior to PT.
