# NRC Assessment of Davis Besse Head Degradation

**Jack Grobe,**

**Mark Kirk,**

# Wastage found in the Vessel Head

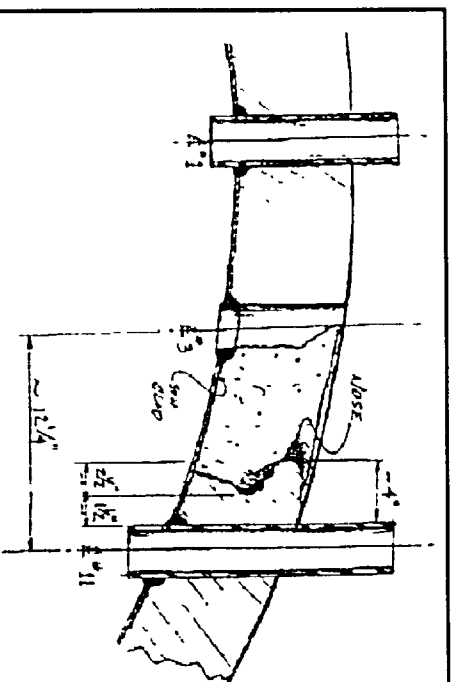
The above figure shows the Davis Besse reactor vessel head degradation between nozzle #3 and nozzle #11. This sketch was provided to the NPC by the licensee
