OPERATIONS NOTEBOOK

SUBJECT: Contingency Strategy

Contingency Strategy for the Failure of One B Train EDG

One Line Description: Service Water (SW) to Auxiliary Feedwater (AFW) Pump Suction Power Supply Issues

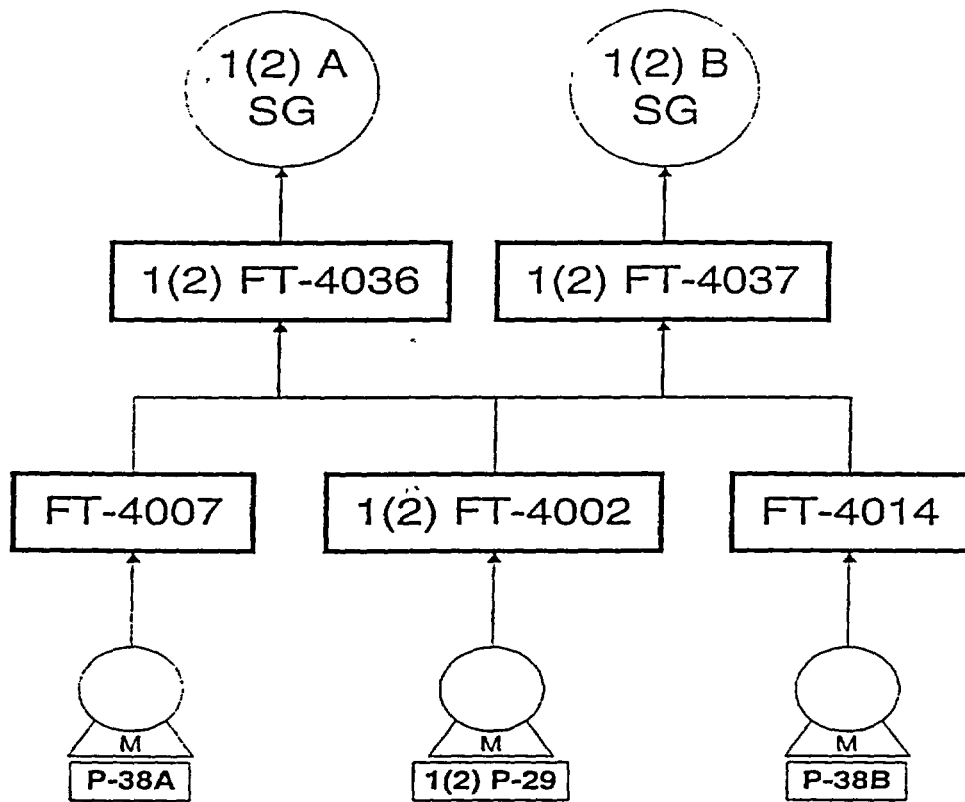
FLOW INDICATORS FOR BOTH UNITS

The attached figure shows the arrangement of individual pump flow indicators and the total flow indicators to each S/G. Should a single AFW pump flow indicator fail, it is still possible to readily determine that pumps flow by looking at the total AFW flow to the applicable S/G and subtracting the known flow of any other AFW pump that may be providing flow. It may also be possible to readily determine individual AFW pump flows for multiple AFW pump failures and/or individual AFW pump flow indicators, depending on the combination of failures, utilizing the same methodology.

If at anytime an individual AFW pump flow cannot be determined to be greater than the minimum required (50 gpm for P-38A/B and 75 gpm for 1(2)P-29) then the affected AFW pump shall be immediately secured to prevent pump damage until adequate flow can be established.
