# OPERATIONS NOTEBOOK

SUBJECT: Contingency Strategy

## Contingency Strategy for the Failure of One B Train EDG

SUBJECT: AFW SW MOV power supplies

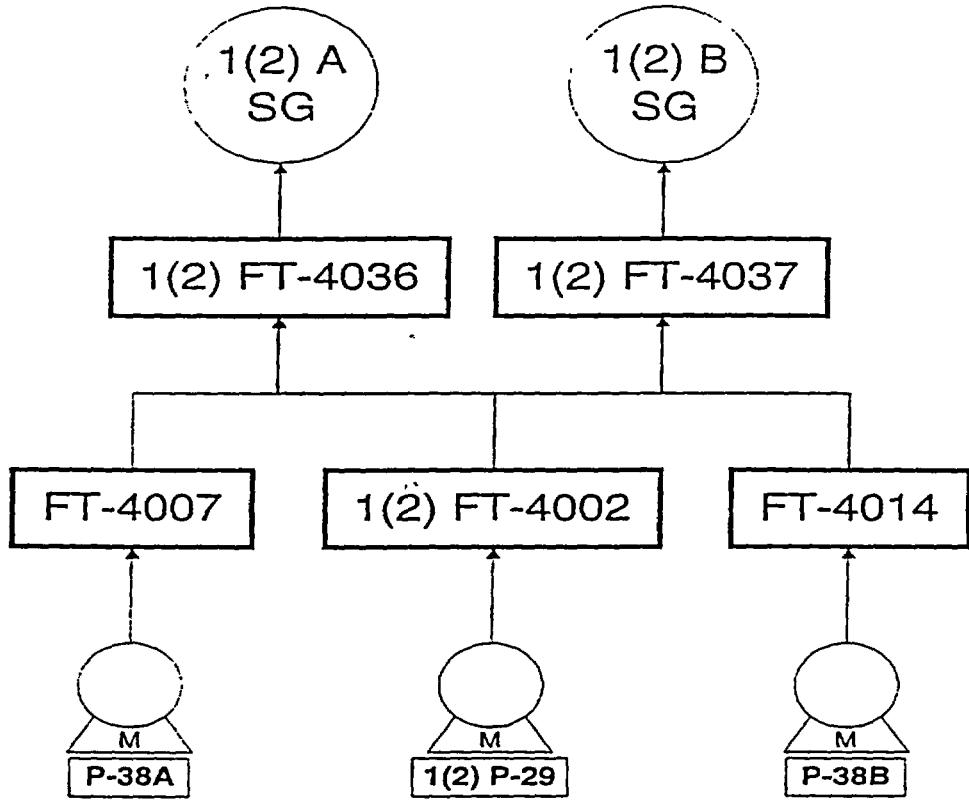
# FLOW INDICATORS FOR BOTH UNITS

The attached figure shows the arrangement of individual pump flow indicators and the total flow indicators to each S/G. Should a single AFW pump flow indicator fail, it is still possible to readily determine that pumps flow by looking at the total AFW flow to the applicable S/G and subtracting the known flow of any other AFW pump that may be providing flow. It may also be possible to readily determine individual AFW pump flows for multiple AFW pump failures and/or individual AFW pump flow indicators, depending on the combination of failures, utilizing the same methodology.

If at anytime an individual AFW pump flow cannot be determined to be greater than the minimum required (50 gpm for P-38A/B and 75 gpm for 1(2)P-29) then the affected AFW pump shall be immediately secured to prevent pump damage until adequate flow can be established.
