Subject: LER -2003-001-00 Manual Reactor Scram (#106) Due To Loss  
Of Condensate/Feedwater]

Grand Gulf Nuclear Station  
Docket No. 50-416  
License No. NPF-29

GNRO-2003/00015

**4. TITLE**  
**Manual Reactor SCRAM Due To Loss Of Condensate/Feedwater**

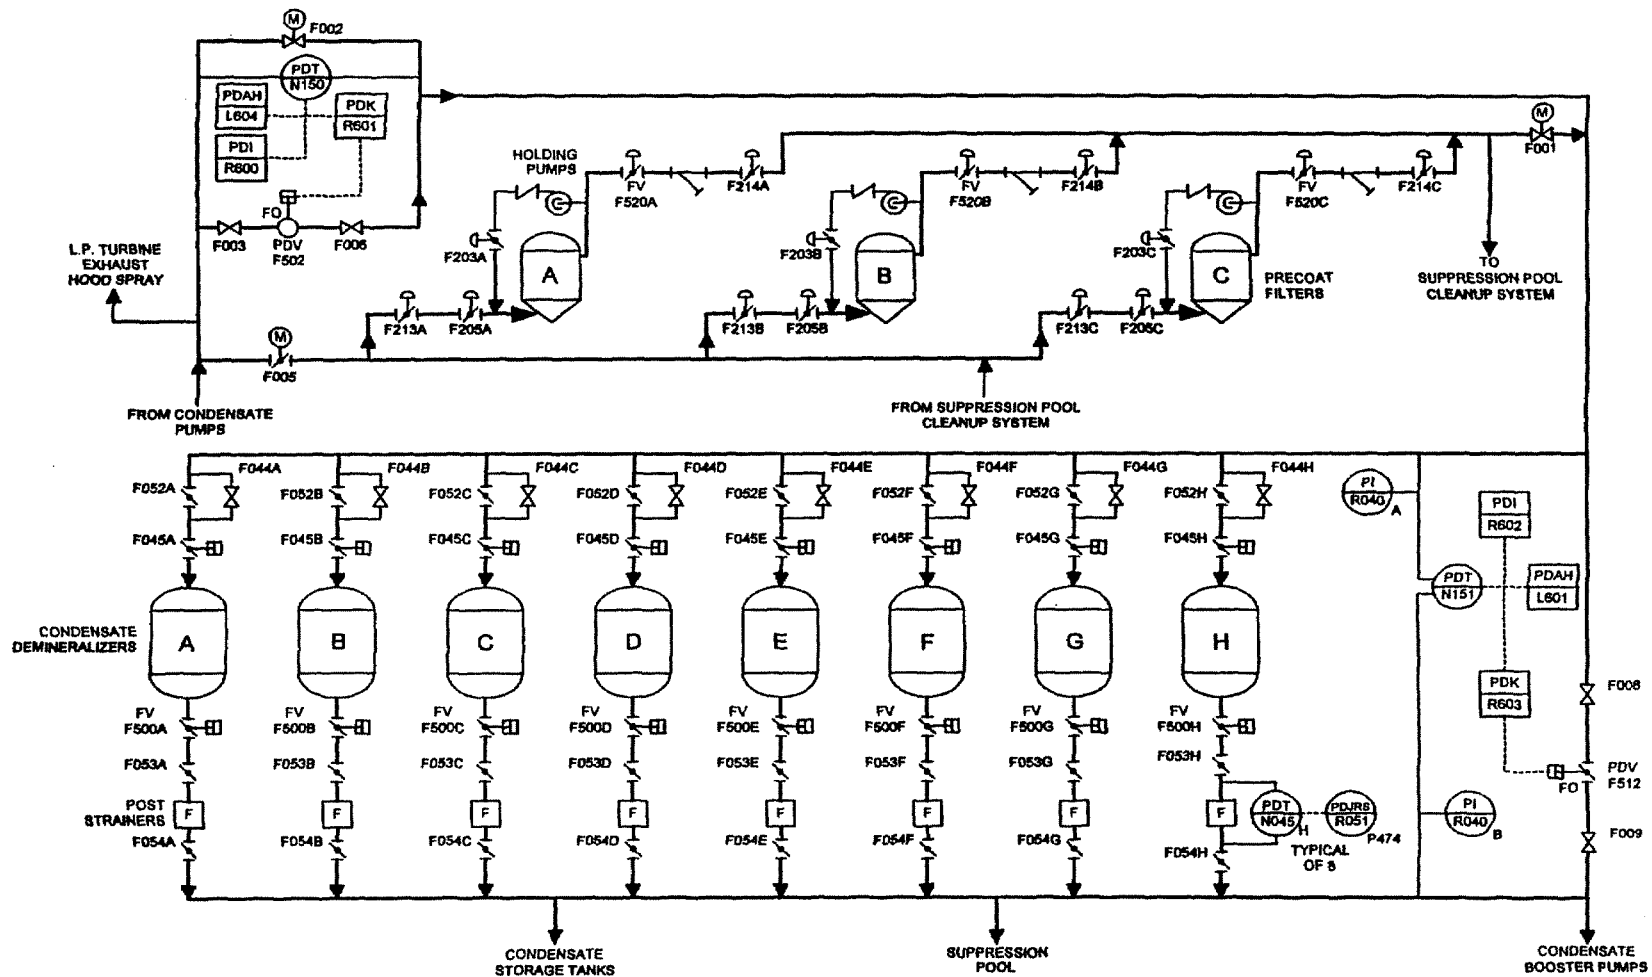
**Condensate Cleanup System**  
Figure 1

Investigation revealed that as they seated the flexible conduit into the 45 degree elbow, an apparent pre-existing nick in the insulation failed allowing a bare wire to make contact with the grounded elbow. This caused a breaker (2L1) in the Condensate Cleanup Control Panel (1H22-P474) to trip. The breaker trip de-energized position indication for the demineralizer inlet valves. The loss of indication on the inlet valves caused the outlet valves for all in-service demineralizers to go closed.

The demineralizer outlet valves are interlocked to the inlet valves such that when the inlet valves are not full open, the outlet valves will automatically close. The other valves in the system have their indication powered directly from the 2L1 source and therefore lost all associated indication at Panel 1H22-P474.

- All demineralizer inlet valves indicated dual position
- The respective position indicating contacts for all demineralizer inlet valves opened, removing the control signal to all demineralizer outlet valves' current-to-pneumatic (I/P) controllers, simultaneously closing all 7 operating demineralizer outlet valves.

Schematic of the condensate demineralizer system.

Additionally, a modification to the condensate system to remove the interlock between the demineralizer inlet and outlet valves has been completed.
