Subject: LER -2003-001-00 Manual Reactor Scram (#106) Due To Loss
Of Condensate/Feedwater]

Grand Gulf Nuclear Station
Docket No. 50-416
License No. NPF-29

GNRO-2003/00015

4. TITLE
Manual Reactor SCRAM Due To Loss Of Condensate/Feedwater

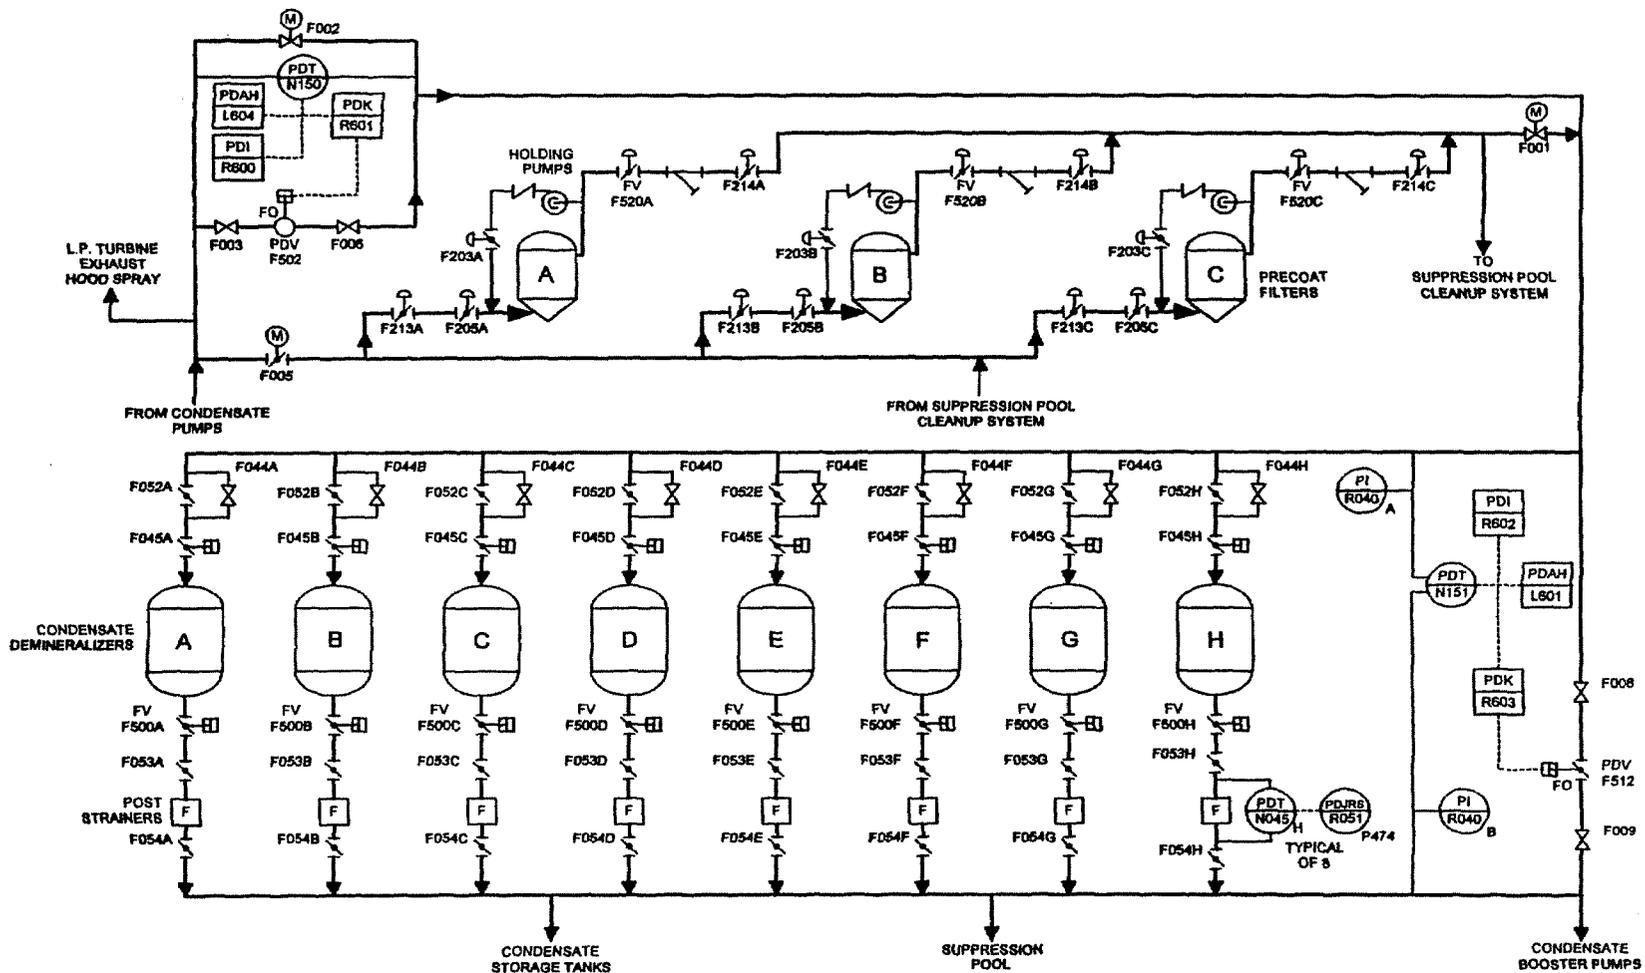
Condensate Cleanup System
Figure 1

Schematic of the condensate demineralizer system.
