Reactor Pressure Vessel Head Material Degradation

Dr. Brian W. Sheron

Associate Director for Project Licensing and Technical Analysis
Office of Nuclear Reactor Regulation
U.S. Nuclear Regulatory Commission

Penn State University
September, 2002

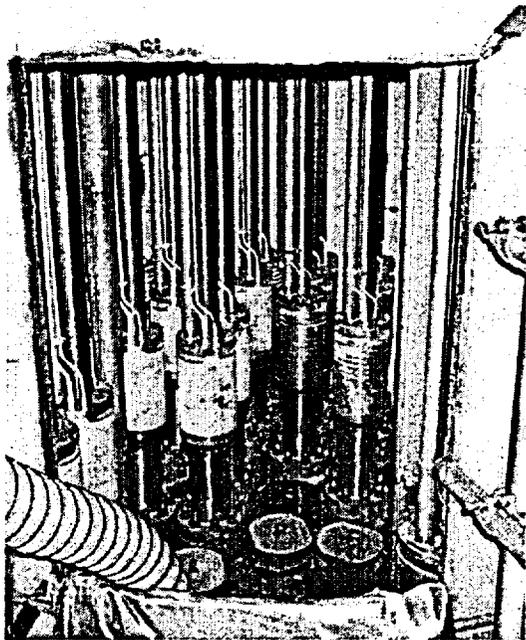
Control Rod Drive Mechanisms

Nozzle #3
Removed

Control
Rod Drive
Mechanism
Still Bolted
to Nozzle

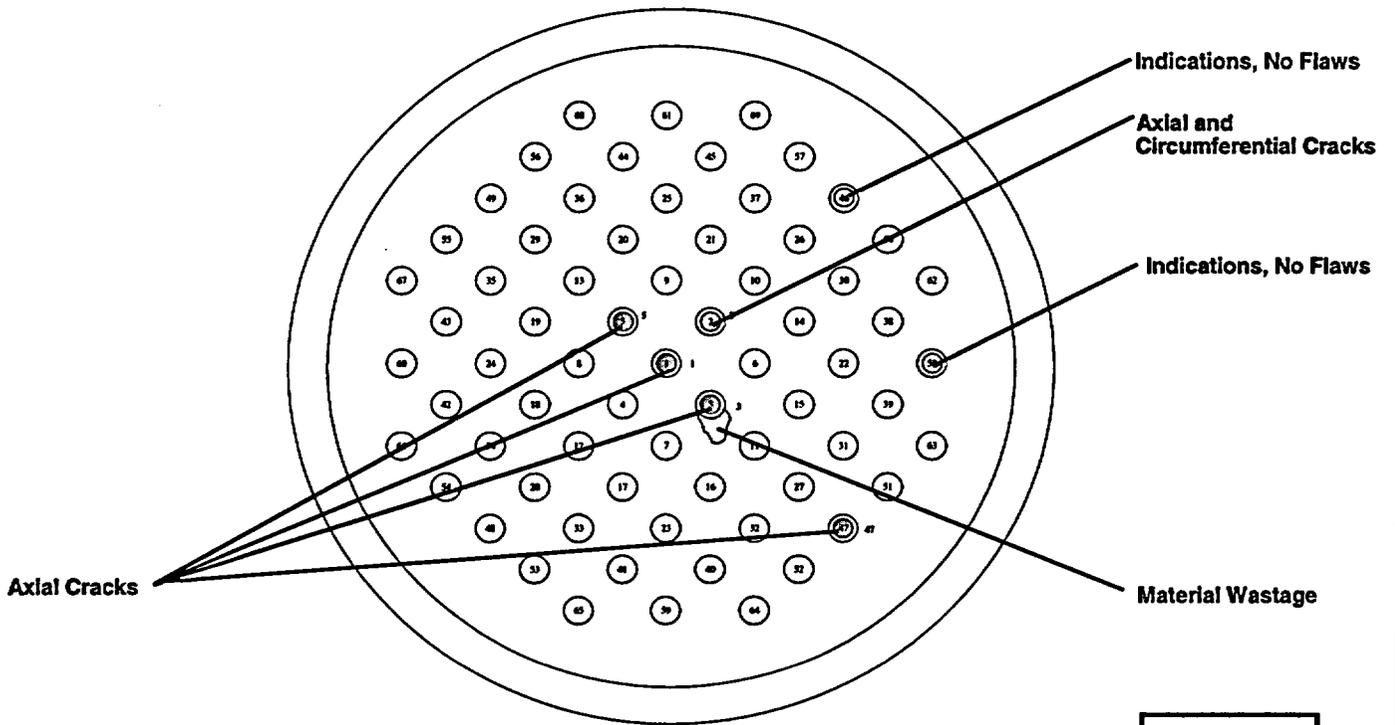
CRDM Nozzle Map

- Davis-Besse Visual Inspection of RPV Head per NRC Bulletin 2001-01
 - February - March 2002
- UT Inspection of All 69 CRDM Nozzles
 - 5 Nozzles with Indications, 3 with Throughwall Cracks
 - Cavity Found Adjacent to Nozzle #3
 - Degraded Area Near Nozzle #2
 - Significant Boron and Corrosion Deposits on the RPV Head

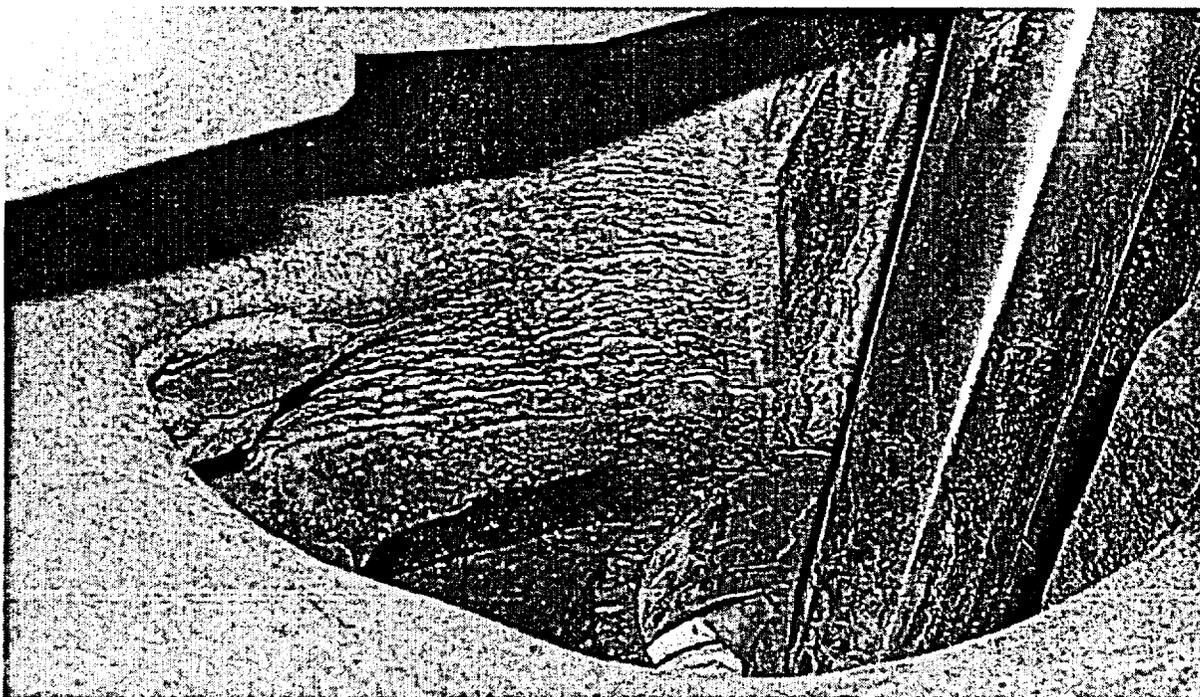
RPV Head Degradation

- **Primary Water Stress Corrosion Cracking**
 - **Susceptible Materials**
 - Alloy 600 Nozzles
 - Alloy 82/182 Welds
 - **Highly Susceptible Heat of Material**
 - 4 Out of the 5 Nozzles with M3935 Were Cracked
 - **High Tensile Stress Because of Weld Residual Stresses (J-Groove Weld)**
 - **Aggressive Environment, High Head Operating Temperature**
 - **Leakage Through Cracks in the Nozzles**

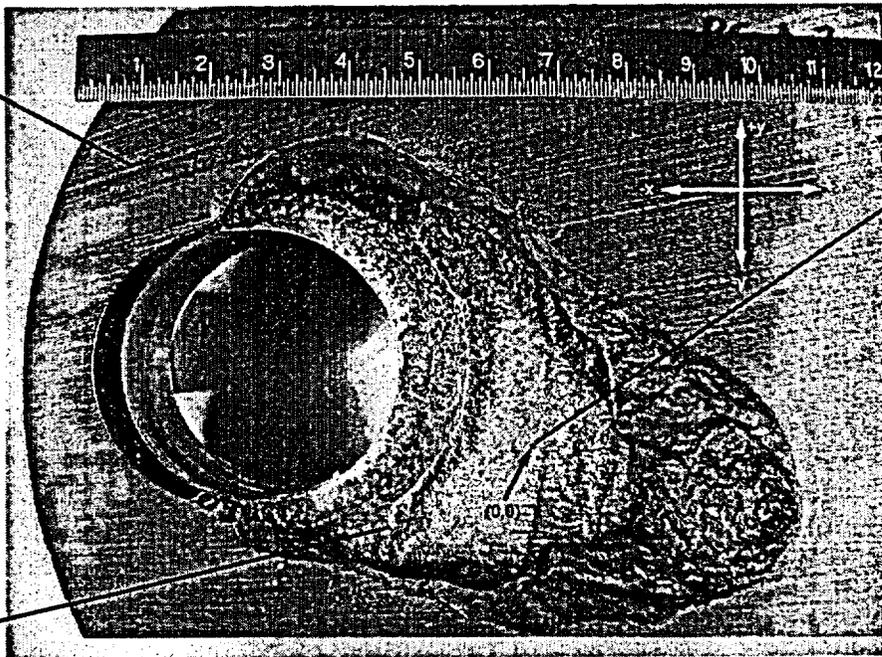
Carbon Steel
RPV Head

Crack in
Cladding

Stainless Steel
Cladding
