REPORT TO CONGRESS
ON
ABNORMAL OCCURRENCES
FISCAL YEAR 2002

April 2003

Office of Nuclear Regulatory Research
United States Nuclear Regulatory Commission
Washington, DC 20555-0001

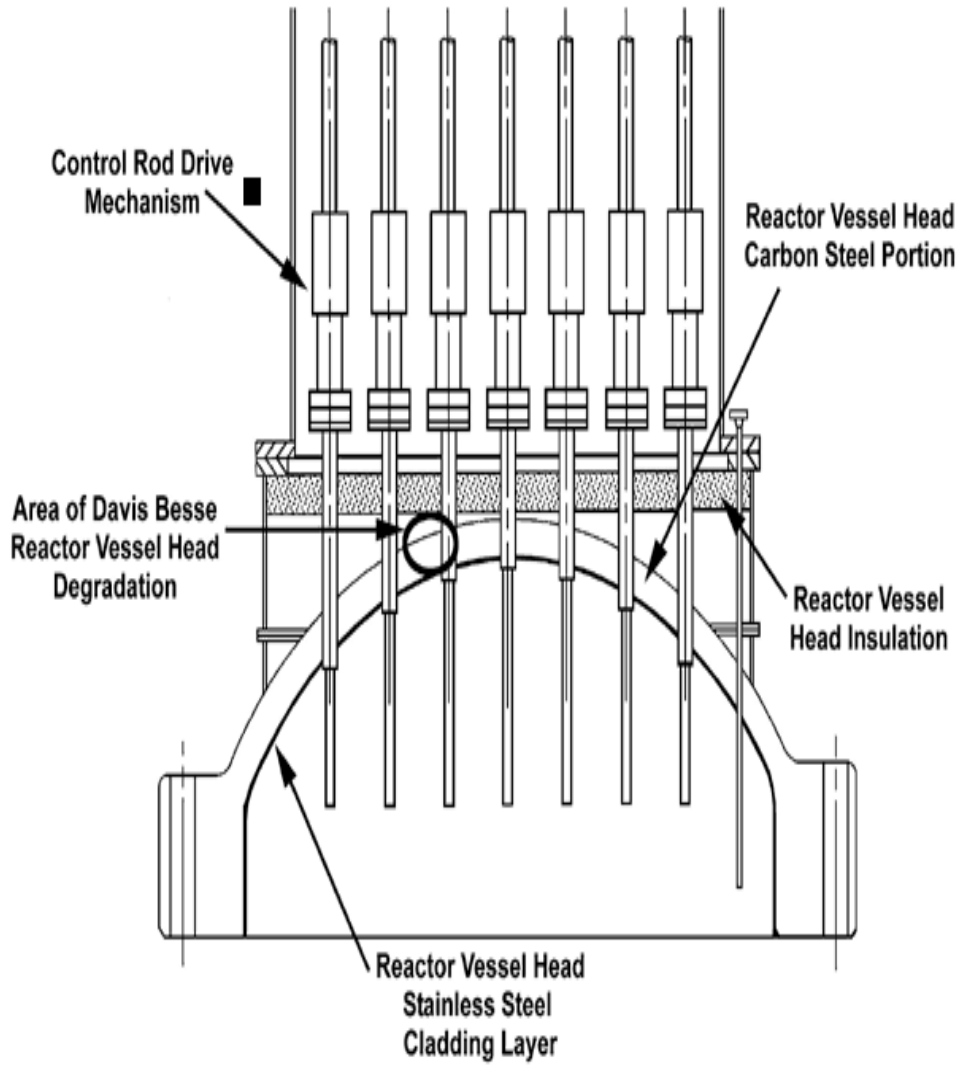
Figure 2. Reactor Vessel Head Degradation Location at Davis-Besse

On February 27, 2002, the licensee notified the NRC that non-destructive examination of CRDM Nozzles 1, 2 and 3 identified that those nozzles contained small through-wall cracks. The licensee decided to repair these three nozzles plus two other nozzles with identified cracks that did not appear to be through-wall. The repair process included machining away the lower portion of the CRDM nozzle to a point above the cracks in the nozzle material. During this activity, CRDM nozzle 3 loosened in the head and on March 6, 2002, the licensee began an investigation to identify the cause. At the same time, activities were underway to remove boric acid deposits from the top of the RPV head caused by leakage of reactor coolant from the cracks and past leaking CRDM flanges. After removing the boric acid deposits, the licensee identified a large corrosion cavity in the head material adjacent to CRDM Nozzle 3 (Figure 2). The cavity was approximately 6 inches in length and 4 to 5 inches in width. Within this area the 6.63 inch thick low alloy steel head was corroded away leaving only the stainless steel cladding layer on the inside. The remaining cladding layer ranged in thickness from 0.20 to 0.31 inches. Subsequent metallurgical examination of this section of cladding identified a shallow crack approximately 3/8 inch in length. This cladding layer is designed as a corrosion resistant layer

and is not specifically designed to retain reactor operating pressure. In addition to the cavity adjacent to Nozzle 3, a comparatively small cavity was identified adjacent to Nozzle 2. This cavity was approximately 1.75 inches wide, 4 inches long, and 0.25 inches deep.

Cause or Causes — On April 18, 2002, the licensee submitted its Root Cause Analysis Report to the NRC. In this report, the licensee concluded that the most probable technical cause of the RPV head degradation was boric acid corrosion resulting from leakage through a crack in the CRDM penetration nozzle attributable to primary water stress corrosion cracking. Further, this corrosion had occurred over a period of several years. Absent more definitive information, the licensee's technical root cause analysis represents a plausible scenario for the degradation.

Licensee — The licensee elected to replace the damaged head with one procured from the owners of the canceled Midland nuclear power plant located in Michigan. The licensee has also completed a number of activities designed to identify the management and human performance deficiencies which contributed to the degradation of the reactor vessel head and implemented a series of inspections and evaluations to identify and correct any other potentially problematic plant issues.
