Mark B. Bezilla
Site Vice President724-682-5234
Fax. 724-643-8069April 4, 2003
L-03-064U. S. Nuclear Regulatory Commission
Attention: Document Control Desk
Washington, DC 20555-0001**Subject: Beaver Valley Power Station, Unit No. 1 and No. 2
BV-1 Docket No. 50-334, License No. DPR-66
BV-2 Docket No. 50-412, License No. NPF-73
Supplemental Information Supporting Proposed Alternative Repair
Methods for Reactor Vessel Head Penetrations (Relief Request No.
BV3-RV-04)**

Beaver Valley Power Station, Unit No. 1 and 2
Supplemental Information Supporting Proposed Alternative Repair Methods for Reactor
Vessel Head Penetrations (Relief Request No. BV3-RV-04)
L-03-064
Page 2

The Embedded Flaw Process for Repair of Reactor Vessel Head Penetrations and Its Application at North Anna Unit 2

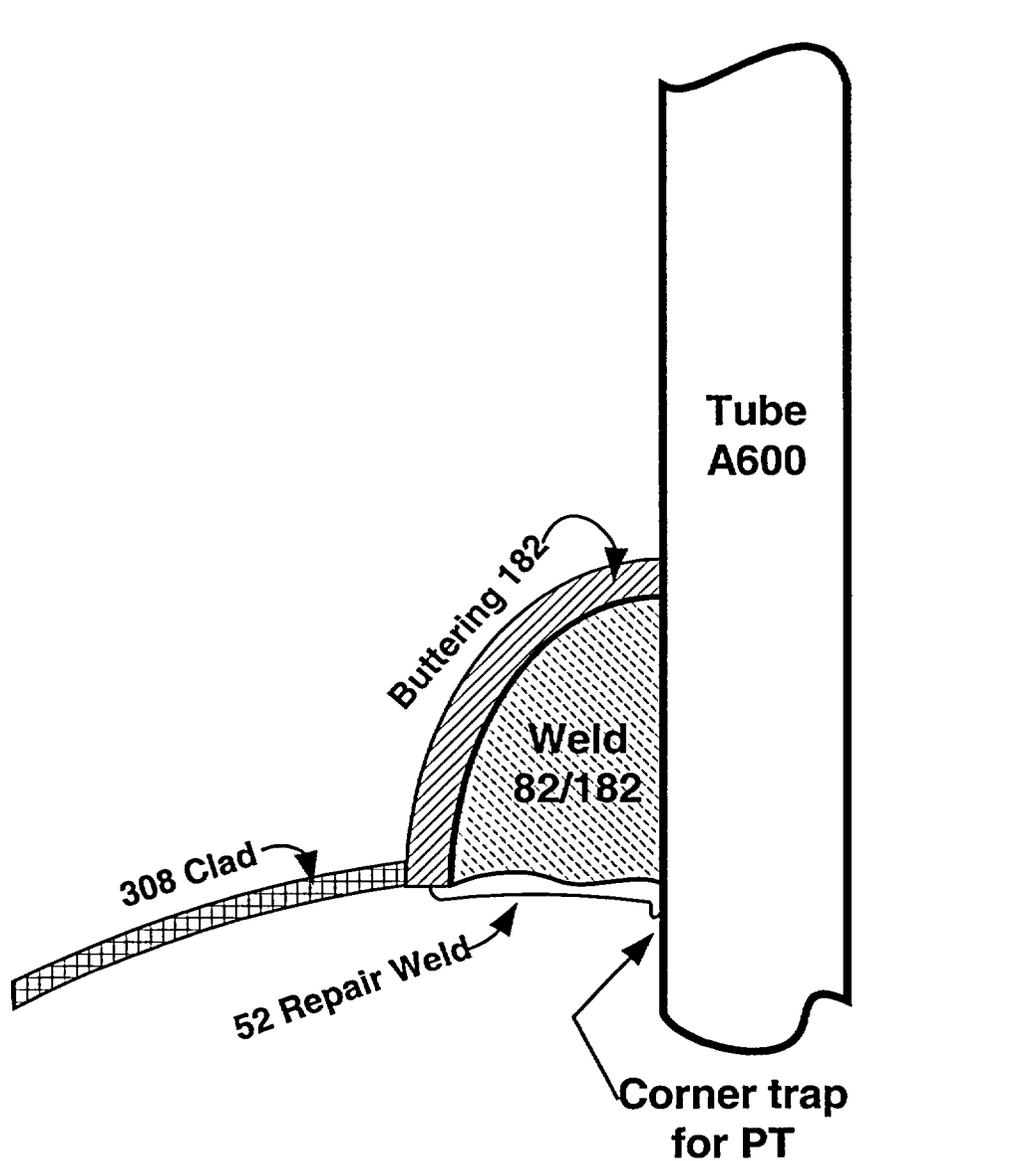
Figure 2-1 As-Repaired Configuration

Four penetrant indications were found at the inner toe of the repair weld, at the boundary with the penetration tube. This configuration is shown in Figure 2-1, and labeled "corner trap for PT." The weld boundary was not completely blended at this location. This left some sharp corners, which retained penetrant. This type of indication was found on penetrations 62 and 63. As noted in Section 2.2, this region was also conditioned with a flapper wheel, which may have led to the indications. All four of these indications were characterized as linear, and all were concluded to be non-relevant indications due to geometric discontinuities.

The indications on the inner periphery of the repair weld, near its boundary with the penetration tube, were the result of the geometry created by lack of blending of the weld layer to the tube surface. These indications were removed by blending to the tube interface, and verified by PT.

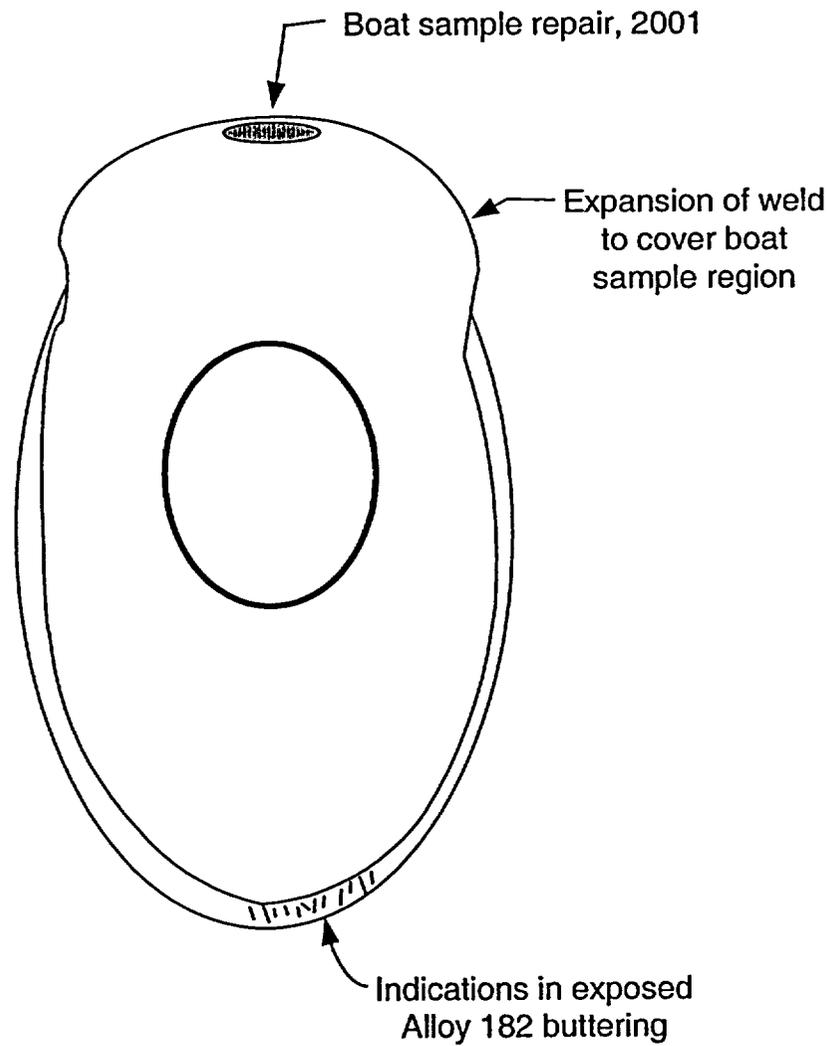
In studying the penetrant results for penetration 62, it was noted that the repair weld was extended outward along the top portion to cover the area where the boat sample had been taken. The results of the boat sample were reported in reference [9] and showed that the boat sample was almost entirely in the buttering. Therefore, the extension of the weld repair in the upper portion of the penetration, in this case, fully covered the buttering. It seems possible that the indication at the bottom portion of this penetration may have resulted from the incomplete extension of the repair weld in that region.

Figure 3-1 Sketch of Weld Repair on Penetration 62, showing the extension to cover the buttering and the portion of the butter that was exposed.

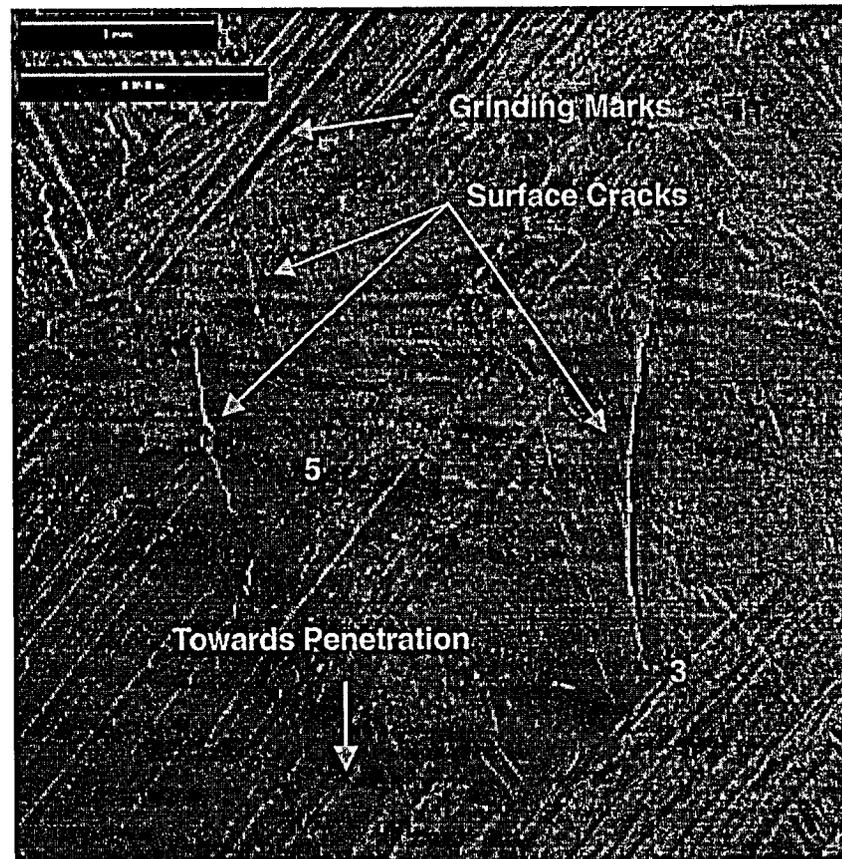
Figure B-4 Surface Cracks in Ground Area at Linear PT 135° Location

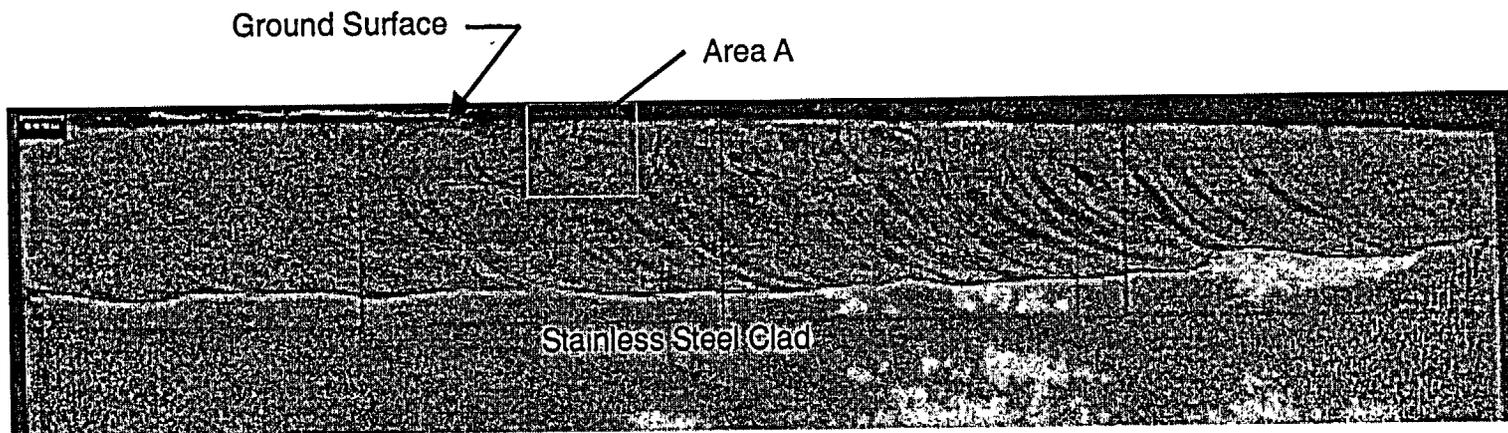
Figure B-7 Section B1 at Tip of PT Indication showing Hot Cracking at Weld Layer Interfaces

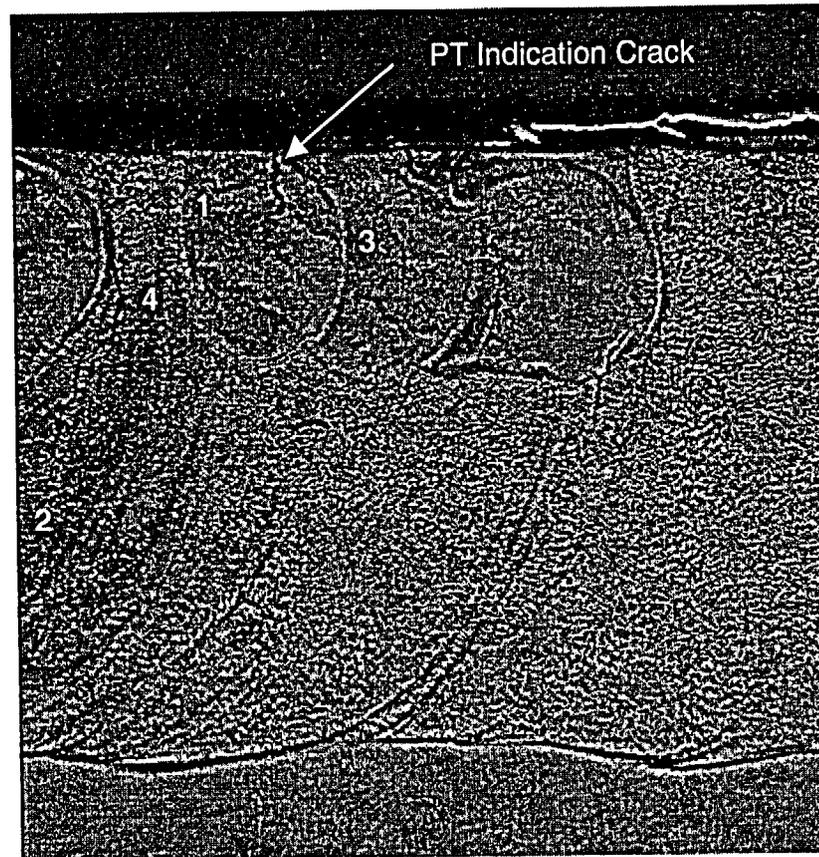
Figure B-7A Area A from Figure B-7 showing PT Indication and Other Hot Cracking with EDS Analyses

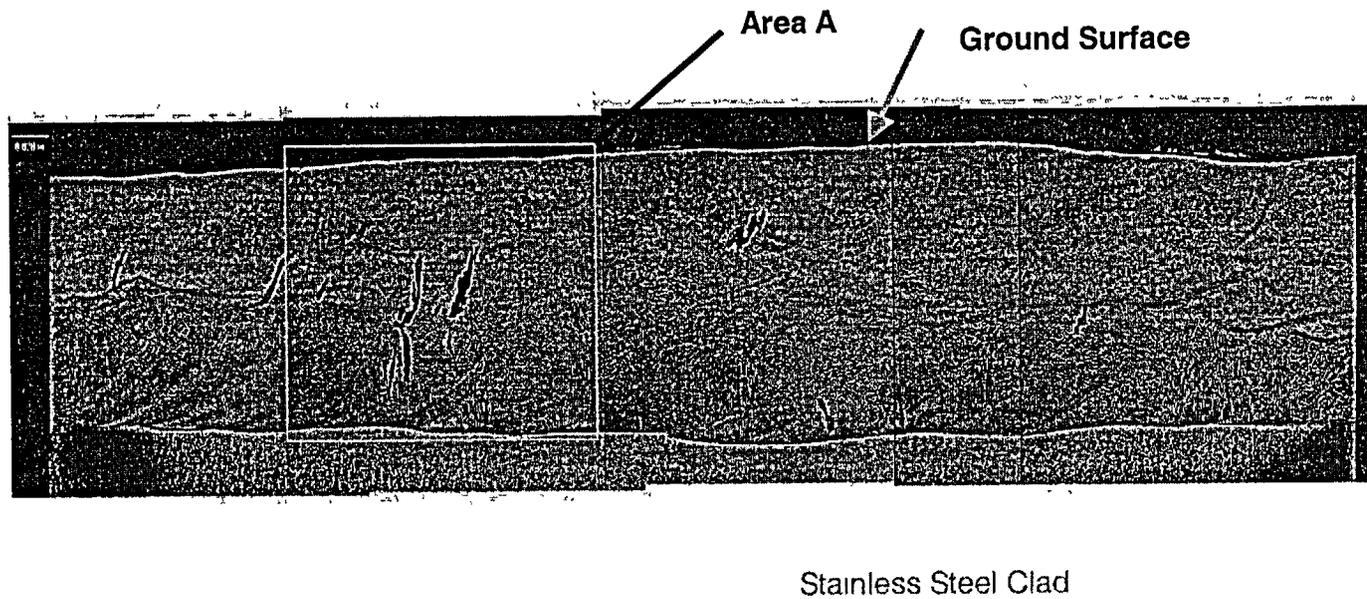
Figure B-8 Section B2 showing Hot Cracking at Weld Layer Interface

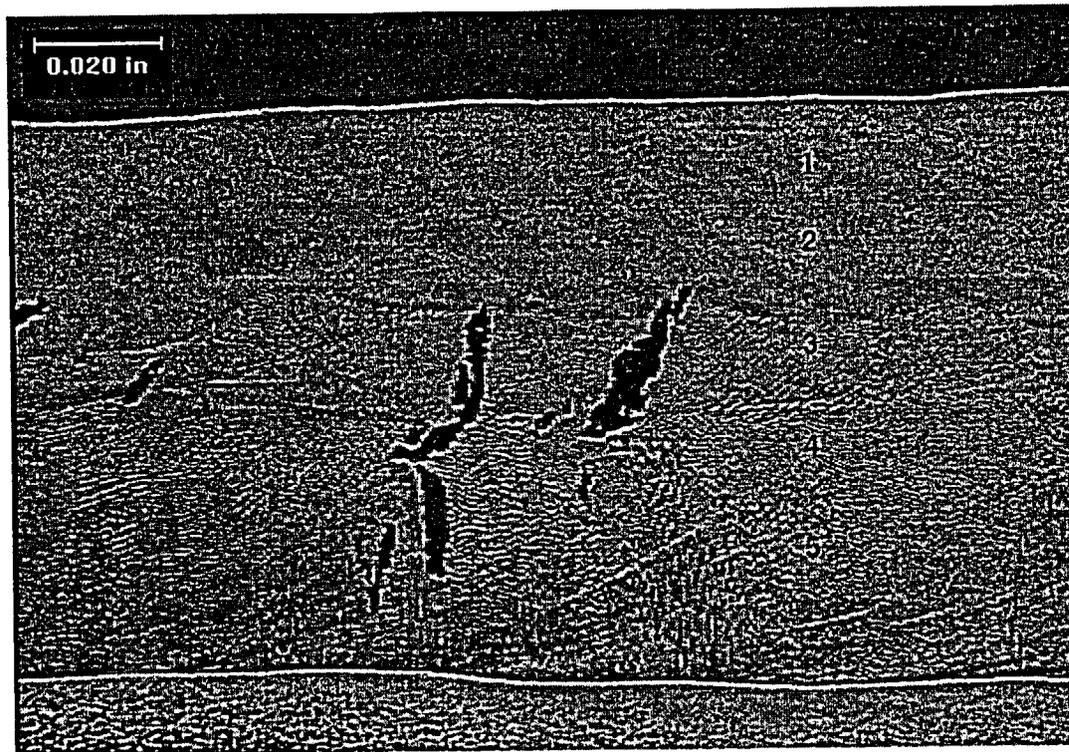
Figure B-8A Area A from Figure B-8 Showing Hot Cracking and EDS Analyses
