# Report to Congress on Abnormal Occurrences

## Fiscal Year 2002

**U.S. Nuclear Regulatory Commission  
Office of Nuclear Regulatory Research  
Washington, DC 20555-0001**

NUREG-0090  
Vol. 25

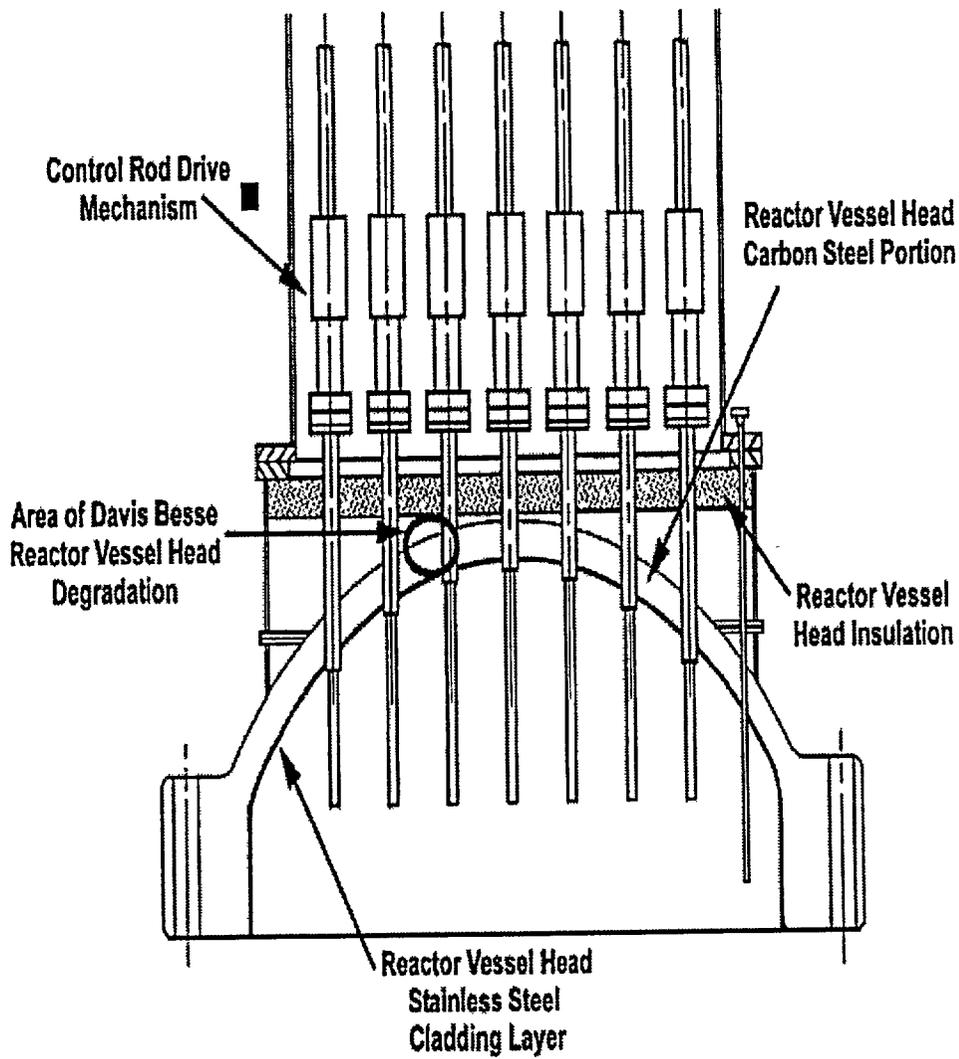
Figure 2. Reactor Vessel Head Degradation Location at Davis-Besse

On February 27, 2002, the licensee notified the NRC that non-destructive examination of CRDM Nozzles 1, 2 and 3 identified that those nozzles contained small through-wall cracks. The licensee decided to repair these three nozzles plus two other nozzles with identified cracks that did not appear to be through-wall. The repair process included machining away the lower portion of the CRDM nozzle to a point above the cracks in the nozzle material. During this activity, CRDM nozzle 3 loosened in the head and on March 6, 2002, the licensee began an investigation to identify the cause. At the same time, activities were underway to remove boric acid deposits from the top of the RPV head caused by leakage of reactor coolant from the cracks and past leaking CRDM flanges. After removing the boric acid deposits, the licensee identified a large corrosion cavity in the head material adjacent to CRDM Nozzle 3 (Figure 2). The cavity was approximately 6 inches in length and 4 to 5 inches in width. Within this area the 6.63 inch thick low alloy steel head was corroded away leaving only the stainless steel cladding layer on the inside. The remaining cladding layer ranged in thickness from 0.20 to 0.31 inches. Subsequent metallurgical examination of this section of cladding identified a shallow crack approximately 3/8 inch in length. This cladding layer is designed as a corrosion resistant layer

and is not specifically designed to retain reactor operating pressure. In addition to the cavity adjacent to Nozzle 3, a comparatively small cavity was identified adjacent to Nozzle 2. This cavity was approximately 1.75 inches wide, 4 inches long, and 0.25 inches deep.

Cause or Causes — On April 18, 2002, the licensee submitted its Root Cause Analysis Report to the NRC. In this report, the licensee concluded that the most probable technical cause of the RPV head degradation was boric acid corrosion resulting from leakage through a crack in the CRDM penetration nozzle attributable to primary water stress corrosion cracking. Further, this corrosion had occurred over a period of several years. Absent more definitive information, the licensee's technical root cause analysis represents a plausible scenario for the degradation.

Licensee — The licensee elected to replace the damaged head with one procured from the owners of the canceled Midland nuclear power plant located in Michigan. The licensee has also completed a number of activities designed to identify the management and human performance deficiencies which contributed to the degradation of the reactor vessel head and implemented a series of inspections and evaluations to identify and correct any other potentially problematic plant issues.
