Davis-Besse Nuclear Power Station
5501 North State Route 2
Oak Harbor, Ohio 43449-9760

Subject: Confirmatory Action Letter Response - Root Cause Analysis Report

Root Cause Analysis Report

Significant Degradation of the Reactor Pressure
Vessel Head

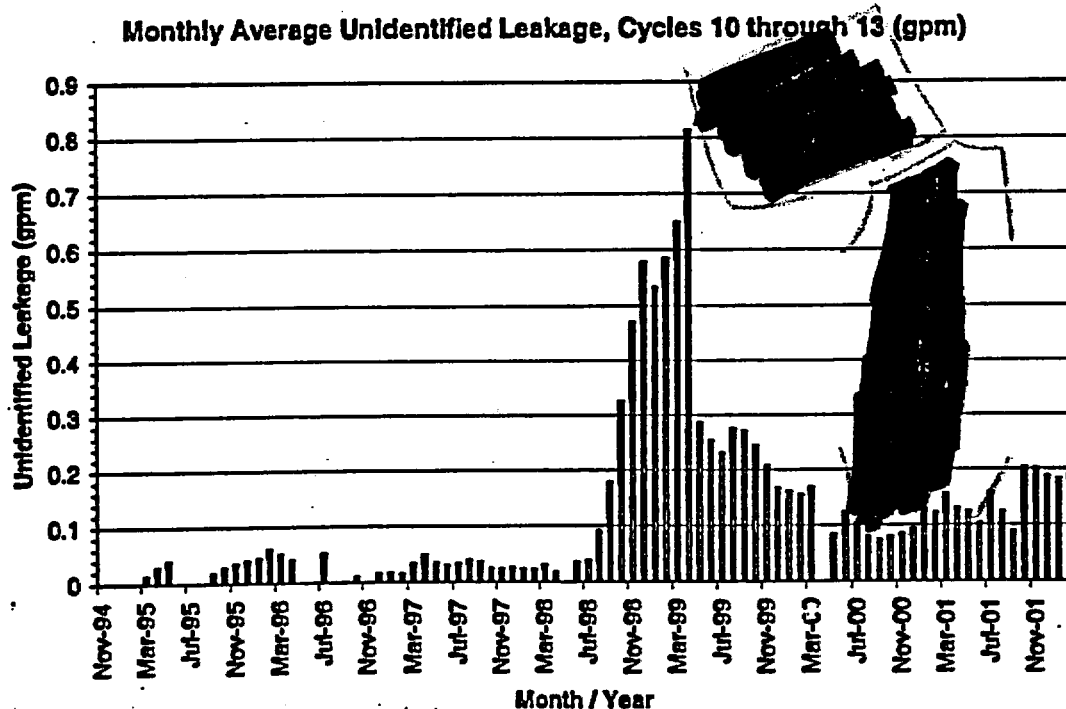
During operating cycles 10 through 13 (November 1994 through February 2002), measured unidentified leakage has ranged from slightly negative to as much as approximately 0.8 gpm in April 1999. From review of data over that time span, it would appear that average unidentified leakage tends to be in the range of 0.0 to 0.03 gpm when the plant is "tight" with no pending maintenance concerns. If unidentified leakage begins to trend upward, efforts are expended to determine the cause, and if necessary, effort is made to repair the source of the leakage. For

example, the high leakage in April 1999 was identified as from the Pressurizer Code Safety Valves and the plant was shutdown to service the valves. Following that shutdown, unidentified leakage remained in the range of 0.15 to 0.25 gpm, some of which was attributable to CRDM flange leakage and some of which may have been attributed to CRDM nozzle leakage.

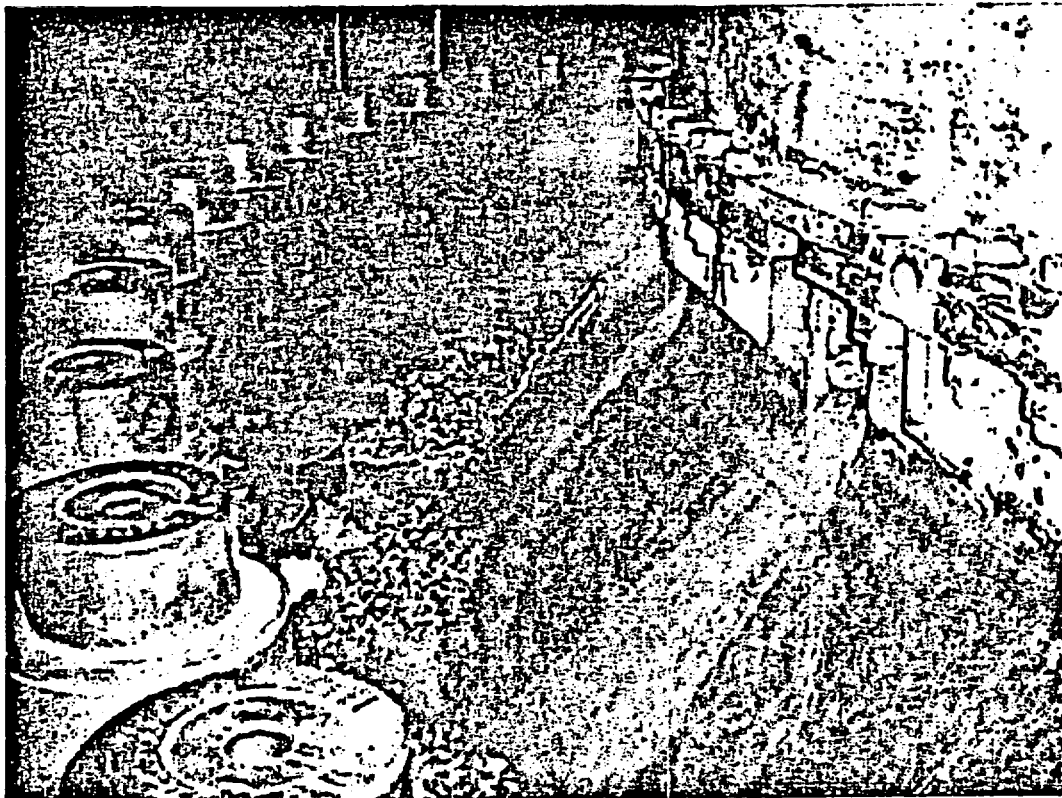
Figure 4. Boric Acid and Iron Oxide on Vessel Flange at 12RFO

The following is a summary of the non-destructive examination effort on the cracked nozzles and degraded RPV head. After removal of insulation from the RPV flange early in 13RFO, boric acid crystal deposits and iron oxide were found to have flowed out from several of the openings (mouse holes) in the lower service structure support skirt (Figure 20). Figure 4 shows deposits on the flange during the inspection in the twelfth refueling outage (12RFO).

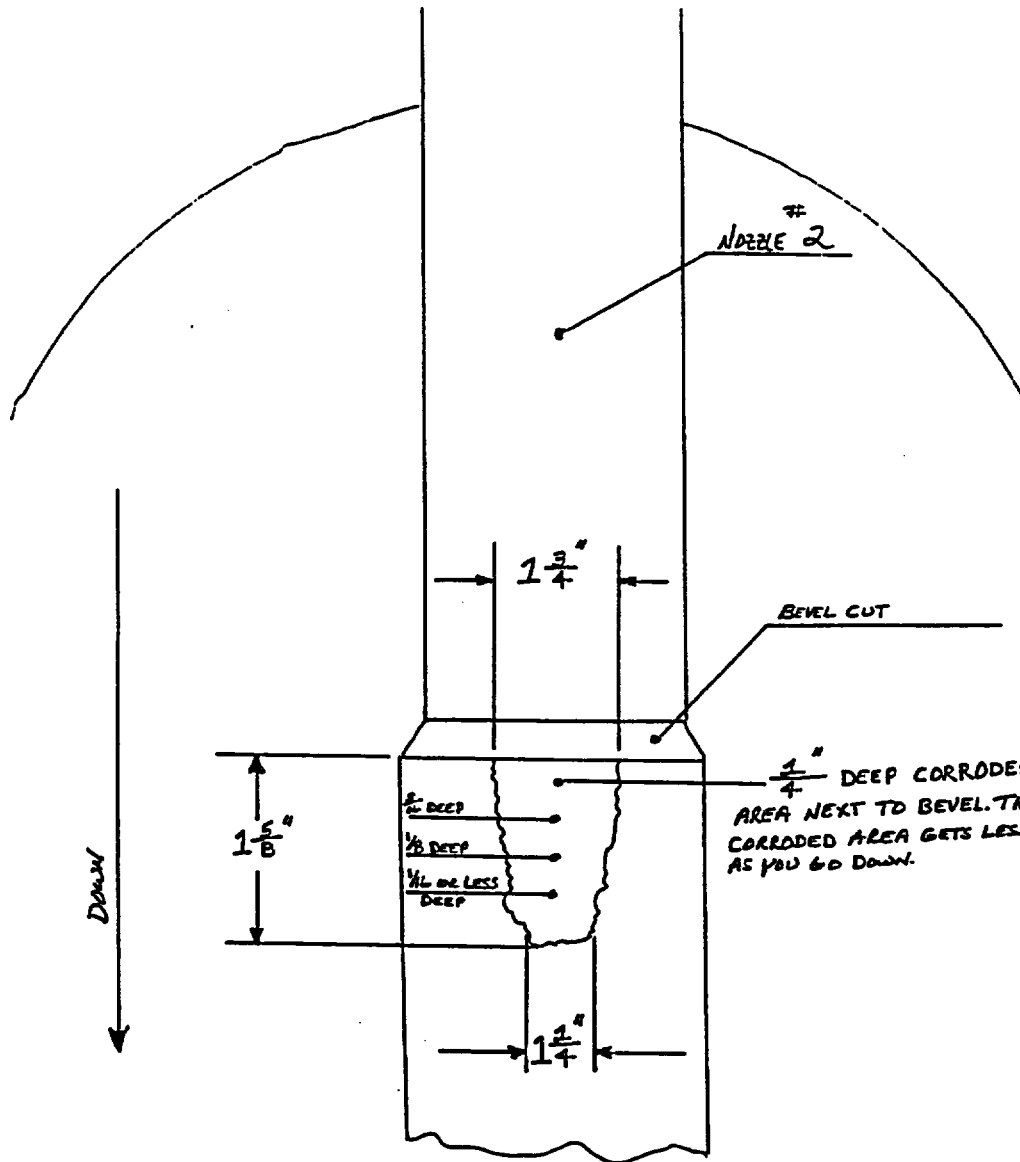
Figure 5. Corrosion at Nozzle 2 Drawing Side View

Degradation was observed at nozzle 2 following the initiation of repair efforts. Figure 5 and 5a shows the observed area of corrosion. The overall corroded area, based on the video examination and approximate measurements from the impression, is 3-1/2 to 4 inches in length starting from the top of the RPV head, about 3/8 inch deep (at the deepest location approximately 1-3/4 inches from the top of the RPV head), and between 1-1/4 to 2 inches at it's widest location. The depth of corrosion decreased as the annulus opening was approached. This type of corrosion profile is similar to testing that has been performed by EPRI (reference 5.3) regarding location of the deepest corrosion and the fact that it could have been identified on the top of the RPV head.

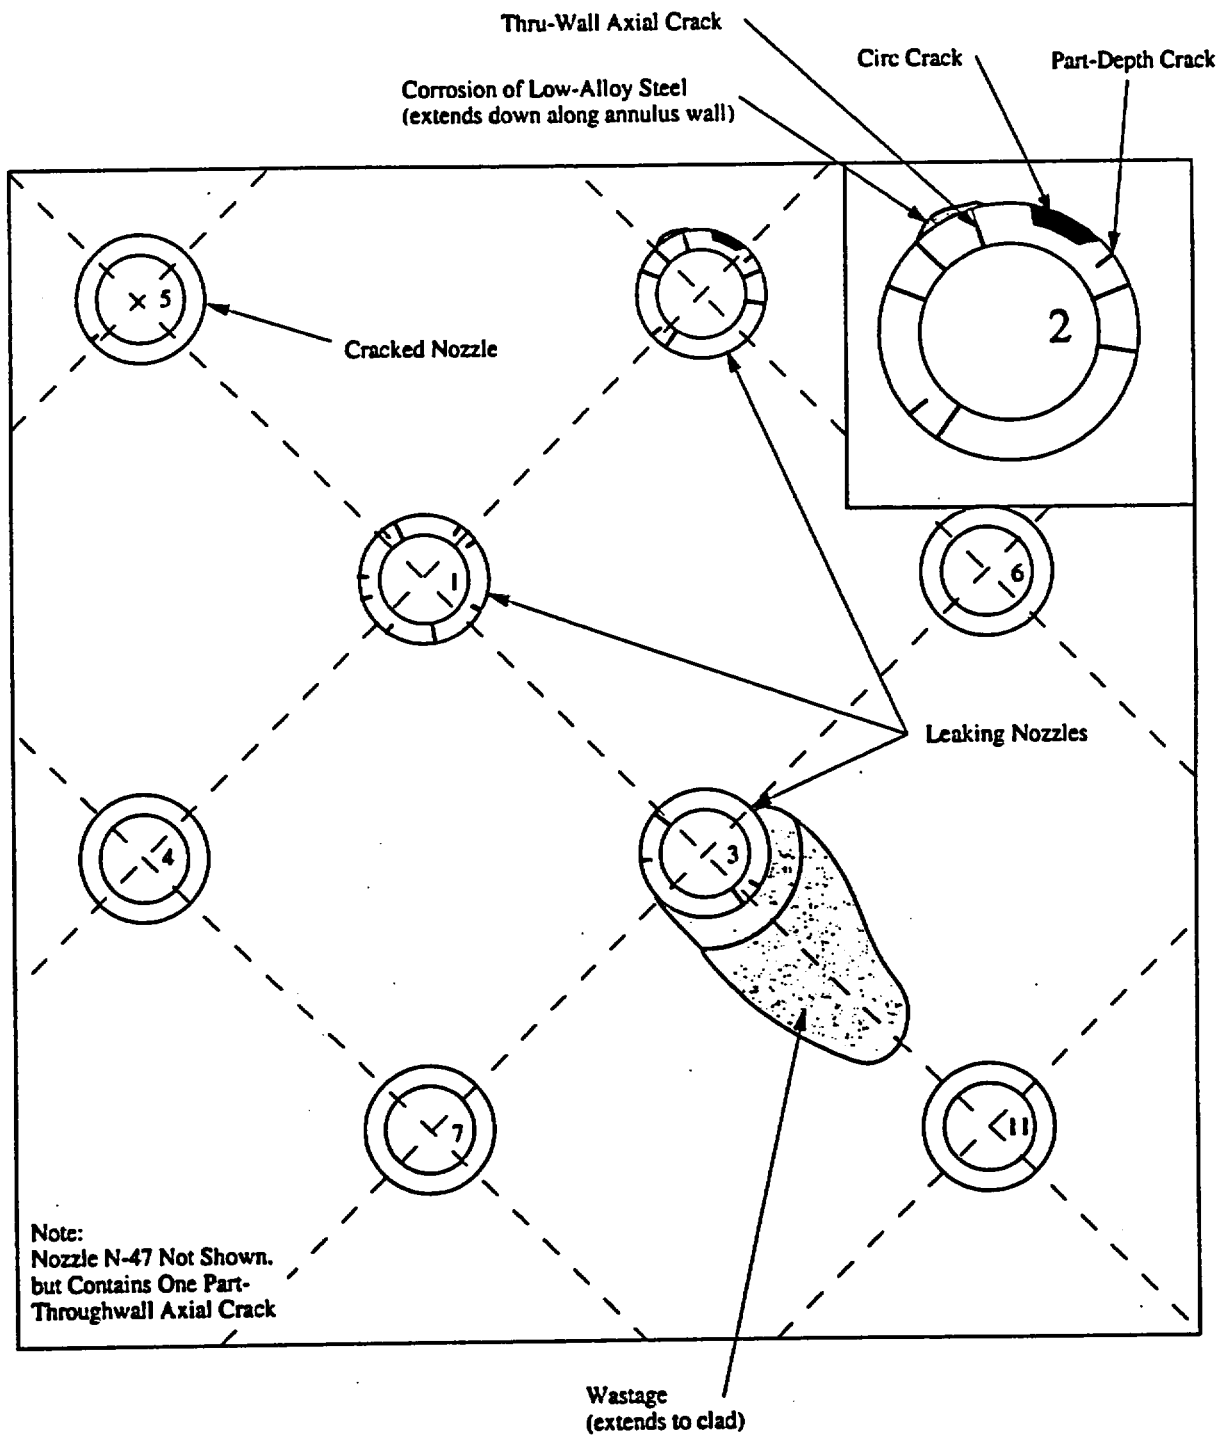
Figure 7. Locations of Cracks and Corrosion on Davis-Besse RPV Head at 13RFO

Figure 7 shows locations of cracks and corrosion on the Davis-Besse RPV top head surface. This figure is included to serve as a reference for the following descriptions of the degraded areas.

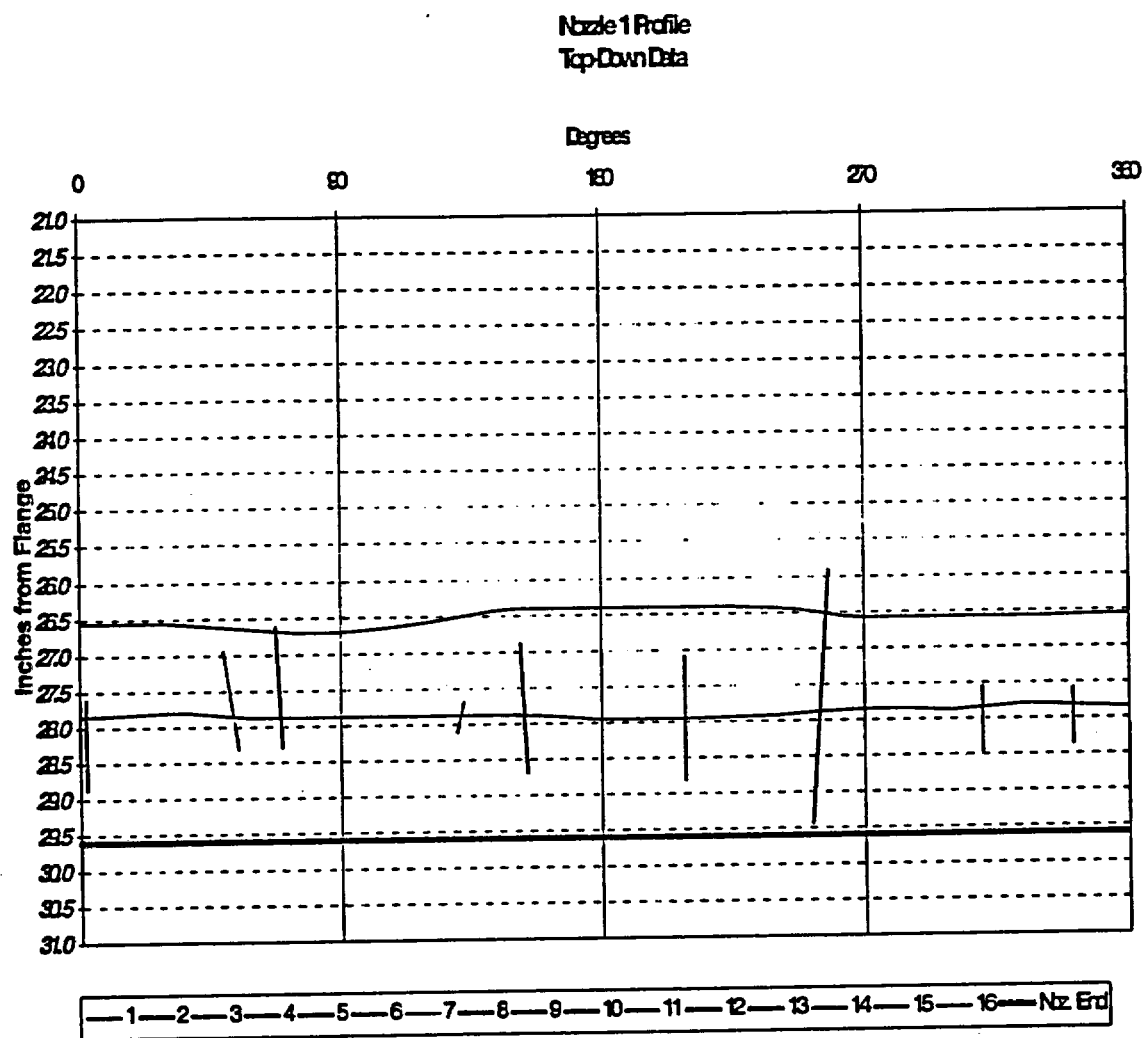
Figure 8. Nozzle 1 Crack Locations and Sizing

The observed degradation at the nozzle 1 location is minimal. A small, crevice (<1/16 inch wide and about 3/4 inch circumferentially), located at the 270° location (looking down from top of RPV head clockwise with 0° in the West direction), was identified at the surface of the RPV head. The observed degradation at nozzle 1 was within the boundary of the pre-established repair plan.

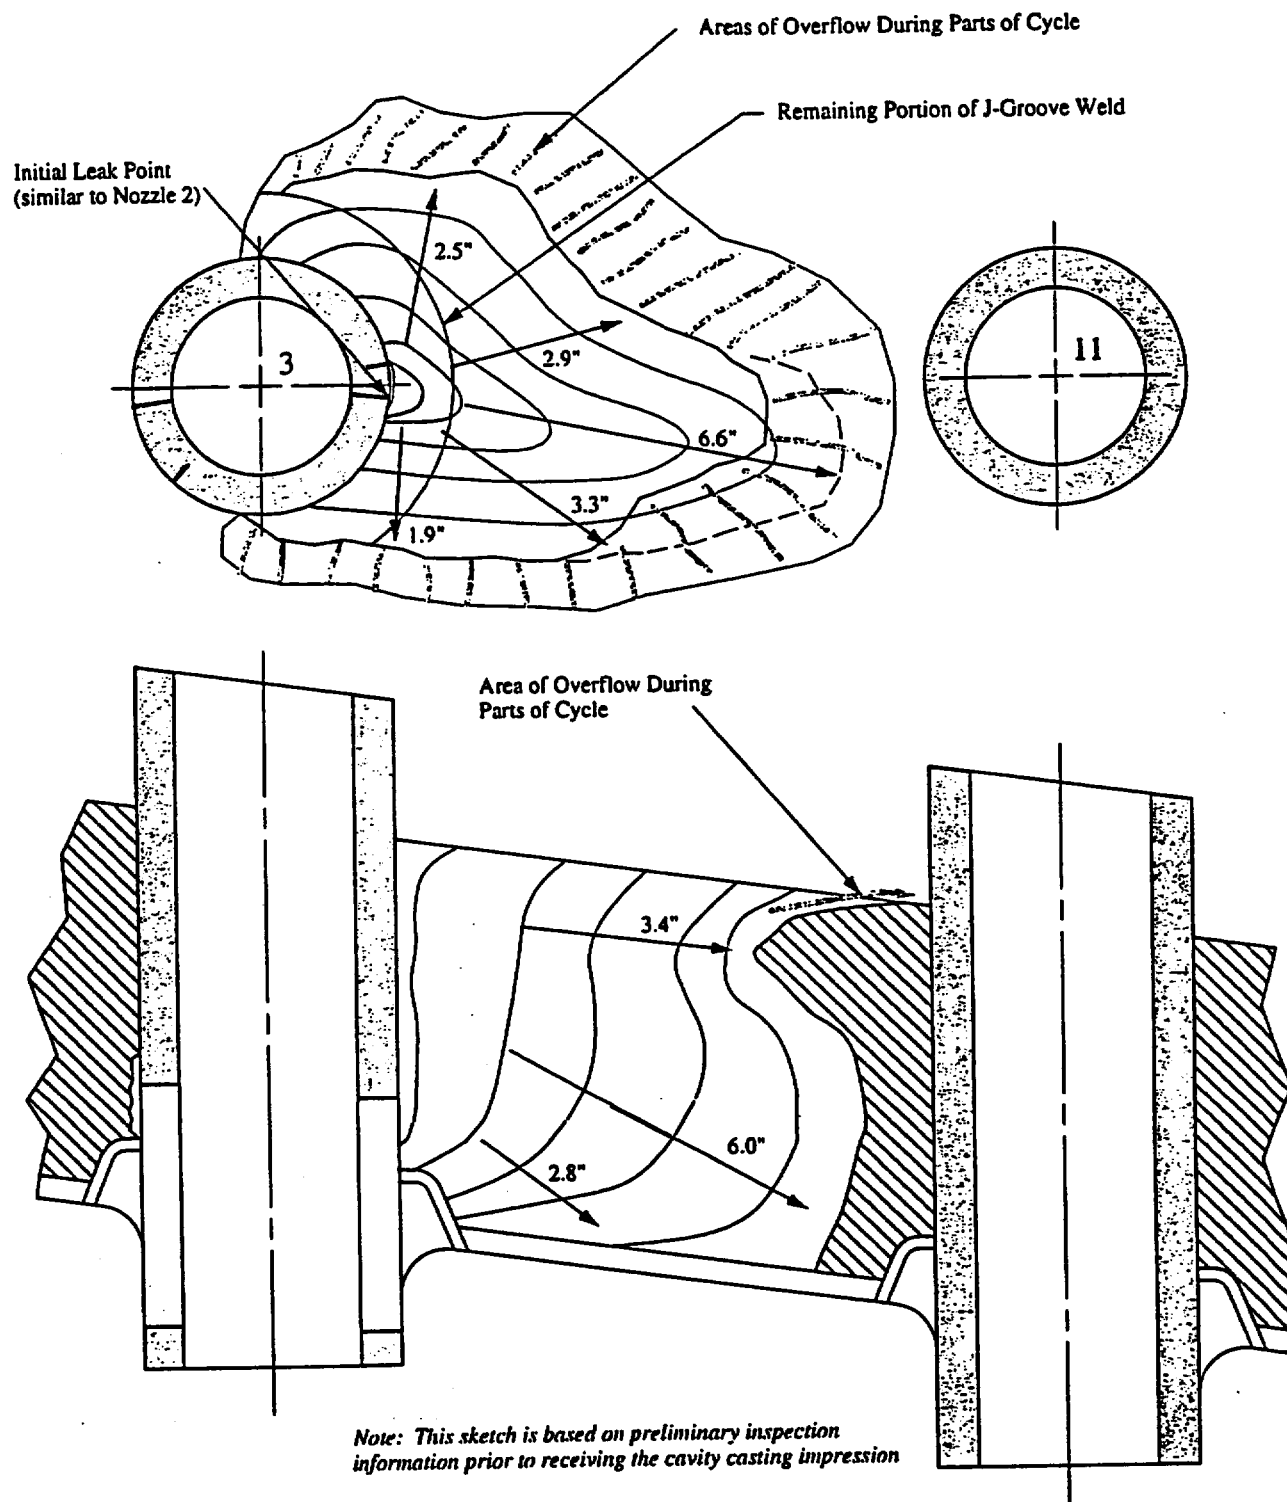
Figure 13. Characterization of Corrosion and Impingement at Nozzle N-3

Degradation observed at nozzle 3 is pictorially shown in Figure 13. The 180° (uphill toward nozzle 1) location is essentially intact, with little to no degradation. The 0° (downhill toward nozzle 11) location exhibits the worst degradation, with the low-alloy steel material corroded away, down to the stainless steel cladding, for approximately 6.6 inches in length and 4 to 5 inches at the widest part. Figure 14 shows cladding thickness measurements made by UT from the underside of the RPV head. (Note: There are several low readings outside the designated area of damage. These are attributed to inclusions or bad readings. These readings do not correspond with visual observations, and will be further verified following excavation of the damaged area.)

From the 270° location to the 0° location (counterclockwise looking down from the top of the RPV head), there is a large undercut area. From the 0° location to the 90° location (counterclockwise looking down from the top of the RPV head), the corrosion is less. Additional data is forthcoming from profilometry and the failure analysis efforts.

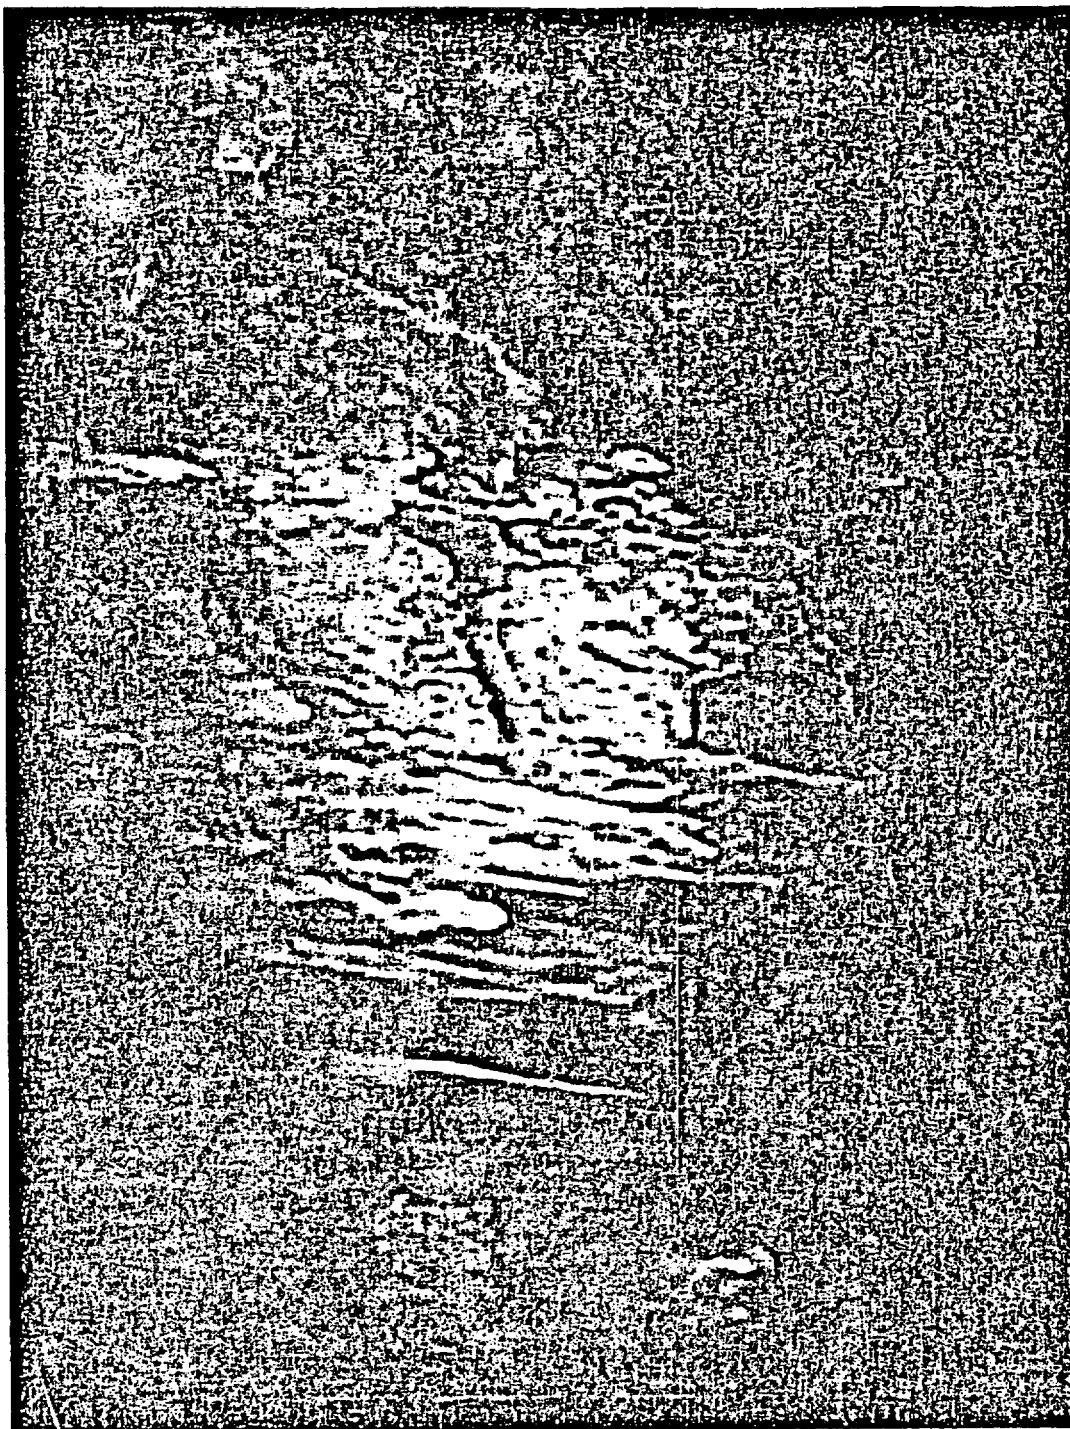
**Figure 29. Flange Leakage with Stalactite Formation from Insulation
and Stalagmite Formation on top of Reactor Vessel Head (8RFO)**

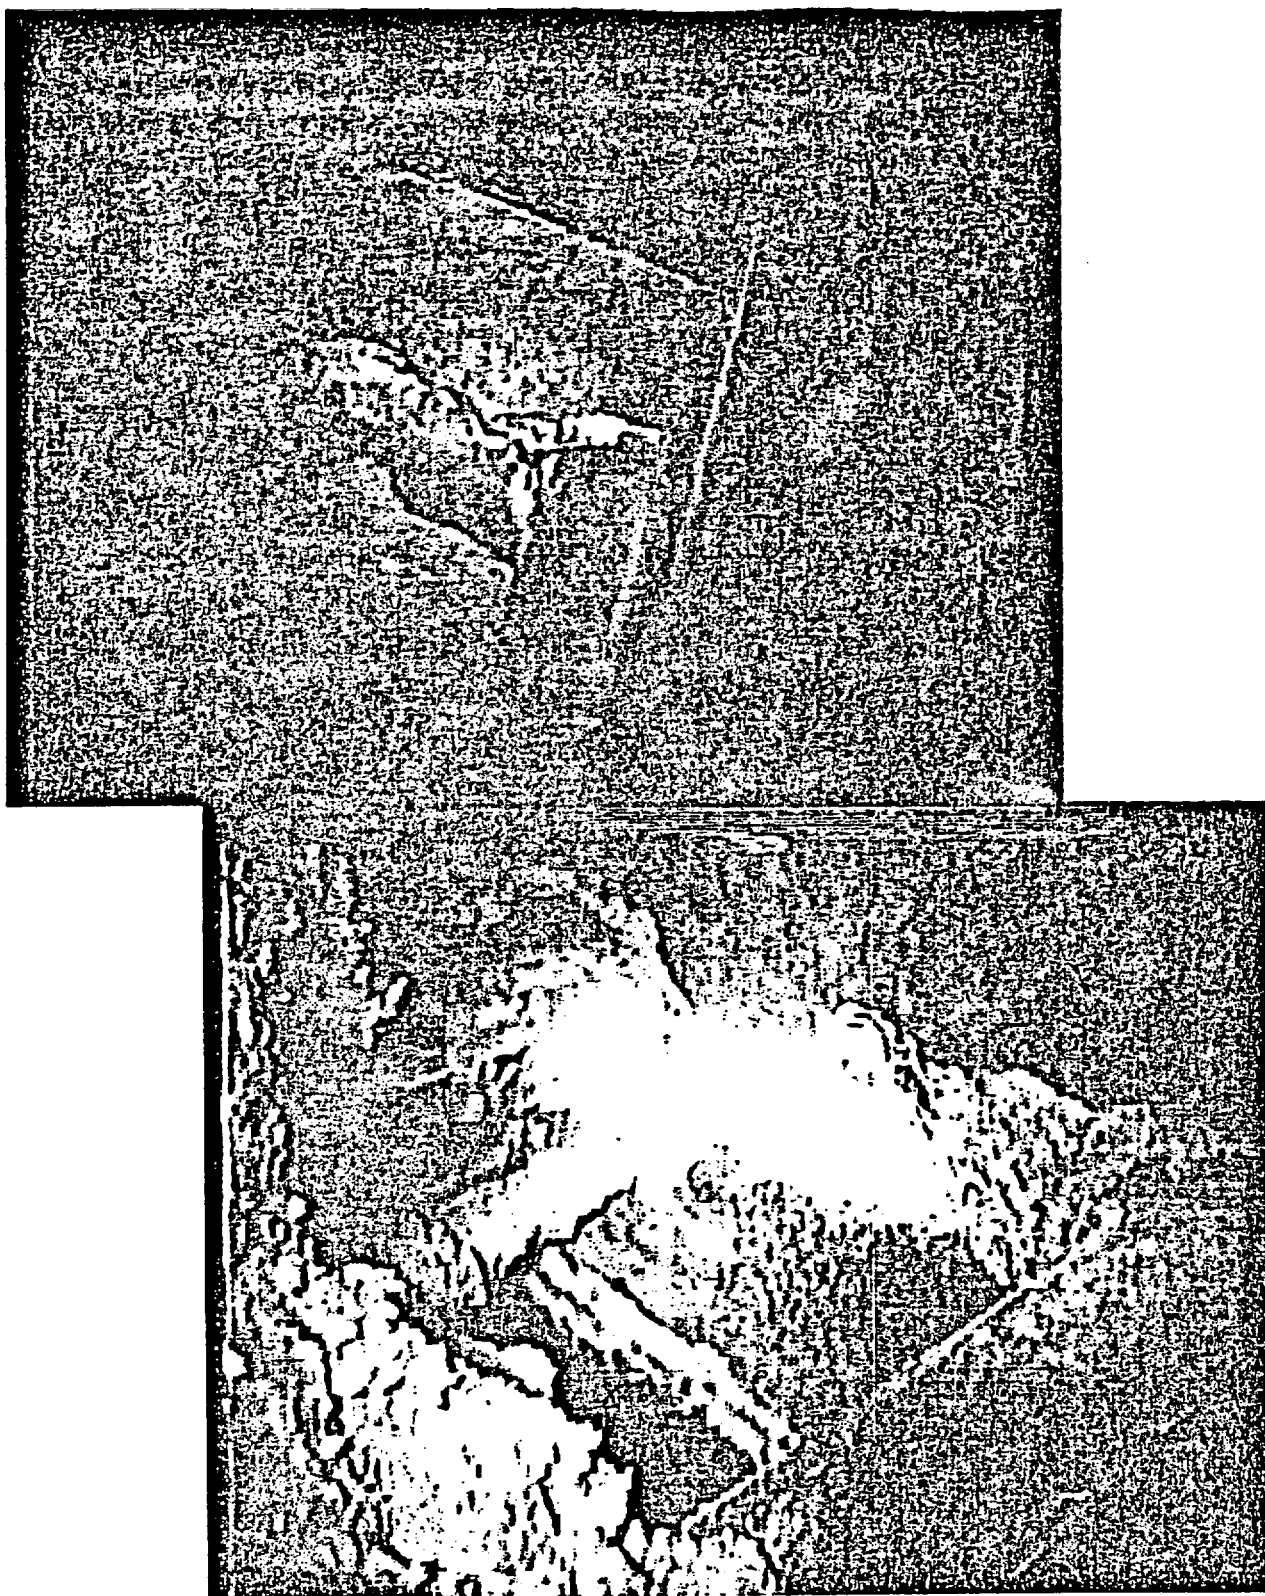
Figure 30. Flange Leakage Crusted On Side of Nozzles and Stalactites from Gaps in Insulation (8RFO)

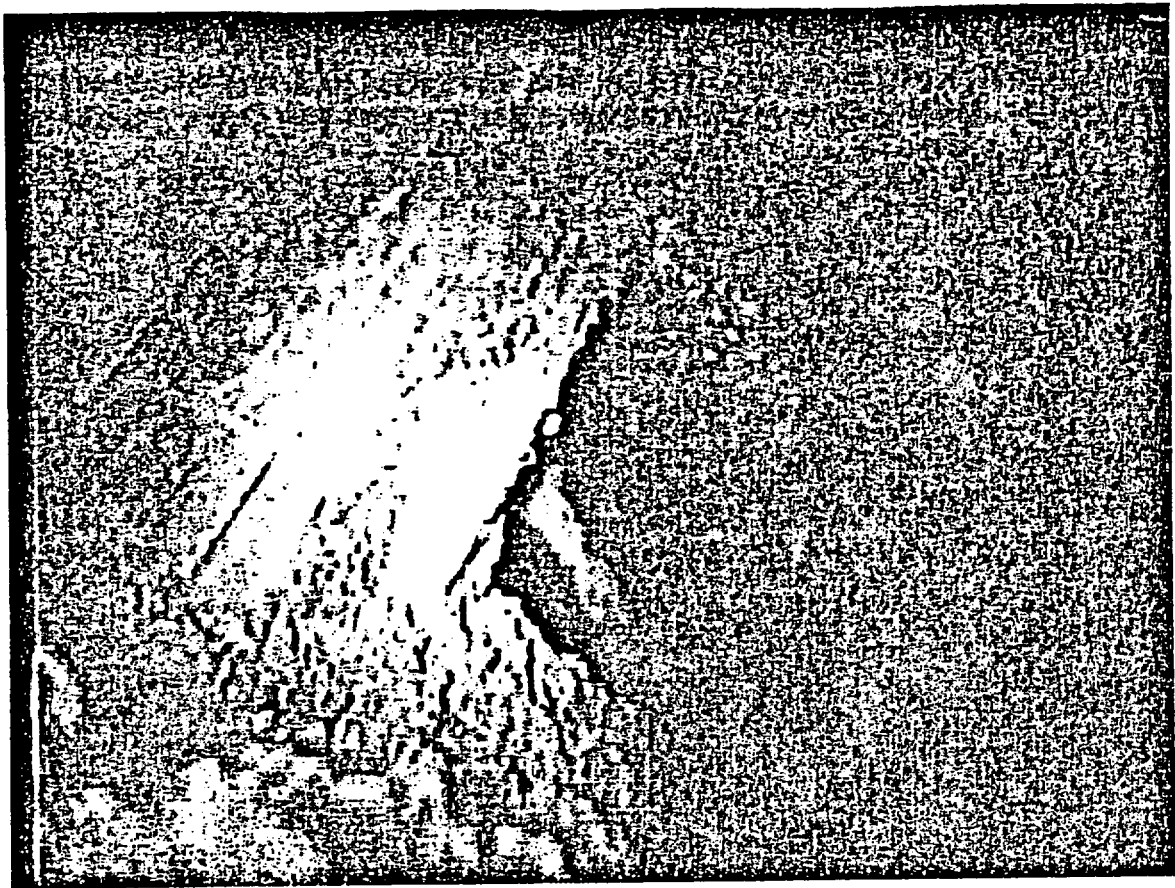
Figure 31. Reddish Brown Boron Deposits Crusted on Side of Nozzle (8RFO)

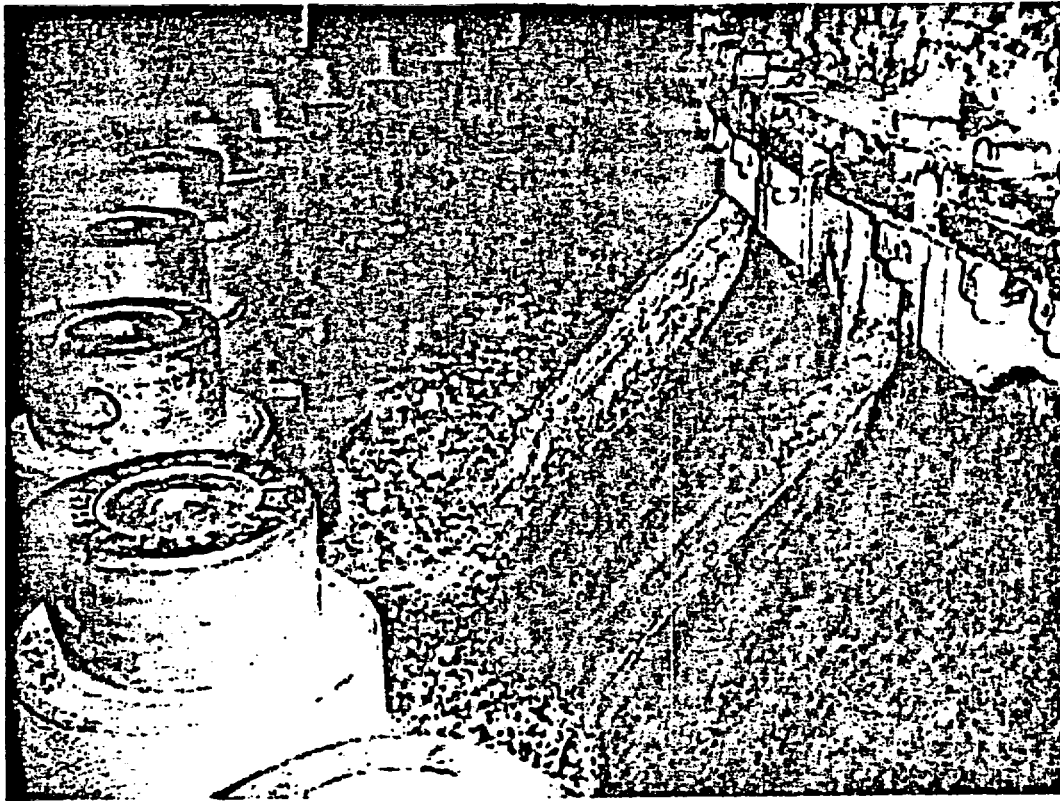
Figure 36. Red Rusty Boric Acid Deposits on Vessel Flange (12RFO)

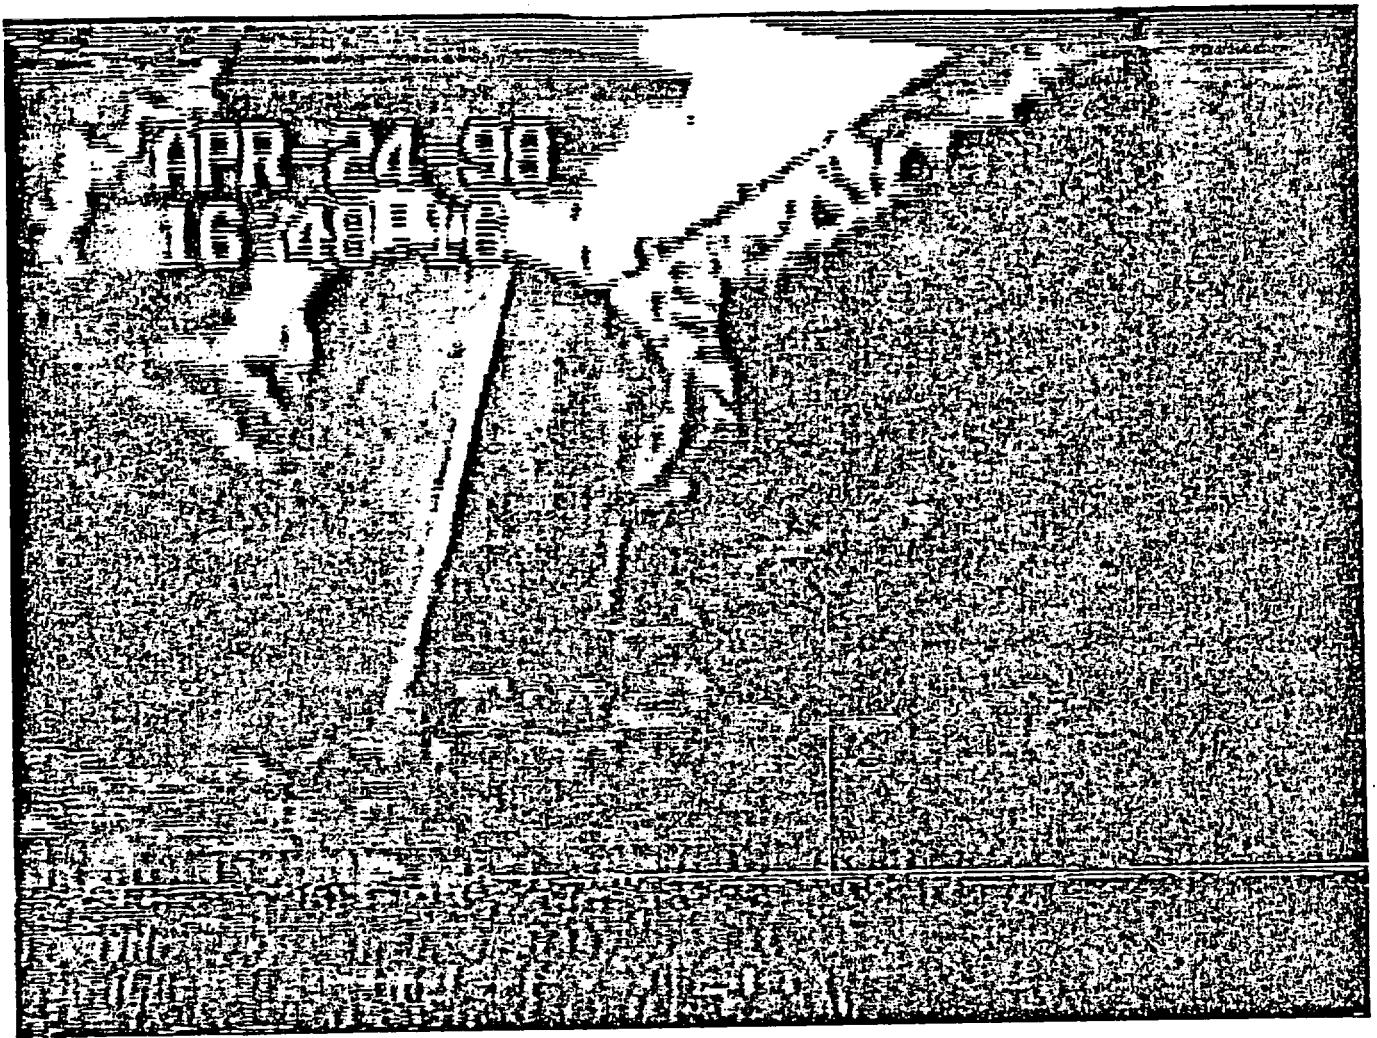
Figure 37. Boron Piled Under the Insulation (11RFO)
