UNITED STATES  
NUCLEAR REGULATORY COMMISSION  
OFFICE OF NUCLEAR REACTOR REGULATION  
WASHINGTON, D.C. 20555-0001

**NRC INFORMATION NOTICE 98-19: SHAFT BINDING IN GENERAL ELECTRIC TYPE SBM CONTROL SWITCHES**

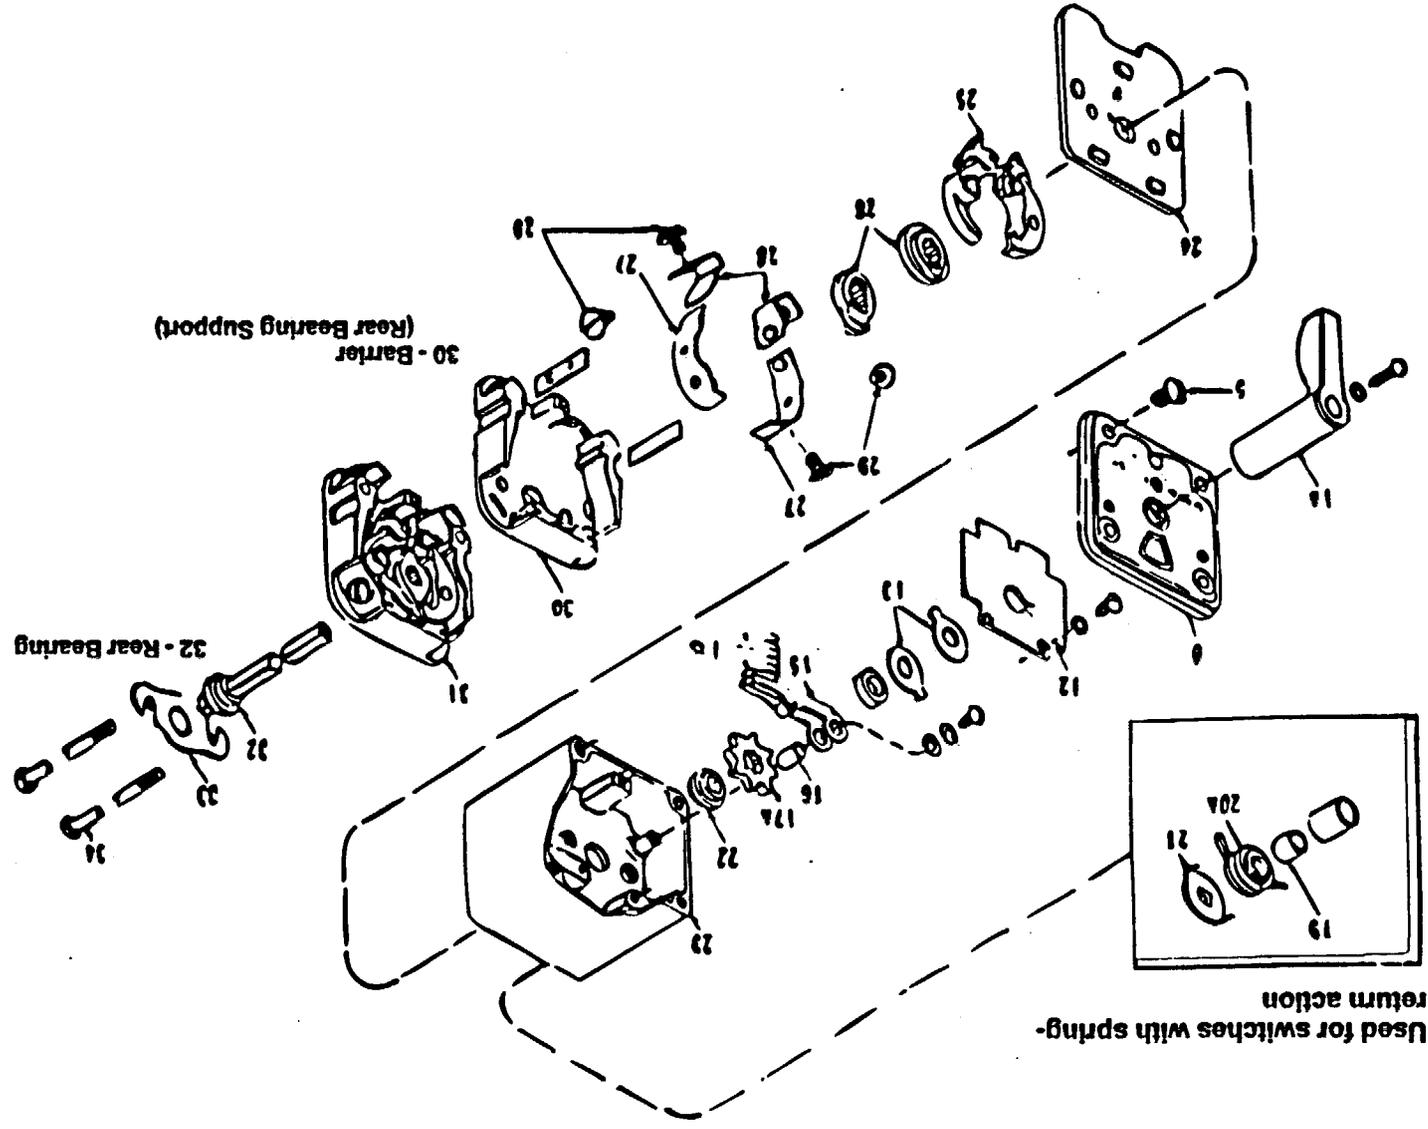
Figure 1 - Exploded View of Type SBM Switch

The failure mode has been identified as binding caused by interference between the rear brass bearing and the phenolic rear bearing support. The exploded view of an SBM switch in the attached Figure 1 shows the rear bearing support plate (Item 30, also called the barrier) and the rear bearing (Item 32) on the switch shaft. The interference is caused by post-mold cure shrinkage of the phenolic material, which takes place for up to 2 years after the phenolic material is molded into the bearing support. GE-ED&C found that the mold used to make the bearing support had worn over the years to the point that the diameter of the opening for the brass rear bearing was still within specifications but near the minimum allowable value. The original GE design did not account for the post-mold cure shrinkage of the phenolic material. The second contributing factor to switch failure is a brass rear bearing at its maximum allowable diameter. Only switches with both the undersized hole in the bearing supports and bearings at the maximum tolerance have experienced failures. Testing confirmed that switches with bearings of nominal size functioned properly, even with undersized holes in the phenolic bearing support.

The failed switches were manufactured between November 1996 and February 1997. Although most of the post-mold cure shrinkage occurs within the first 12 to 18 months, GE conservatively assumed that switches manufactured after March 1996 may be susceptible. These switches can be identified by the last two characters on the green quality control acceptance sticker. The affected date codes are PL, RL, SL, TL, UL, VL, WL, XL, YL, ZL, NM, OM, PM, RM, SM, TM, UM, VM, WM, XM, YM, ZM, NN, and ON. The manufacturer has improved the SBM switch manufacturing process to allow for phenolic post-mold cure shrinkage, and switches manufactured as of March 1, 1998, should no longer be susceptible to the failure mode.
