UNITED STATES
NUCLEAR REGULATORY COMMISSION
OFFICE OF NUCLEAR REACTOR REGULATION
WASHINGTON, D.C. 20555-0001

June 3, 1998

NRC INFORMATION NOTICE 98-19: SHAFT BINDING IN GENERAL ELECTRIC TYPE SBM CONTROL SWITCHES

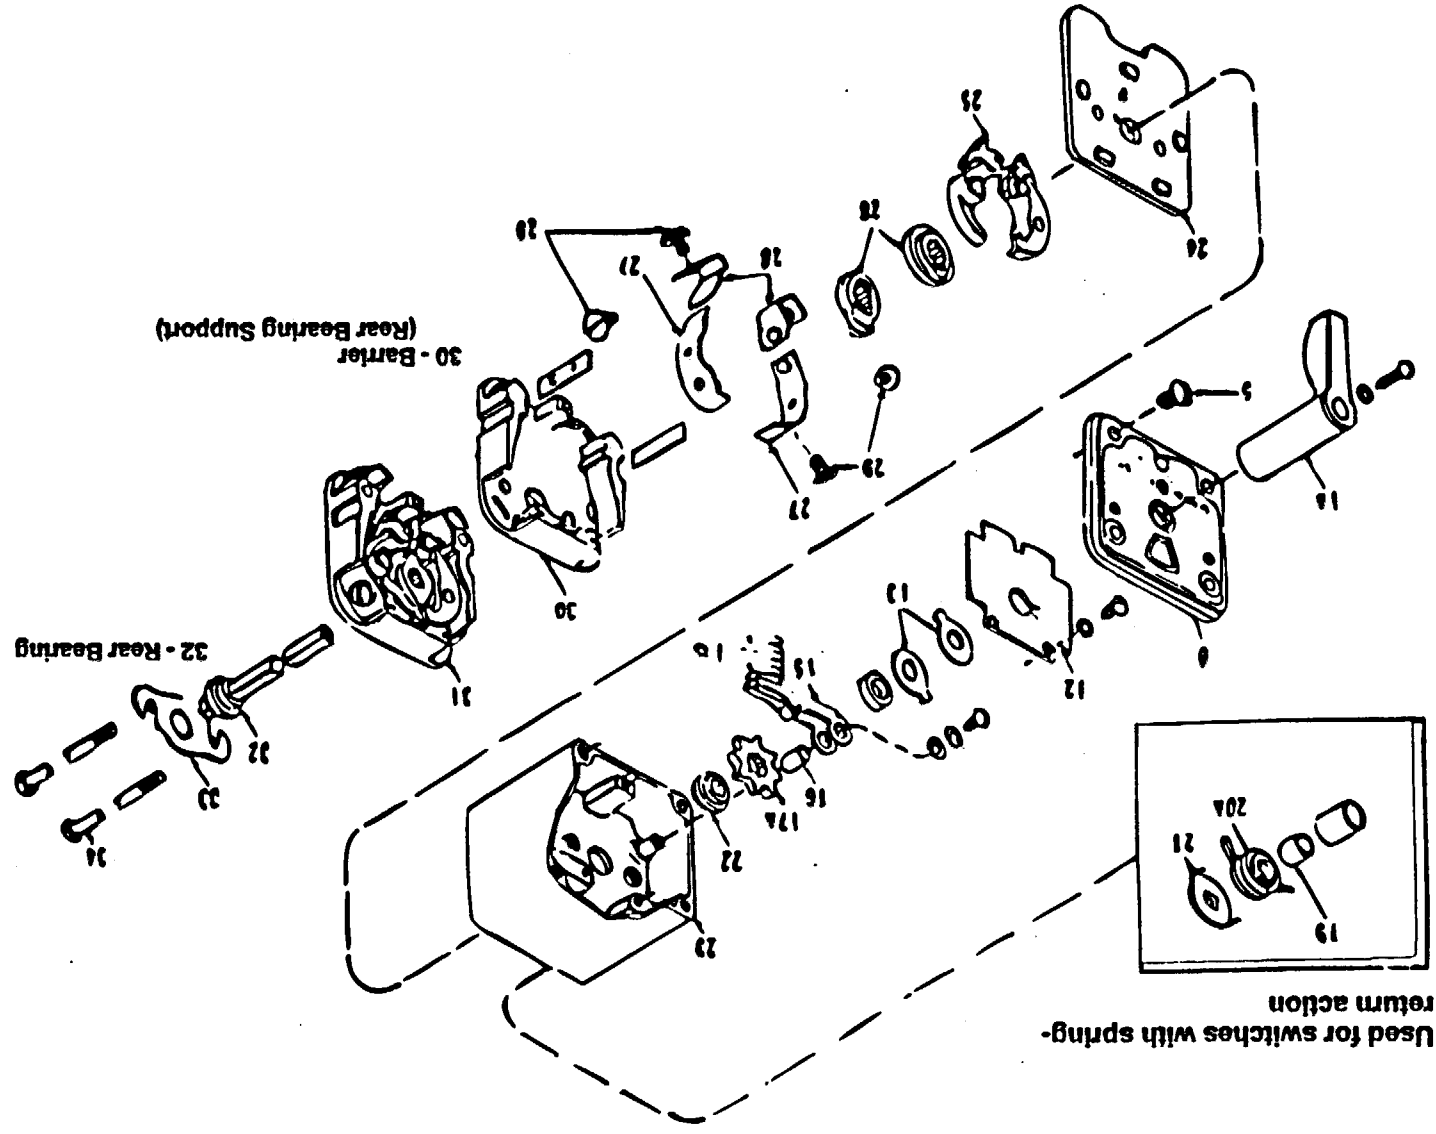
Figure 1 - Exploded View of Type SBM Switch

The failure mode has been identified as binding caused by interference between the rear brass bearing and the phenolic rear bearing support. The exploded view of an SBM switch in the attached Figure 1 shows the rear bearing support plate (Item 30, also called the barrier) and the rear bearing (Item 32) on the switch shaft. The interference is caused by post-mold cure shrinkage of the phenolic material, which takes place for up to 2 years after the phenolic material is molded into the bearing support. GE-ED&C found that the mold used to make the bearing support had worn over the years to the point that the diameter of the opening for the brass rear bearing was still within specifications but near the minimum allowable value. The original GE design did not account for the post-mold cure shrinkage of the phenolic material. The second contributing factor to switch failure is a brass rear bearing at its maximum allowable diameter. Only switches with both the undersized hole in the bearing supports and bearings at the maximum tolerance have experienced failures. Testing confirmed that switches with bearings of nominal size functioned properly, even with undersized holes in the phenolic bearing support.

The failed switches were manufactured between November 1996 and February 1997. Although most of the post-mold cure shrinkage occurs within the first 12 to 18 months, GE conservatively assumed that switches manufactured after March 1996 may be susceptible. These switches can be identified by the last two characters on the green quality control acceptance sticker. The affected date codes are PL, RL, SL, TL, UL, VL, WL, XL, YL, ZL, NM, OM, PM, RM, SM, TM, UM, VM, WM, XM, YM, ZM, NN, and ON. The manufacturer has improved the SBM switch manufacturing process to allow for phenolic post-mold cure shrinkage, and switches manufactured as of March 1, 1998, should no longer be susceptible to the failure mode.
