UNITED STATES  
NUCLEAR REGULATORY COMMISSION  
OFFICE OF NUCLEAR REACTOR REGULATION  
WASHINGTON, D.C. 20555-0001

April 20, 1998

**NRC INFORMATION NOTICE 98-14: UNDOCUMENTED CHANGES TO NON-POWER  
REACTOR SAFETY SYSTEM WIRING**

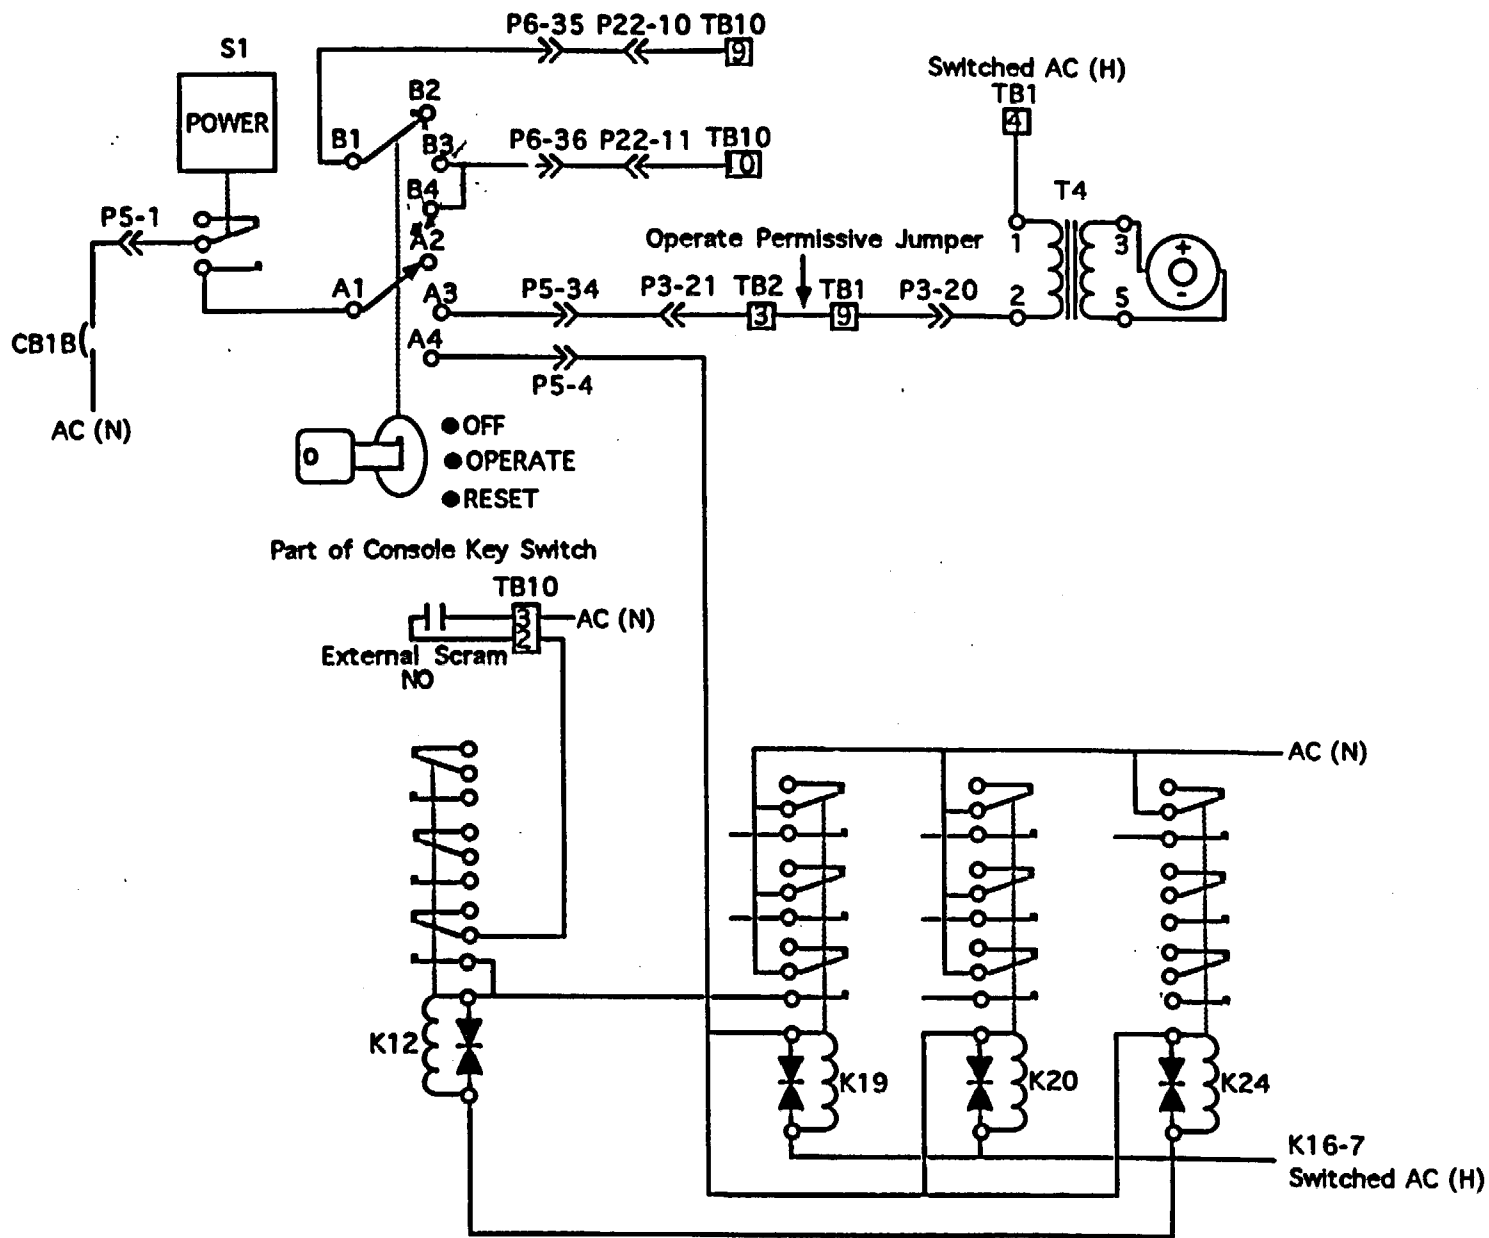
Figure 1. Reactor Operate Circuit, As-designed

Upon further investigation, the licensee discovered that the wiring of the scram circuit was different from the wiring shown in the Instrument Maintenance Manual provided by the reactor vendor. Figure 1 shows part of the circuitry as designed. If the key switch is in the OPERATE

position, ac power is supplied from terminal block one, terminal number four (TB1-4) through TB1-9, to TB2-3, the A3 and A1 contacts of the three-position switch, and then the console power switch. This allows transformer four (T4) to power the rod magnets. When the key is turned to RESET, this circuit is opened and the magnet current is cut off. This prevents rod withdrawal if the rods are down, or causes the rods to drop if they are up. This design feature prevents a single failure of the three-position switch from disabling the scram circuits. In the RESET position, power is supplied to the scram reset relays (K19, K20, and K24), which reset the scram relays (only one scram relay, K12, is shown). If the key switch sticks in the RESET position, the scram relay will continued to be energized by the reset relay even if a scram signal occurs. This is not a problem because the power would already be cut off to the magnets.

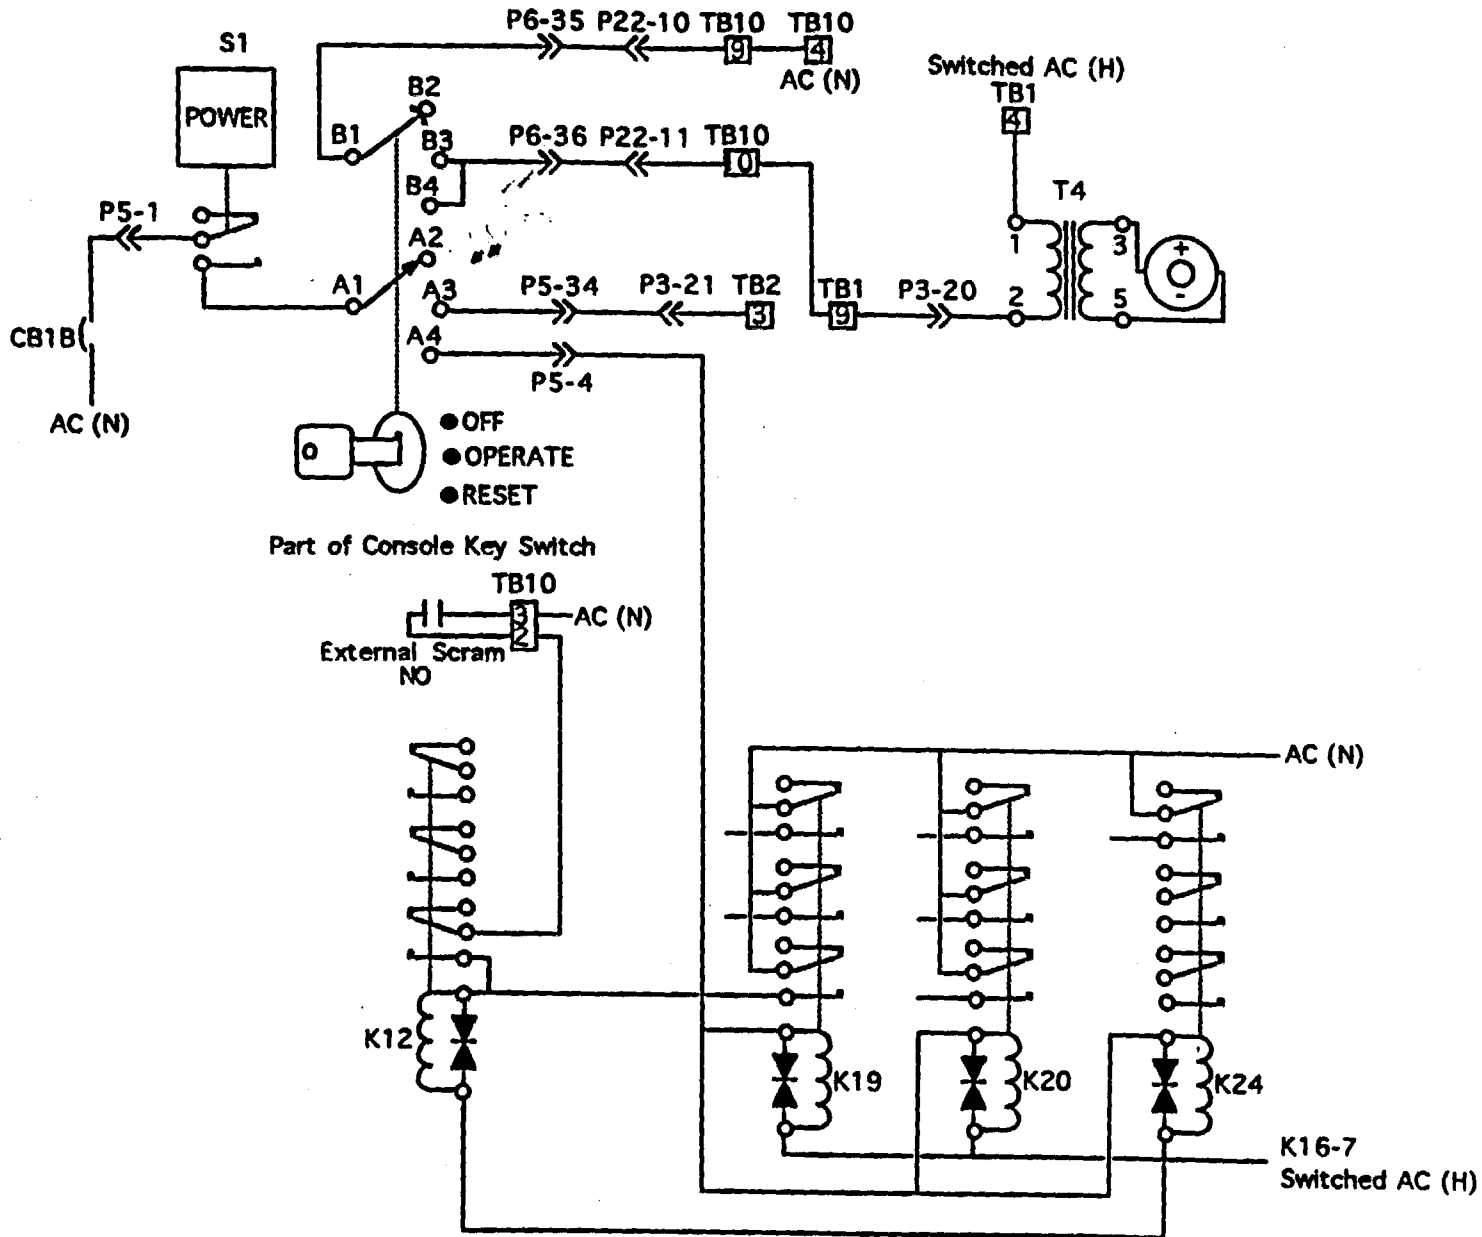
Figure 2. Reactor Operate Circuit - As Found

Figure 2 shows the wiring as found in the OSU console. The wiring that was between TB1-9 and TB2-3 in the "as designed" circuit was between TB1-9 and TB10-10 in the OSU console. As a result, there is power to the magnets when the switch is in the RESET or OPERATE position.

The licensee concluded that the location of the jumper was probably modified during initial installation of the reactor console in 1967. This modification was probably done to provide power to the "B deck" on the three-position switch to power REACTOR ON lights.

The licensee took a number of corrective actions. The three-position switch was removed, cleaned, relubricated, and reinstalled in the console. The reactor console wiring was restored to its as-designed condition. The wiring in the scram circuitry and in other non-scram-related circuits was checked physically and electronically to demonstrate that the wiring in the console is as designed. The reactor startup procedure was rewritten to test that the magnet power is cut off when the three-position switch is placed in the RESET position. The reactor console was subject to routine startup checks and the semiannual console check procedure. The reactor vendor was contacted to obtain checkout procedures to confirm that all suggested surveillances are done before reactor operation.
