UNITED STATES  
NUCLEAR REGULATORY COMMISSION  
OFFICE OF NUCLEAR REACTOR REGULATION  
WASHINGTON, D.C. 20555-0001

March 25, 1998

**NRC INFORMATION NOTICE 98-11: CRACKING OF REACTOR VESSEL INTERNAL  
BAFFLE FORMER BOLTS IN FOREIGN PLANTS**

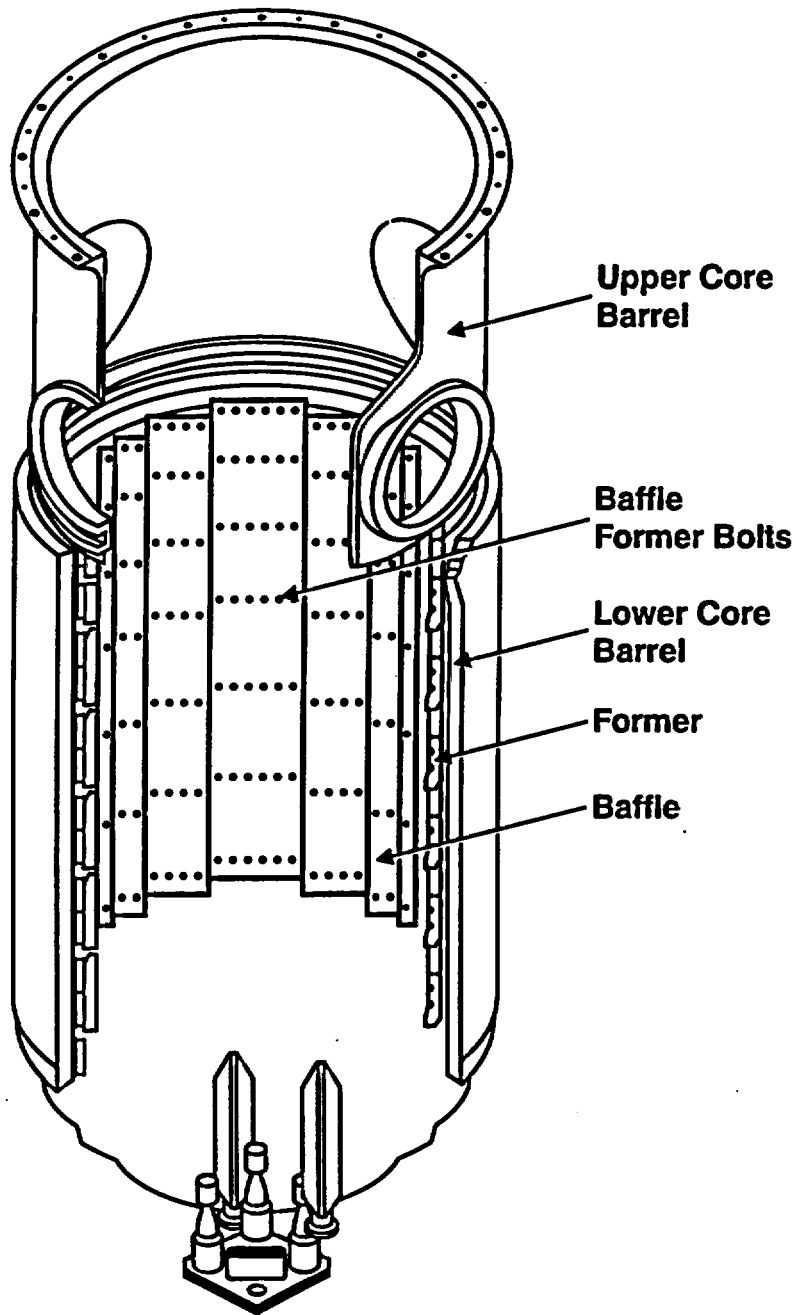
Typical PWR Reactor Vessel Internals

The U.S. Nuclear Regulatory Commission (NRC) is issuing this information notice to alert addressees to the cracking of reactor vessel internal baffle former bolts (see Figures 1 and 2) found at several foreign PWRs and to inform addressees of actions taken and planned by domestic PWR owners groups in response to this experience. It is expected that the recipients will review the information for applicability to their facilities and consider actions, as appropriate, to avoid similar problems. However, suggestions contained in this information notice are not NRC requirements; therefore, no specific action or written response is required.

Reactor vessel internals are structures located within the reactor vessel that support and orient the reactor fuel assemblies and direct coolant flow through the core. The core baffle is part of the internals structure, which consists of vertical plates that surround the outer faces of the peripheral fuel assemblies. The baffle directs coolant flow through the core. The vertical plates are bolted to the edges of horizontal former plates that are bolted to the inside surface of the core barrel. There are typically eight levels of former plates located at various elevations within the core barrel. The bolts that secure the baffle plates to the former plates are referred to as "baffle former bolts."

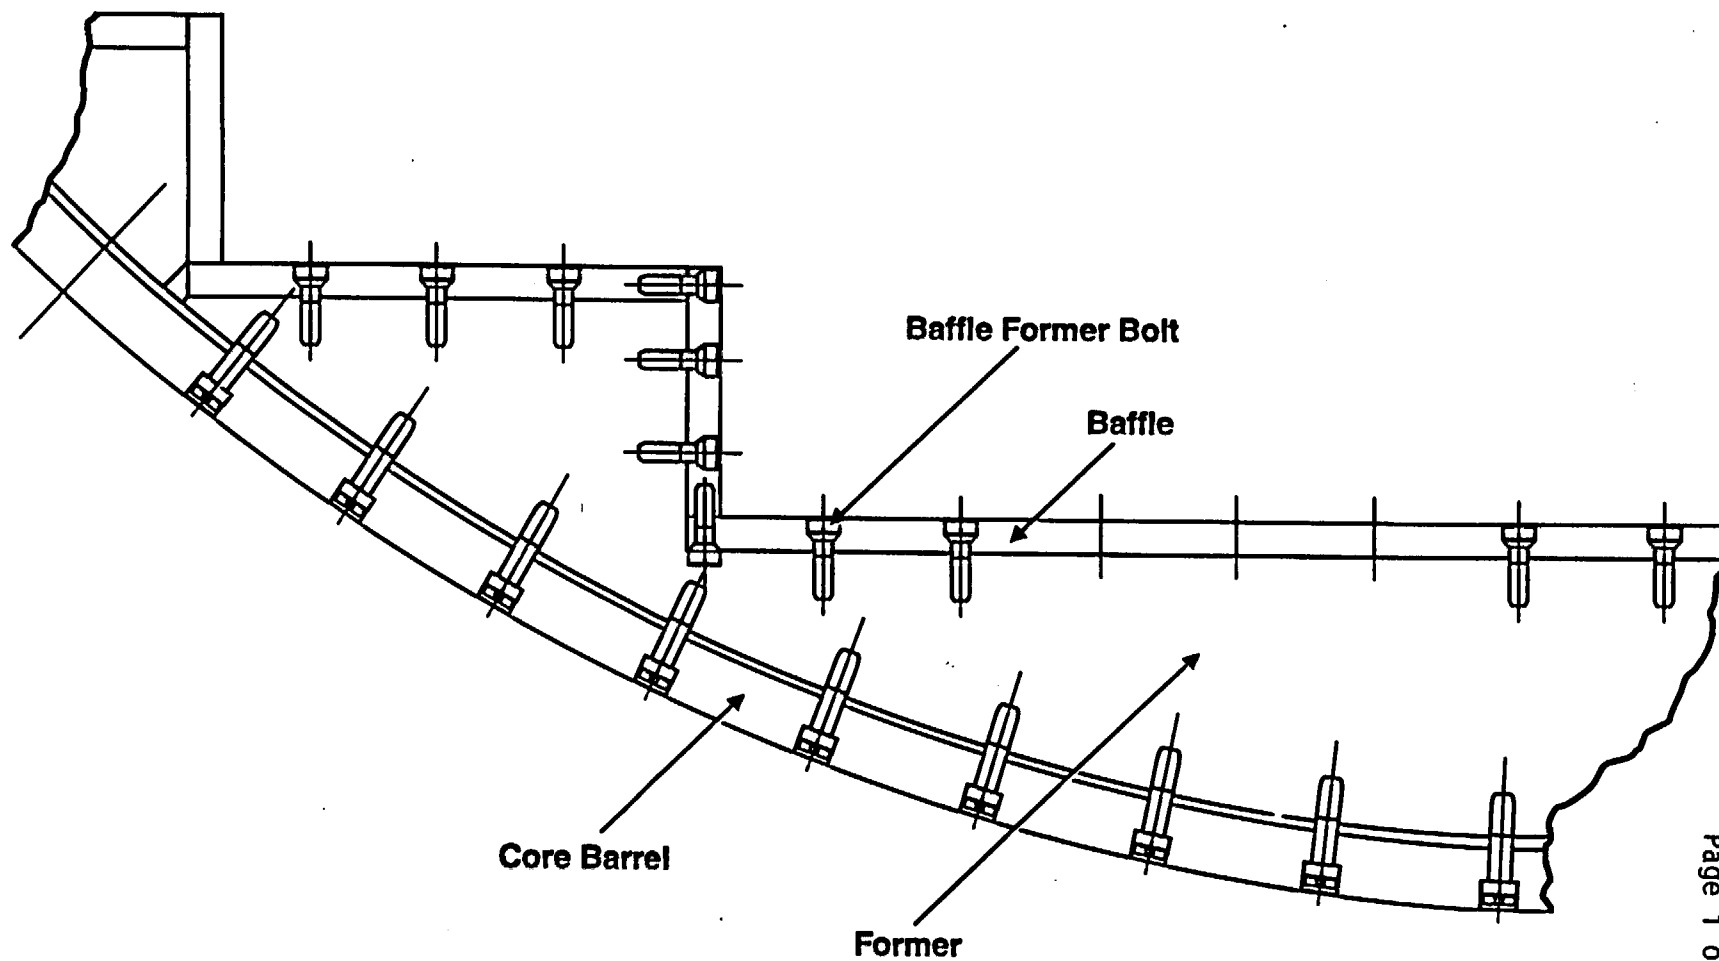
Typical PWR Core Barrel, Former, and Baffle Arrangement

European plants identified the cracking of baffle former bolts as early as 1988 and this problem continues to occur. Although this cracking is not fully understood, testing of cracked bolts suggests an age-related intergranular stress-corrosion cracking process influenced by bolt material, fluence, stress, and temperature. The reported cracking occurred in 316 cold-worked stainless steel bolts. Most of the cracking reported has been in four French 900-MWe (megawatt electric) PWRs.

The NRC is not aware of cracking of baffle former bolts in domestic PWRs. Domestic reactor baffle former bolts are subject to the visual inservice inspection requirements of Section XI of the American Society of Mechanical Engineers Boiler and Pressure Vessel Code. However, the baffle bolt cracking reported in foreign PWRs has occurred at the juncture of the bolt head and the shank, which is not accessible for visual inspection.
