UNITED STATES
NUCLEAR REGULATORY COMMISSION
OFFICE OF NUCLEAR REACTOR REGULATION
WASHINGTON, D.C. 20555-0001

July 17, 1997

**NRC INFORMATION NOTICE 97-52: INADVERTENT LOSS OF CAPABILITY FOR
EMERGENCY CORE COOLING SYSTEM MOTORS**

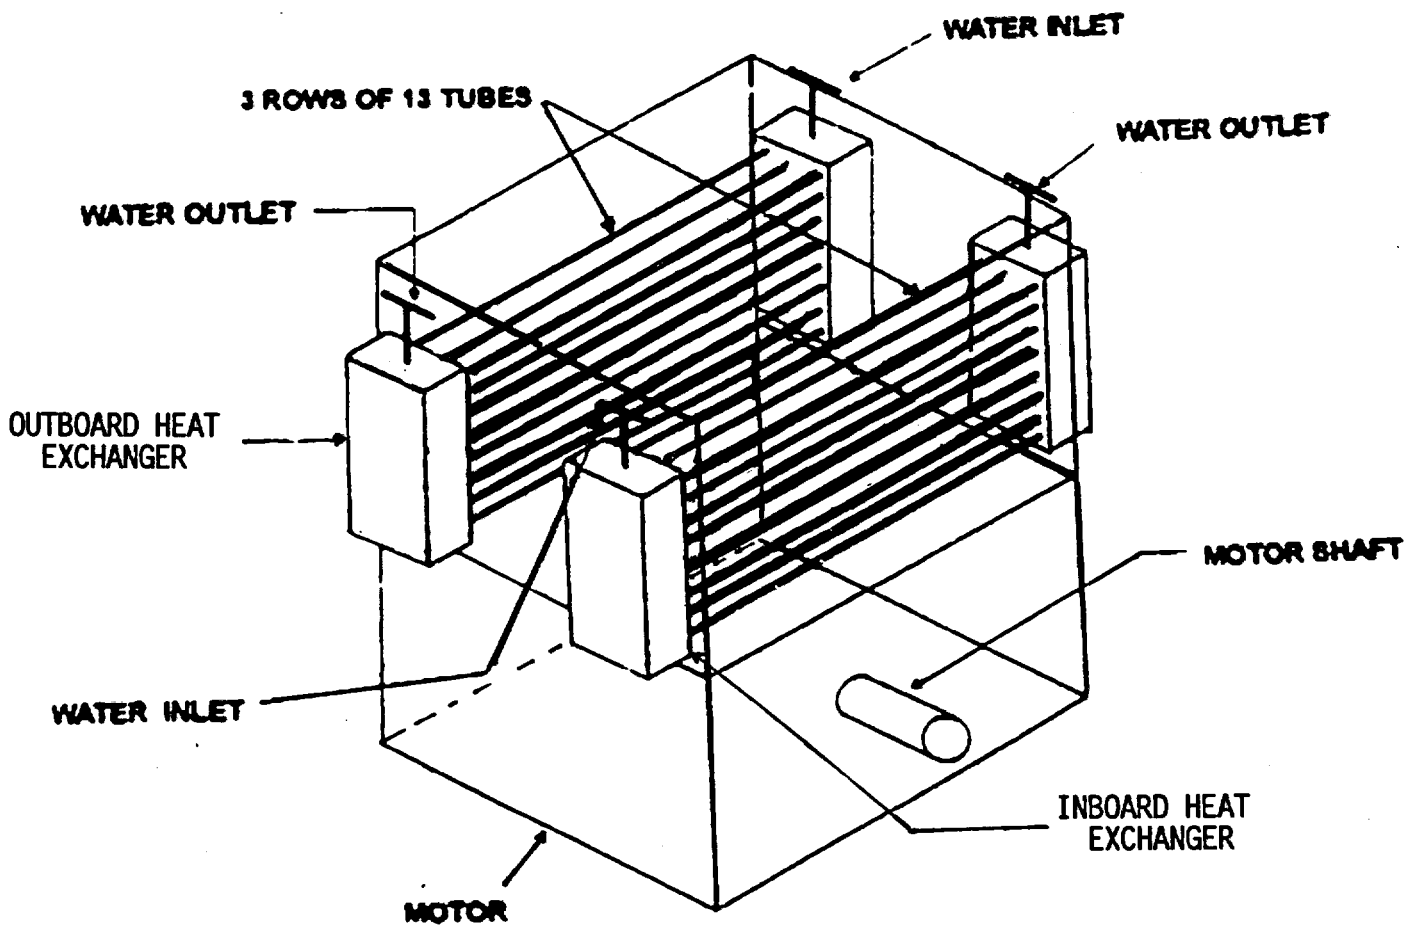
FIGURE I - TYPICAL MOTOR COOLER

On October 15, 1996, the licensee for Vogtle Electric Generating Plant noted that there was no cooling water flow to the inboard heat exchanger for the Unit 1, train B safety injection pump (SIP) motor cooler. The licensee also found that the cooling water flow to the motor cooler's outboard heat exchanger was significantly reduced. With the reduction in motor cooling capacity, the train B SIP would have been unable to perform its intended safety function during a postulated design-basis accident [medium break loss-of-coolant accident (LOCA)]. Insufficient motor cooling would likely result in motor bearing failure.

The train B SIP, including its motor and cooler, was supplied by the Westinghouse Corporation and consists of a 3-inch, 11-stage pump, model JHF, manufactured by Pacific Pumps, and a 450-HP, 3547-RPM, 4000-V ac, 3-phase electric motor manufactured by Westinghouse Electric Corporation. The motor cooler consists of two three-pass, cross-counterflow, finned-tube, heat exchangers supplied by Sentry Equipment Corporation. Figure I is a diagram of the typical motor-cooler configuration. Each heat exchanger has an inlet and an outlet plenum. The plenums have internal baffles that are oriented to create a cross-counterflow flowpath. Figure II is an end view of a typical heat exchanger. The licensee determined that the plenum gaskets were installed backwards in the inboard heat exchanger.

The licensee addressed this issue with corrective actions that included development of a maintenance procedure to disassemble and reassemble motor coolers. The procedure includes checklists of precautions regarding orientation of motor cooler gaskets and plenums; checklists to include taking temperature readings of the plenums; steps for measurement of individual motor cooler flows; and directions to "match-mark" cooler components to prevent incorrect orientation at the conclusion of maintenance work.

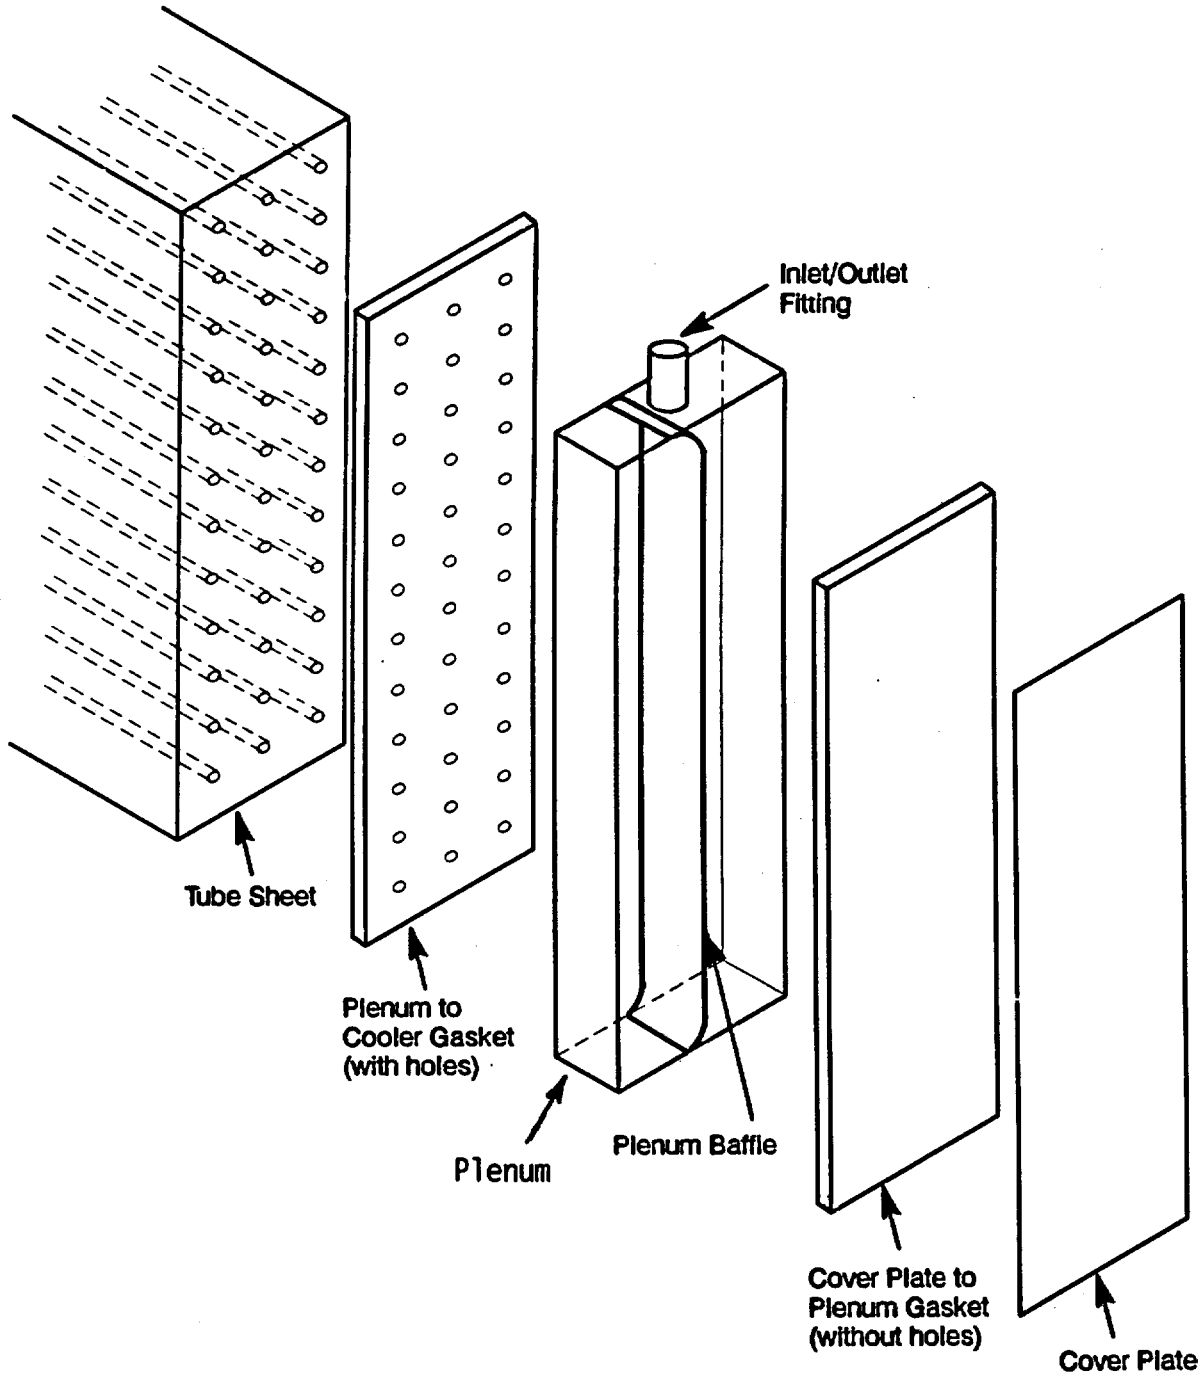
FIGURE II - END VIEW OF HEAT EXCHANGER ASSEMBLY

The solid cover plate to plenum gasket was installed in place of the plenum to tube sheet gasket (with holes).

This incorrect installation blocked the cooling water flowpath. While reinstalling the gaskets correctly, the licensee recognized that it was possible to install the plenum incorrectly, e.g., rotated 180 degrees around the axis of the inlet/outlet fitting. This orientation would cause the cooling water flowpath to be altered from a three-pass, cross-counterflow flowpath to a single-pass, once-through flowpath. As a result the available surface area for heat transfer would be decreased by two-thirds per heat exchanger. Figure III shows top views of heat exchangers with plenums configured for three-pass operation and one-pass operation. In the absence of "match marks" or some other position indicator, an improperly oriented plenum could remain visually undetected.

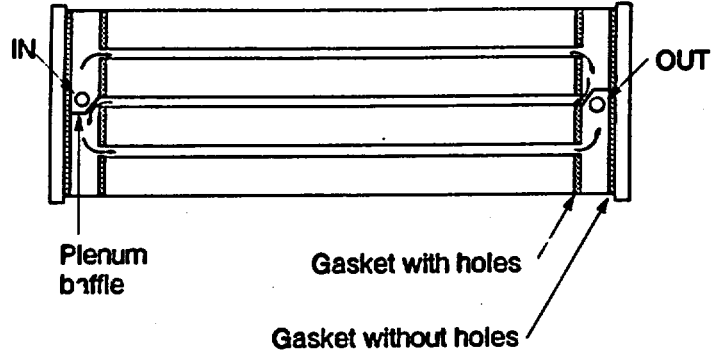
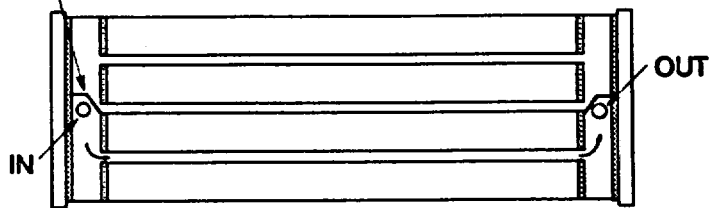
**FIGURE III - TOP VIEW HEAT EXCHANGER
ASSEMBLY**

**Reversed
plenum
baffle**
**Top View Motor Cooler
One-Pass configuration**

flowpath to a single-pass, once-through flowpath. This orientation would decrease the available surface area for heat transfer by two-thirds per motor cooler. In the absence of "match marks" or some other position indicator, an improperly oriented plenum could remain visually undetected.
