UNITED STATES
NUCLEAR REGULATORY COMMISSION
OFFICE OF NUCLEAR REACTOR REGULATION
WASHINGTON, DC 20555-0001

April 18, 1997

**NRC INFORMATION NOTICE 97-19: SAFETY INJECTION SYSTEM WELD FLAW AT
SEQUOYAH NUCLEAR POWER PLANT, UNIT 2**

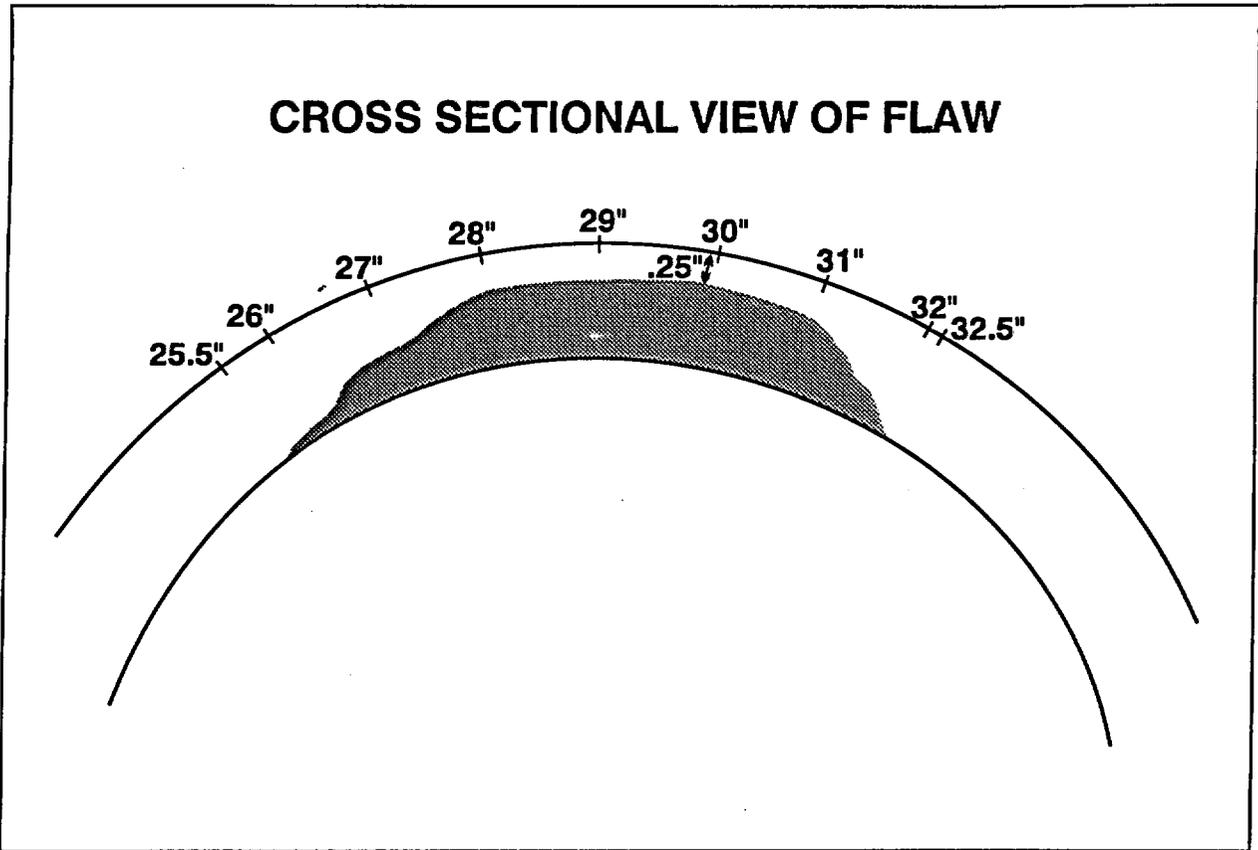
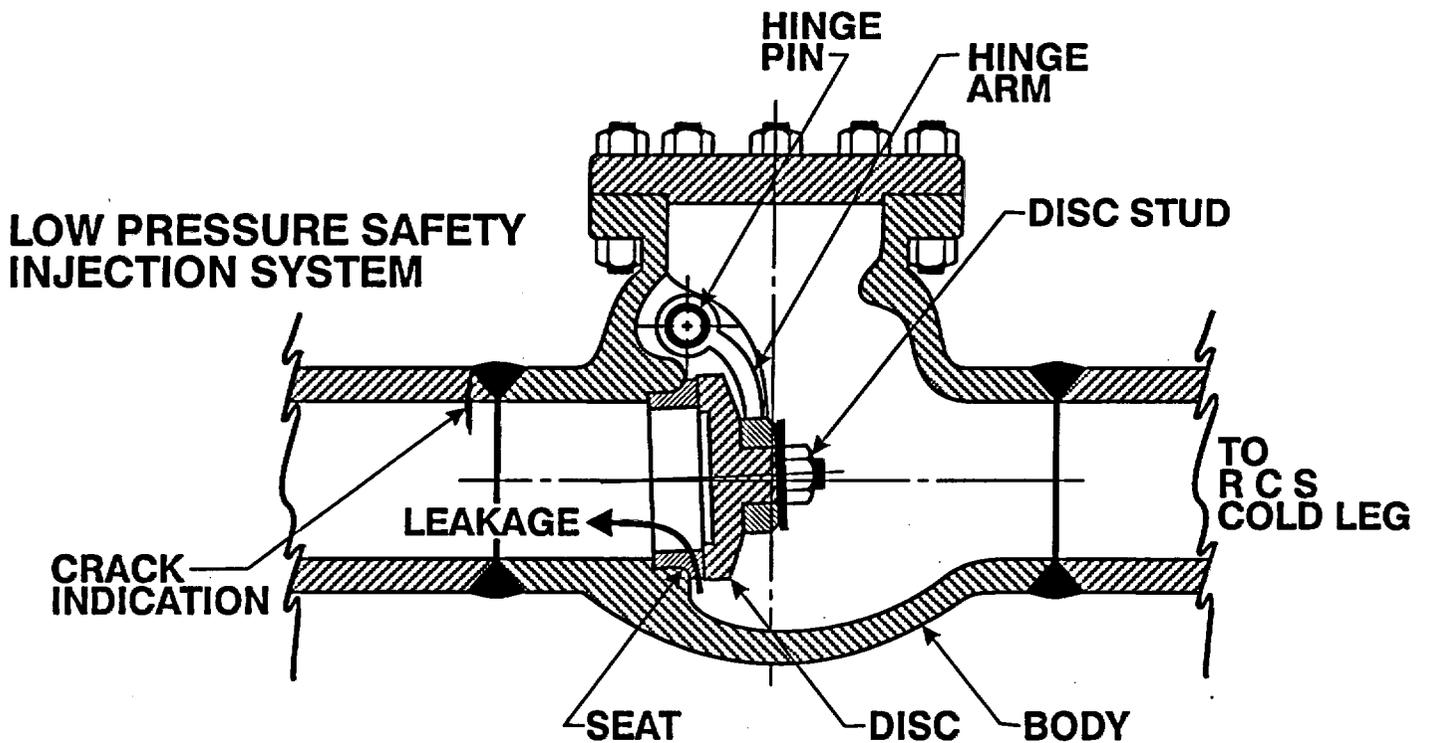
CROSS SECTIONAL VIEW OF FLAW

On May 2, 1996, a routine American Society of Mechanical Engineers (ASME) Section XI ultrasonic test (UT) inservice inspection (ISI) at Sequoyah Unit 2 revealed a pipe crack indication in a low-pressure safety injection system (SIS) line. The UT indicated a 7-inch (17.8 cm)-long, 75-percent through-wall 7-inch circumferential crack on the inside surface of the (25.4 cm) 10-inch Schedule 140 stainless steel line. The crack was located at the top dead center of the base metal adjacent to the upstream weld of the check valve closest to the Reactor Coolant System (RCS) cold leg (see figure). This check valve isolates the RCS from the SIS. Although the crack was on the upstream side of the check valve, the circumstances that created this crack initially appeared to also reflect those described in NRC Bulletin 88-08, "Thermal Stresses in Piping Connected to Reactor Coolant Systems," and a review of the plant records revealed that this valve had a history of leakage. In addition, the records also showed that this particular weld had been reworked four times during plant construction before it was finally accepted.

The initiation and propagation of this particular crack was initially attributed to intermittent leakage of hot reactor coolant through the check valve seat into the stagnant cold fluid side of the check valve (a cause similar to that described in the earlier bulletin). The weld and adjacent base metal were replaced, and a subsequent metallurgical examination established that the cracking began at the inside diameter surface of the counterbore region of the pipe-to-valve weld and progressed radially outward through the sensitized region of the heat-affected zone (HAZ). The metallurgical evaluation concluded that the cracking in the pipe was caused by intergranular stress-corrosion cracking which, in turn, was caused by exposure of the sensitized region of the HAZ to oxygenated boric acid water in the SIS. This situation was exacerbated by additional sensitization due to the large residual stresses caused by the four cycles of repair to this weld zone.

Identification of potential crack locations of this type may be facilitated by considering the history of the weld zones and the leak-tightness of the check valves in low-pressure SISs connected to RCS piping when performing required ISI testing .
