UNITED STATES
NUCLEAR REGULATORY COMMISSION
OFFICE OF NUCLEAR REACTOR REGULATION
WASHINGTON, DC 20555-0001

April 18, 1997

**NRC INFORMATION NOTICE 97-19: SAFETY INJECTION SYSTEM WELD FLAW AT
SEQUOYAH NUCLEAR POWER PLANT, UNIT 2**

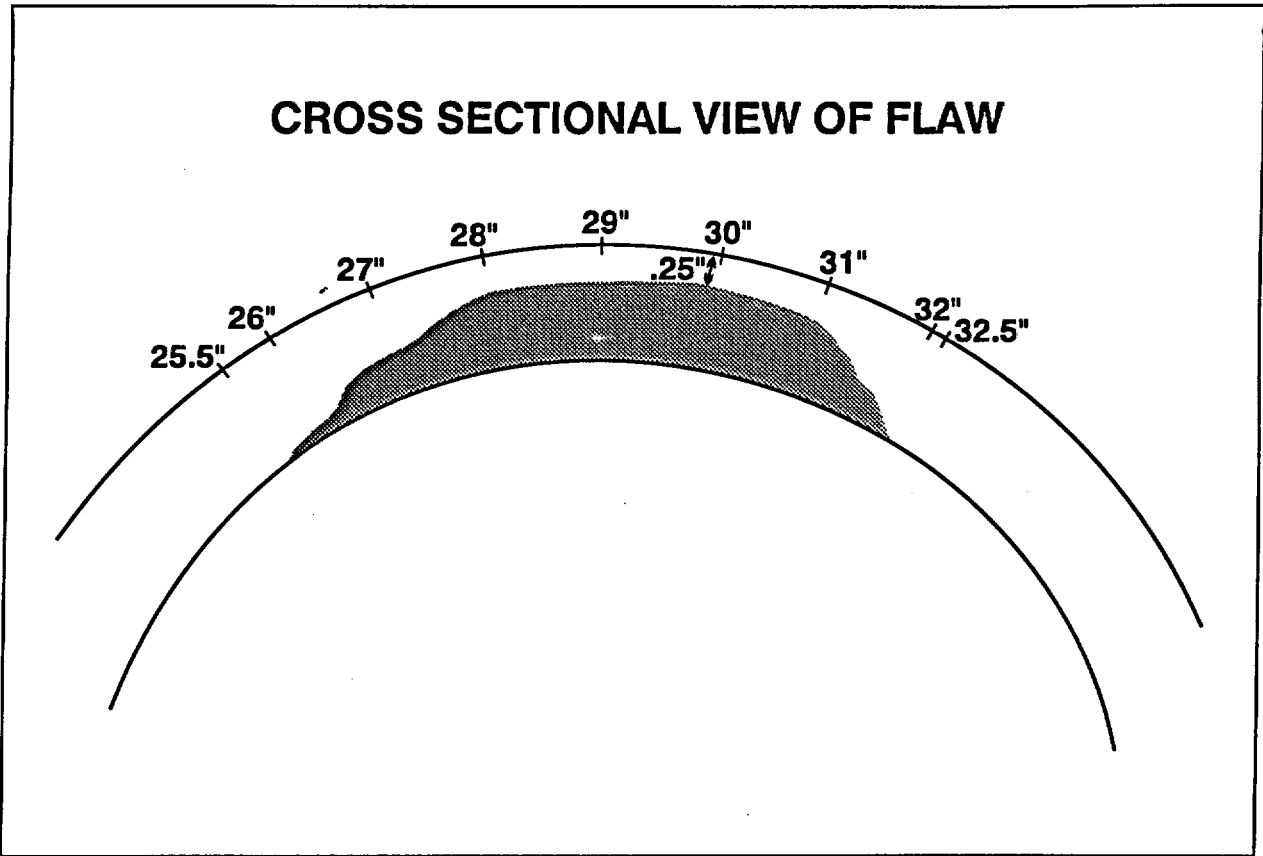
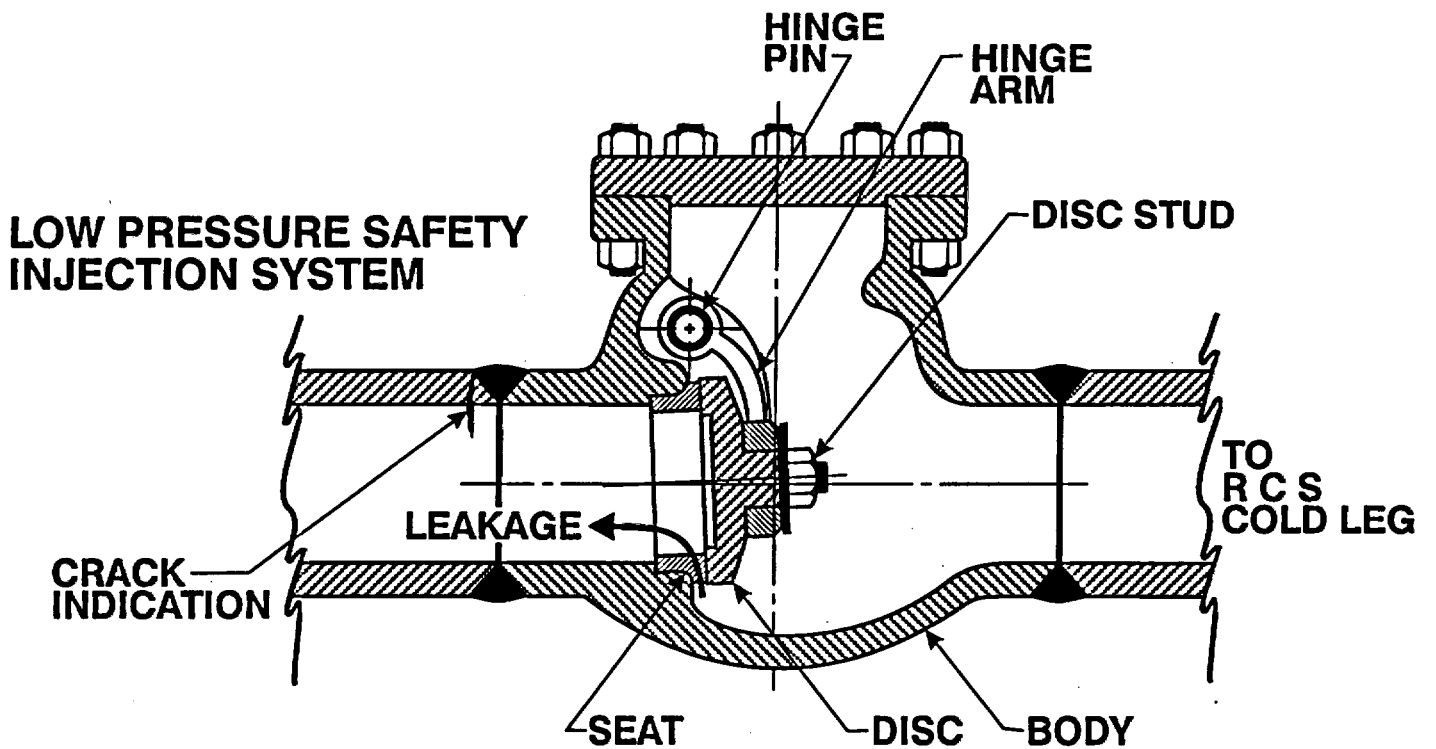
On May 2, 1996, a routine American Society of Mechanical Engineers (ASME) Section XI ultrasonic test (UT) inservice inspection (ISI) at Sequoyah Unit 2 revealed a pipe crack indication in a low-pressure safety injection system (SIS) line. The UT indicated a 7-inch (17.8 cm)-long, 75-percent through-wall 7-inch circumferential crack on the inside surface of the (25.4 cm) 10-inch Schedule 140 stainless steel line. The crack was located at the top dead center of the base metal adjacent to the upstream weld of the check valve closest to the Reactor Coolant System (RCS) cold leg (see figure). This check valve isolates the RCS from the SIS. Although the crack was on the upstream side of the check valve, the circumstances that created this crack initially appeared to also reflect those described in NRC Bulletin 88-08, "Thermal Stresses in Piping Connected to Reactor Coolant Systems," and a review of the plant records revealed that this valve had a history of leakage. In addition, the records also showed that this particular weld had been reworked four times during plant construction before it was finally accepted.

The initiation and propagation of this particular crack was initially attributed to intermittent leakage of hot reactor coolant through the check valve seat into the stagnant cold fluid side of the check valve (a cause similar to that described in the earlier bulletin). The weld and adjacent base metal were replaced, and a subsequent metallurgical examination established that the cracking began at the inside diameter surface of the counterbore region of the pipe-to-valve weld and progressed radially outward through the sensitized region of the heat-affected zone (HAZ). The metallurgical evaluation concluded that the cracking in the pipe was caused by intergranular stress-corrosion cracking which, in turn, was caused by exposure of the sensitized region of the HAZ to oxygenated boric acid water in the SIS. This situation was exacerbated by additional sensitization due to the large residual stresses caused by the four cycles of repair to this weld zone.

Identification of potential crack locations of this type may be facilitated by considering the history of the weld zones and the leak-tightness of the check valves in low-pressure SISs connected to RCS piping when performing required ISI testing .
