UNITED STATES
NUCLEAR REGULATORY COMMISSION
OFFICE OF NUCLEAR REACTOR REGULATION
WASHINGTON, D.C. 20555-0001

March 24, 1997

**NRC INFORMATION NOTICE 97-12: POTENTIAL ARMATURE BINDING IN GENERAL
ELECTRIC TYPE HGA RELAYS**

RELAY SERVICE ADVICE LETTER

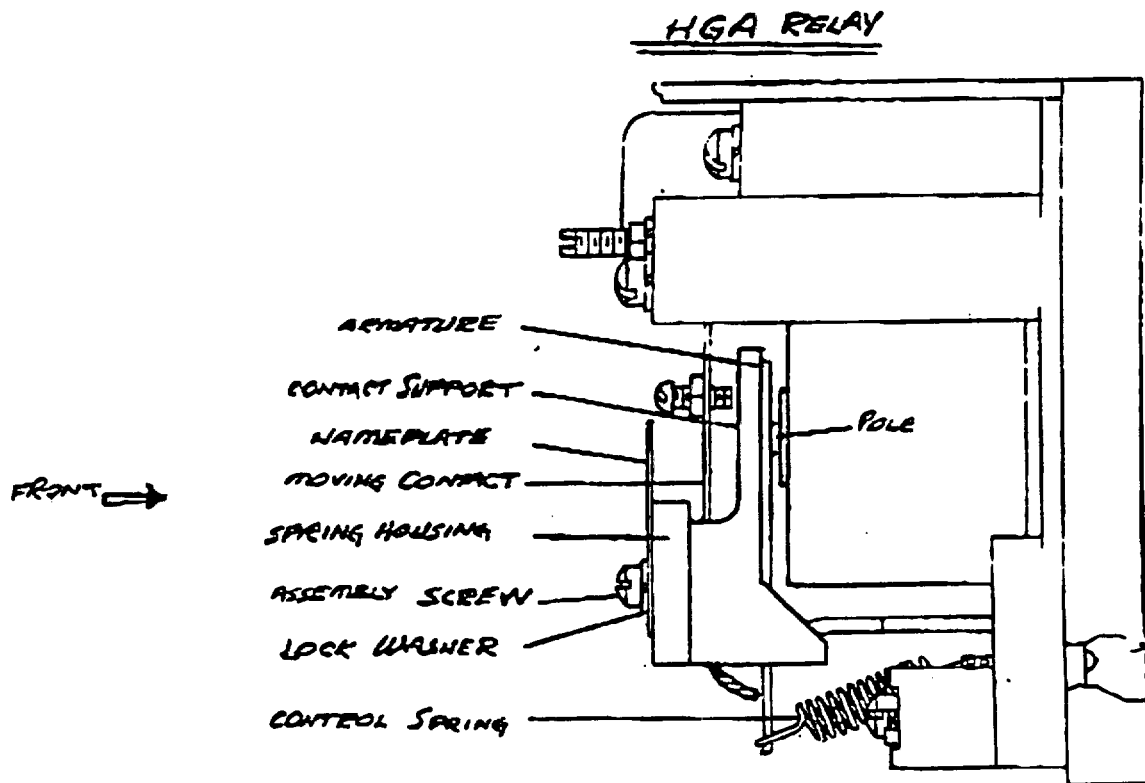
FIG. 1. (SIDE VIEW)

However, a dimensional analysis of the most critical parts indicated that the molded contact support was slightly out of tolerance. Specifically, the assembly hole of the contact support was slightly off center.

It is conceivable that this offset combined with the manufacturing tolerances of the armature and magnet frame, possible foreign matter in the hinge area and maybe excessive side pressure applied to the contact support when assembled could cause friction between the contact support and magnetic frame resulting in armature binding.

1. De-energize the relay, coil and contacts.
2. Close the armature fully by hand, (push armature against the pole, see Fig. 1), and gradually release. For correct operation, the armature should move to the fully open position with no binding and with correct contact action. The normally open contacts should open and the normally closed contacts should close. If binding is detected, we recommend the following:

The contact support should be replaced as follows: (Refer to Fig. 1)

1. Disengage the control spring from the armature end. (Note the groove location of the spring hook on the armature).
2. Remove the assembly screw with its lockwasher.

3. Remove the nameplate and spring housing assembly.
4. Remove the moving contacts from the contact support and note their location for correct reassembly.

5. Remove the contact support.
6. Install the new contact support. Make sure the armature is seated properly in the contact support.
7. Locate the moving contacts in the contact support.

8. Install the nameplate and spring housing assembly.
9. Tighten the assembly screw and lockwasher (16 in-lbs. approx.). Hold contact support and spring housing assembly together while tightening assembly screw.

10. Engage the control spring on the same groove on the armature of the relay.
11. Operate the armature of the relay by hand to make sure that there is no binding.
