UNITED STATES
NUCLEAR REGULATORY COMMISSION
OFFICE OF NUCLEAR REACTOR REGULATION
WASHINGTON, D.C. 20555-0001

January 8, 1997

**NRC INFORMATION NOTICE 97-01: IMPROPER ELECTRICAL GROUNDING RESULTS IN
SIMULTANEOUS FIRES IN THE CONTROL ROOM
AND THE SAFE-SHUTDOWN EQUIPMENT ROOM**

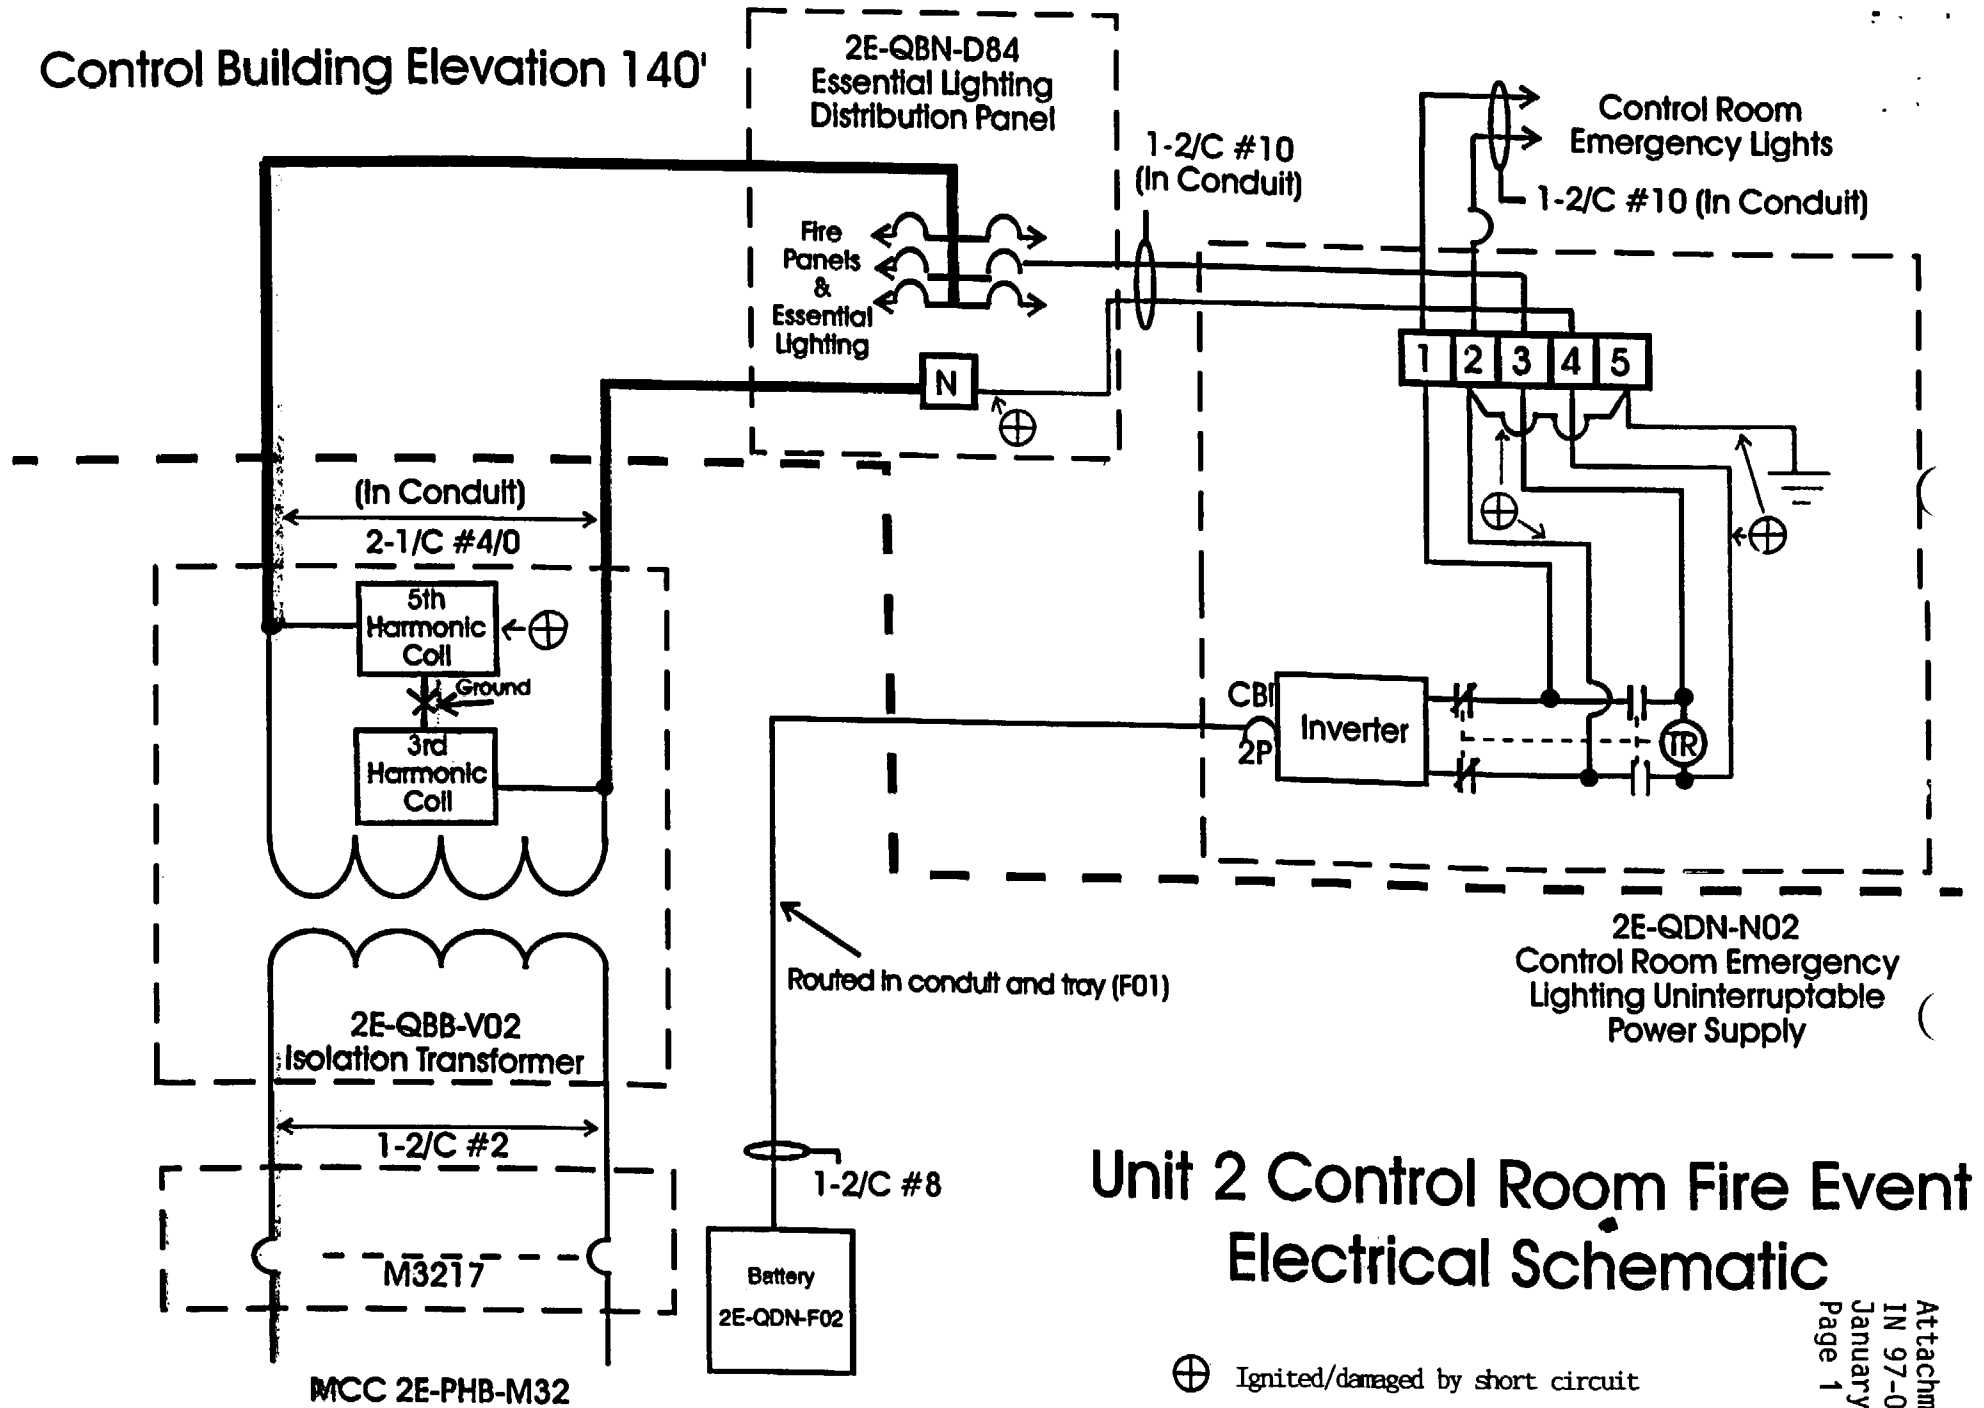
Figure 1

At approximately 5:00 p.m. on April 4, 1996, during a refueling outage, a licensee firewatch detected smoke in the back panel area of the control room at the Palo Verde Nuclear Generating Station, Unit 2. Licensee operators observed smoke emanating from the Train B emergency lighting uninterruptible power supply (ELUPS) panel in the control room.

The control room staff dispatched auxiliary operators to inspect their assigned areas to check for possible fire conditions and additional problems. An auxiliary operator discovered smoke and fire in the Train B dc equipment room on the 100-foot level of the auxiliary building. The fire was located in the 480/120-volt essential lighting isolation transformer. The trouble alarms resulting from the lost power supply masked the actual fire alarm in the Train B dc equipment room.

The licensee's root-cause investigation indicated that the core of the regulating isolation transformer (located in the Train B dc equipment room) failed and made contact with the transformer coils, causing a short circuit fault to station ground through the transformer's panel ground. The purpose of the subject transformer is to isolate nonsafety-related portions of the circuit from the safety-related function of the circuit. The investigation also determined that the neutral leg of the transformer had not been grounded. An alternate source of power for the essential lighting uninterruptible power supply panel is provided by an inverter. The system had been designed with ground connections on the neutral leg of the inverter instead of grounding the neutral leg of the power supply (regulating transformer) in accordance with industry practice. The neutral wiring conductors within the inverter and from the inverter to the essential lighting distribution panel became the return fault path to the regulating transformer. These conductors were not designed to handle the high fault currents to which they were subjected. As a result, these wires ignited under these high fault currents. These components are depicted in Figure 1. The licensee also determined that the fires were related and were caused by a design error in the electrical grounding, which dated back to plant construction. The licensee found similar grounding arrangements in the other two Palo Verde units.

Unit 2 Control Room Fire Event Electrical Schematic

⊕ Ignited/damaged by short circuit

The licensee's corrective actions included grounding the neutral leg of the isolation transformer and fusing the output of the transformer to limit fault propagation. The licensee also removed the ground from the control room ELUPS panel. These modifications did not impact the isolation function of the transformer.
