UNITED STATES
NUCLEAR REGULATORY COMMISSION
OFFICE OF NUCLEAR REACTOR REGULATION
WASHINGTON, D.C. 20555-0001

January 8, 1997

**NRC INFORMATION NOTICE 97-01: IMPROPER ELECTRICAL GROUNDING RESULTS IN
SIMULTANEOUS FIRES IN THE CONTROL ROOM
AND THE SAFE-SHUTDOWN EQUIPMENT ROOM**

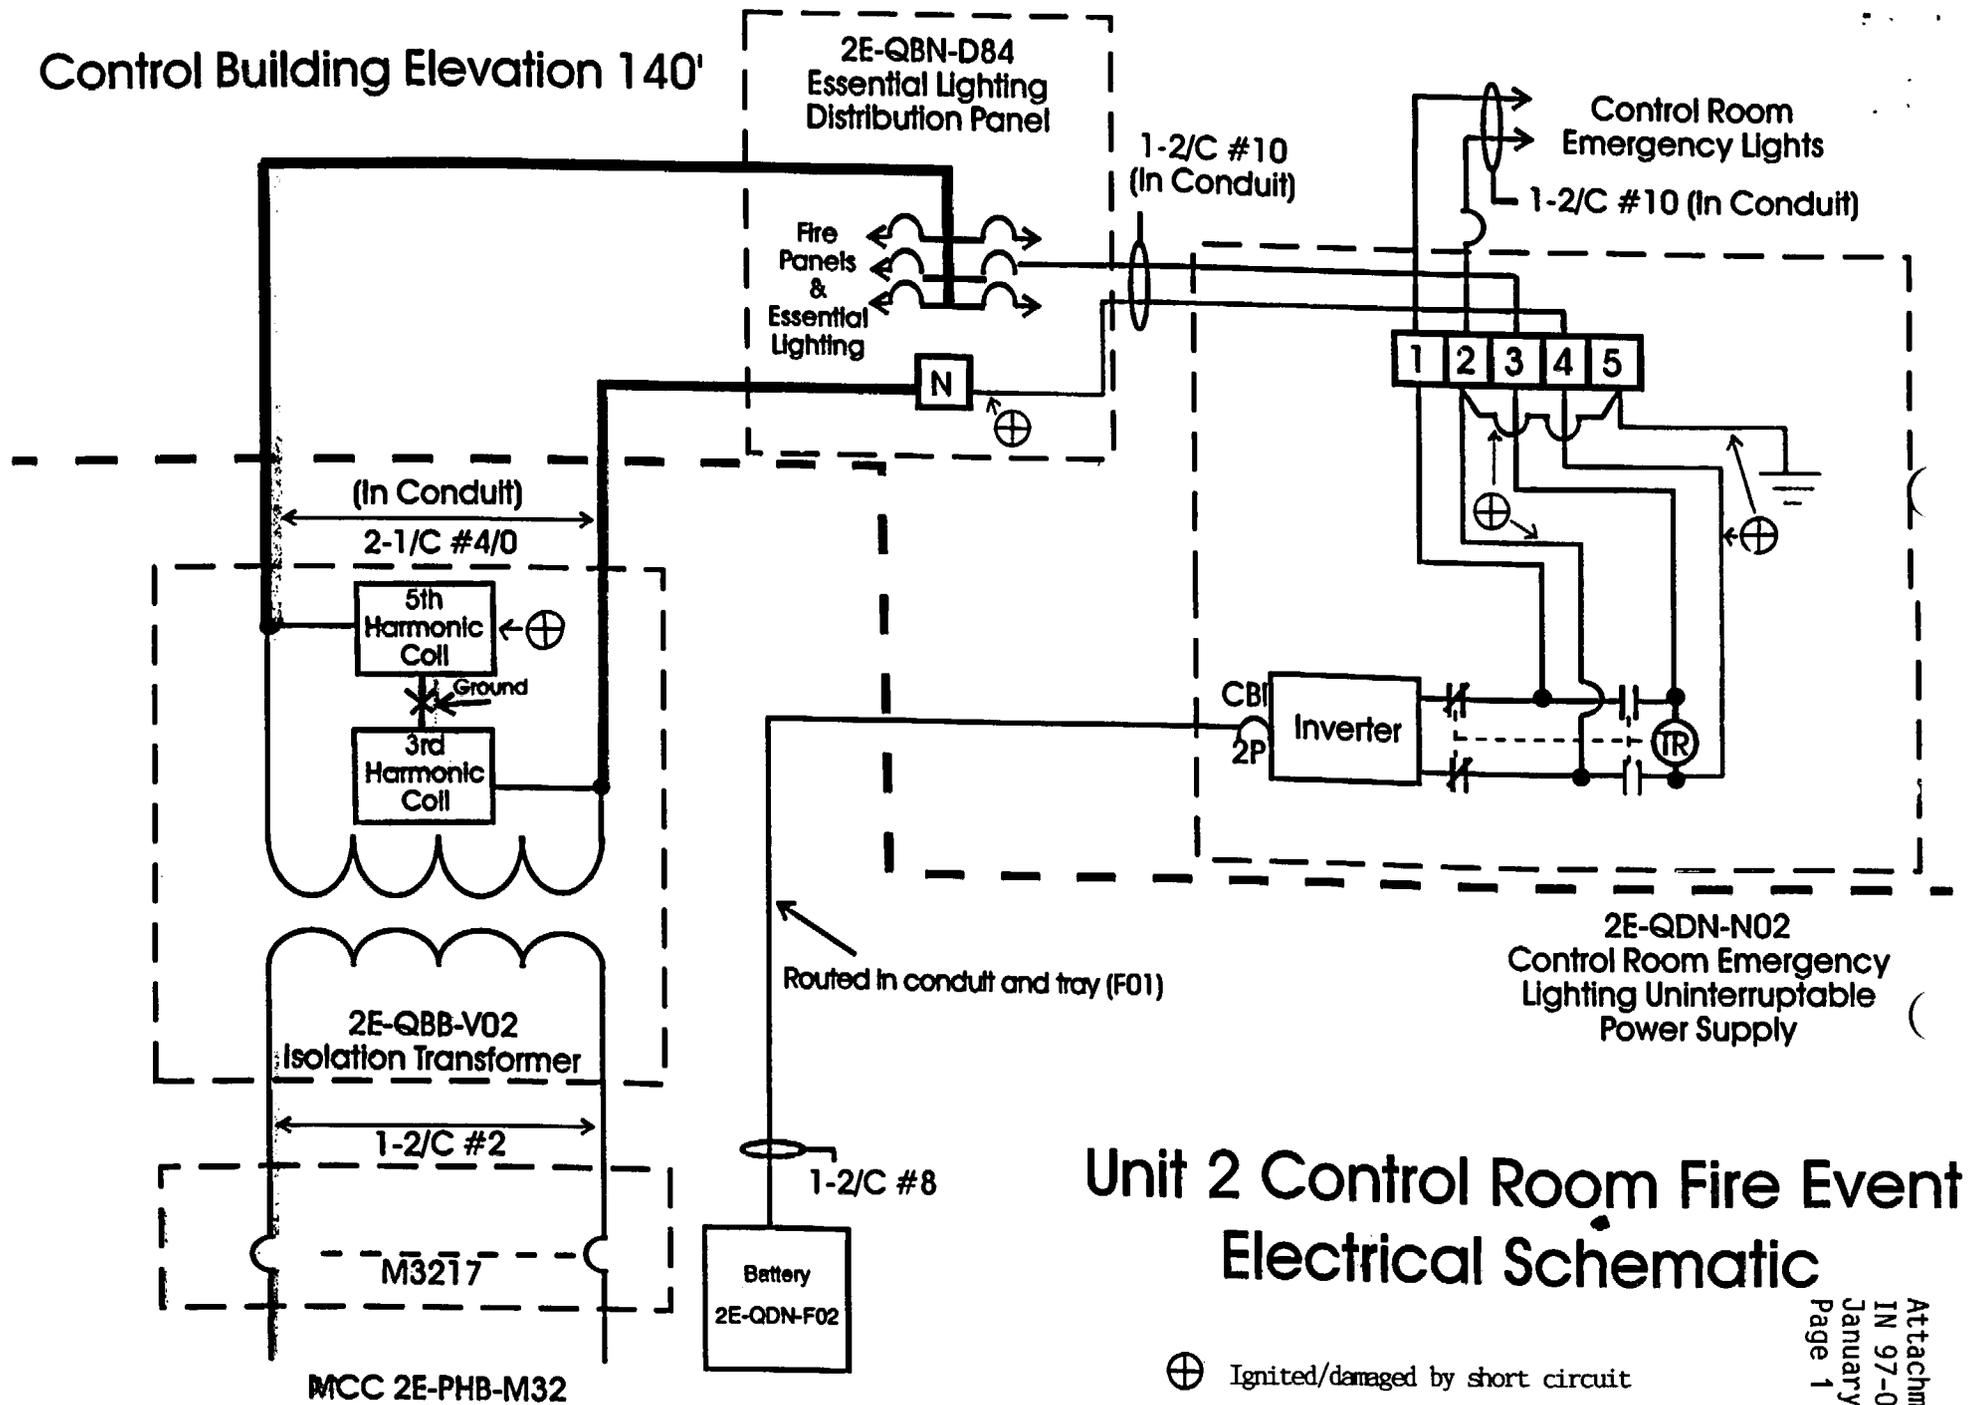
Figure 1

The licensee's root-cause investigation indicated that the core of the regulating isolation transformer (located in the Train B dc equipment room) failed and made contact with the transformer coils, causing a short circuit fault to station ground through the transformer's panel ground. The purpose of the subject transformer is to isolate nonsafety-related portions of the circuit from the safety-related function of the circuit. The investigation also determined that the neutral leg of the transformer had not been grounded. An alternate source of power for the essential lighting uninterruptible power supply panel is provided by an inverter. The system had been designed with ground connections on the neutral leg of the inverter instead of grounding the neutral leg of the power supply (regulating transformer) in accordance with industry practice. The neutral wiring conductors within the inverter and from the inverter to the essential lighting distribution panel became the return fault path to the regulating transformer. These conductors were not designed to handle the high fault currents to which they were subjected. As a result, these wires ignited under these high fault currents. These components are depicted in Figure 1. The licensee also determined that the fires were related and were caused by a design error in the electrical grounding, which dated back to plant construction. The licensee found similar grounding arrangements in the other two Palo Verde units.

The event was of concern because a single electrical fault caused simultaneous fires in the control room and the Train B dc equipment room which supports alternative post-fire safe shutdown capability in the event of a control room fire. This electrical design error is important because it created a fire vulnerability in two separate areas of the plant. The fire could have resulted in operational challenges which are outside of the plant's design basis

Unit 2 Control Room Fire Event Electrical Schematic

⊕ Ignited/damaged by short circuit

The licensee's corrective actions included grounding the neutral leg of the isolation transformer and fusing the output of the transformer to limit fault propagation. The licensee also removed the ground from the control room ELUPS panel. These modifications did not impact the isolation function of the transformer.
