UNITED STATES
NUCLEAR REGULATORY COMMISSION
OFFICE OF NUCLEAR REACTOR REGULATION
WASHINGTON, DC 20555-0001

November 20, 1996

NRC INFORMATION NOTICE 96-61: FAILURE OF A MAIN STEAM SAFETY VALVE TO RESEAT CAUSED BY AN IMPROPERLY INSTALLED RELEASE NUT

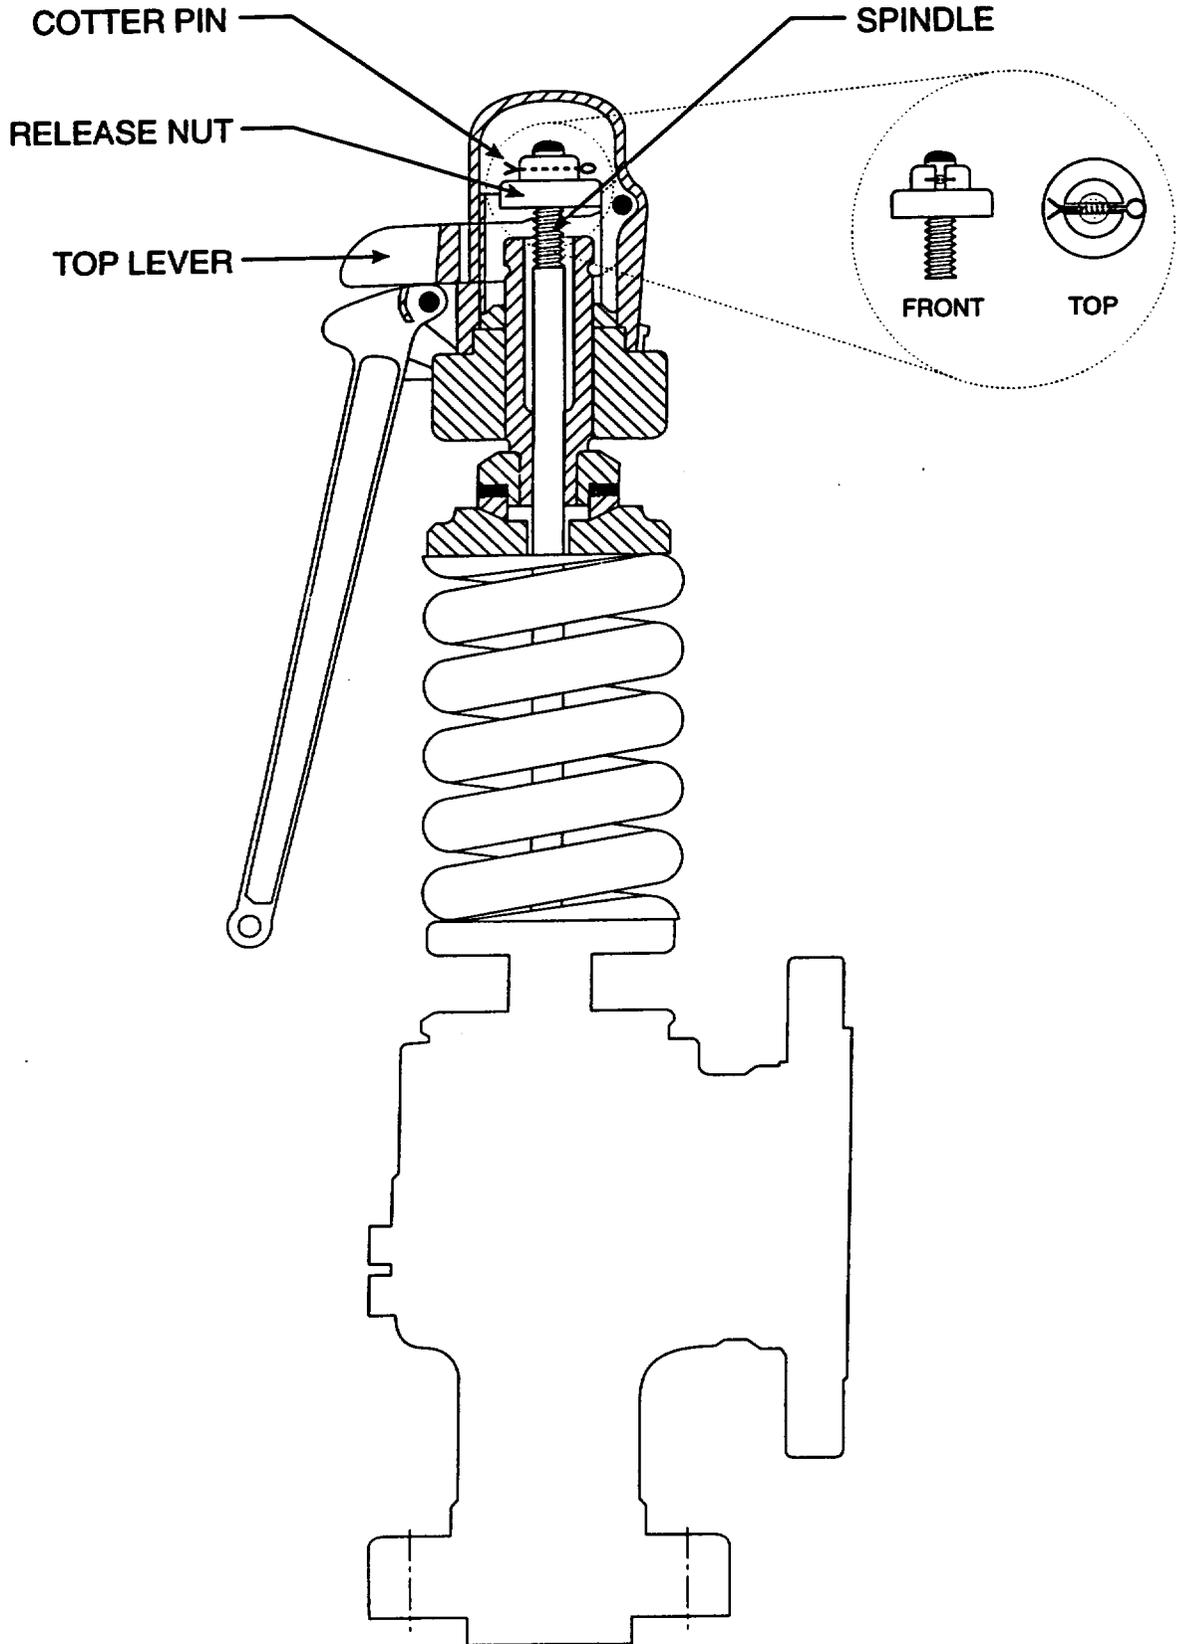
STEAM SAFETY VALVE

The licensee determined that PSV-2685 failed to reseat because a release nut on the valve spindle had been improperly installed. The release nut is installed to provide a surface against which a lifting lever can bear to permit opening of the valve manually. The nut is castellated to provide a slot through which a cotter pin may be aligned with a hole in the spindle so that, with the cotter pin engaged in the slot and extending through the hole in the stem, the nut would be prevented from turning. With the nut held in its fixed position, there was to be a specified clearance between the bottom of the nut and the top of the lifting lever beneath to allow for expansion and contraction of the spindle during thermal cycles. Following the ANO-1 event, the licensee found that the release nut had been threaded onto the valve spindle at a position too low to be properly staked by the cotter pin. Because the cotter pin could not prevent the rotation of the nut, vibration occurring during the valve discharge caused the nut to turn and travel down the stem until it rested upon the lifting lever mechanism. Without any clearance between the bottom of the nut and the top of the lever, the valve was held open.

As a result of its review of the event, the licensee concluded that a contributing cause of the problem was an inadequate instruction related to establishing the proper position of the release nut with respect to the cotter pin hole in the stem. The instruction, derived from vendor guidance, specified the clearance between the release nut and the lifting lever as 1/16 inch to 1/8 inch. The minimum value of 1/16 inch was necessary to allow enough space to accommodate thermal effects on clearances, but the maximum value of 1/8 inch was an unneeded limitation that distracted attention from the need to ensure that the nut was staked sufficiently with the cotter pin to preclude nut rotation. The licensee changed the maintenance procedure to eliminate the confusion about the nut-to-lever clearance and modified the design of the release nut to increase the depth of the slot, thereby providing greater assurance of proper engagement between the cotter pin and the nut. In subsequent action, the licensee determined that the manual lifting devices were unnecessary from an operational standpoint and removed the lever and nut assemblies from all the steam safety valves.
