UNITED STATES
NUCLEAR REGULATORY COMMISSION
OFFICE OF NUCLEAR REACTOR REGULATION
WASHINGTON, DC 20555-0001

NRC INFORMATION NOTICE 96-61: FAILURE OF A MAIN STEAM SAFETY VALVE TO RESEAT CAUSED BY AN IMPROPERLY INSTALLED RELEASE NUT

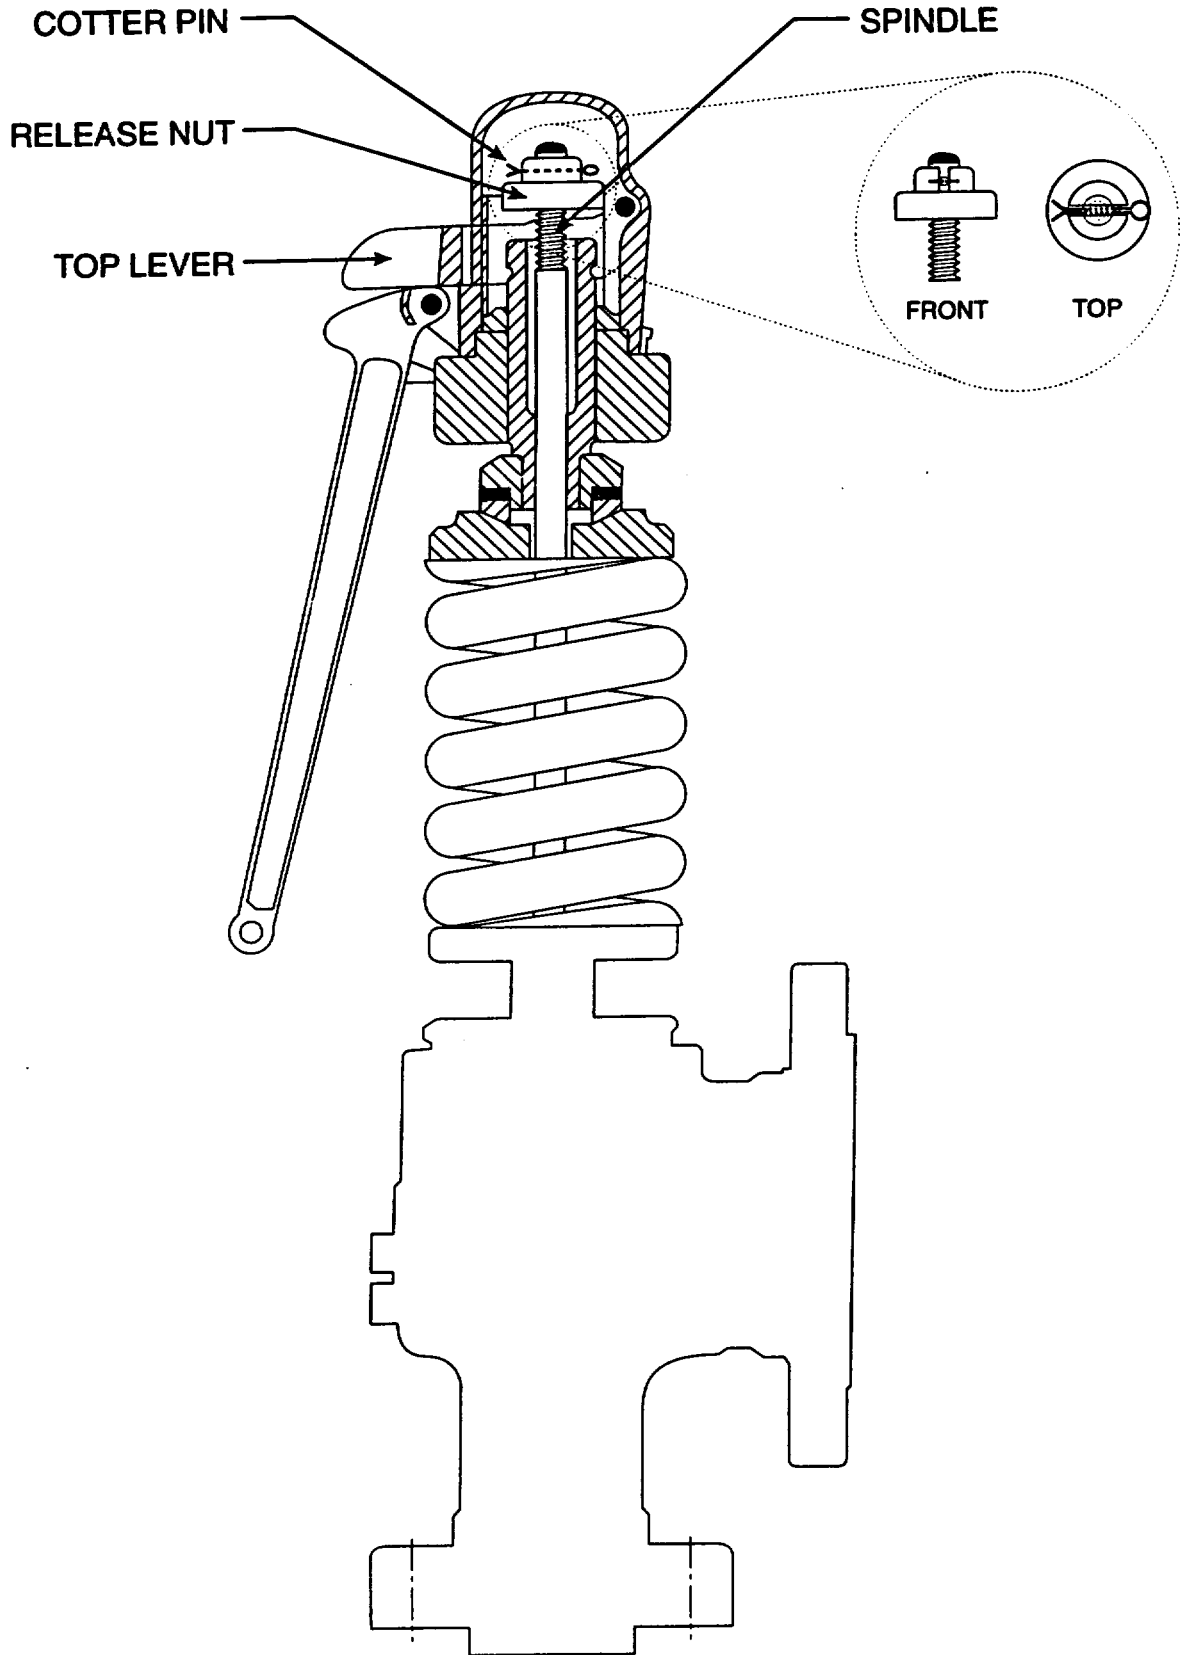
STEAM SAFETY VALVE

The licensee determined that PSV-2685 failed to reseat because a release nut on the valve spindle had been improperly installed. The release nut is installed to provide a surface against which a lifting lever can bear to permit opening of the valve manually. The nut is castellated to provide a slot through which a cotter pin may be aligned with a hole in the spindle so that, with the cotter pin engaged in the slot and extending through the hole in the stem, the nut would be prevented from turning. With the nut held in its fixed position, there was to be a specified clearance between the bottom of the nut and the top of the lifting lever beneath to allow for expansion and contraction of the spindle during thermal cycles. Following the ANO-1 event, the licensee found that the release nut had been threaded onto the valve spindle at a position too low to be properly staked by the cotter pin. Because the cotter pin could not prevent the rotation of the nut, vibration occurring during the valve discharge caused the nut to turn and travel down the stem until it rested upon the lifting lever mechanism. Without any clearance between the bottom of the nut and the top of the lever, the valve was held open.
