UNITED STATES  
NUCLEAR REGULATORY COMMISSION  
OFFICE OF NUCLEAR MATERIAL SAFETY AND SAFEGUARDS  
WASHINGTON, D.C. 20555

September 26, 1996

NRC INFORMATION NOTICE 96-52:      CRACKED INSERTION RODS ON TROXLER  
MODEL 3400 SERIES PORTABLE MOISTURE  
DENSITY GAUGES

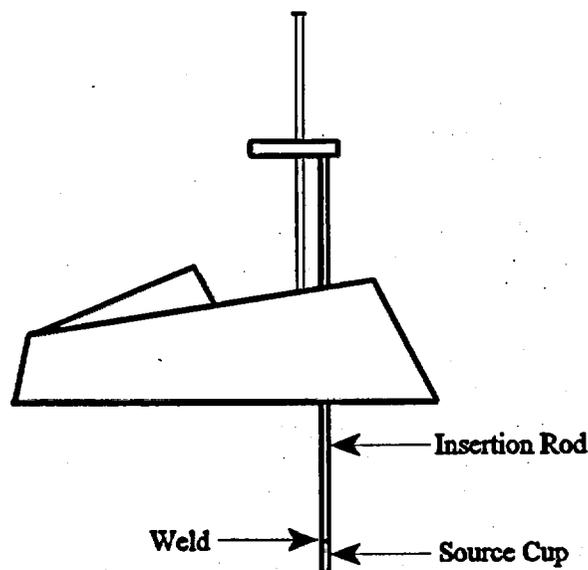
Typical Model 3400 Series Gauge

- The failure resulted from an initial crack in the weld region of the insertion rod that grew progressively until it failed completely in a brittle manner, releasing the contained sealed source.

- The initial transverse crack likely resulted from the insertion rod being subjected to a severe bending load (possibly an impact) not sufficient to cause catastrophic brittle failure.

- The initial crack propagated slowly due to repeated loads during use. The crack extended approximately 290° before the final brittle fracture.
- The region of crack initiation (the heat-affected zone around the weld) was very hard, but the weld was very soft. This differential in hardness was caused by material selection, joint configuration, and the welding procedure, and provided a stress concentration in the region around the weld. The stress concentration made the weld area more susceptible to crack initiation in a high-bending load condition.

The figure below shows the typical configuration of a Troxler model 3400 series gauge and the locations of the insertion rod, source cup, and weld:

Based on the results of the manufacturer's and the third-party contractor's investigations, and the recommendations made in Troxler's bulletin, users of Troxler model 3400 series gauges with serial numbers less than 13301 are encouraged to have their gauges inspected for cracks in the weld area of the insertion rod. In addition, it is recommended that these gauges be rechecked for cracks on at least a 5 year basis (more or less frequently depending on use level and conditions). It is further recommended that users of model 3400 series gauges with serial numbers 13301 and above also have their insertion rods checked for cracks in the weld area and consider periodic re-inspection, as well.

Inspections of insertion rod weld areas should only be performed by persons qualified to conduct an appropriate nondestructive examination (NDE) for macroscopic cracks (e.g., visual examination with magnification or dye penetrant) and licensed to handle the contained radioactive material. Visual examinations without magnification and examinations by unqualified persons are not recommended, as these could lead to inaccurate results and unnecessary doses to persons performing the examination. Persons who possess Troxler model 3400 series gauges who wish to have their insertion rods inspected should contact either the manufacturer or an NDE inspector qualified to perform the inspection. For guidance on finding qualified NDE inspectors, licensees may contact the Technical Services Division of the American Society for Nondestructive Testing, Inc., at (800) 222-2768 or the Non-Destructive Testing Management Association at (800) 317-0822.

Users who determine that their gauge's insertion rod contains a crack should immediately stop using the gauge and notify the manufacturer. Repair or replacement of cracked insertion rods should only be performed by qualified persons, authorized by license to perform these activities. The manufacturer or other licensee authorized to perform the repair or replacement will indicate the manner in which the gauge should be returned for service.
