UNITED STATES
NUCLEAR REGULATORY COMMISSION
OFFICE OF NUCLEAR REACTOR REGULATION
WASHINGTON, D.C. 20555-0001

NRC INFORMATION NOTICE 96-50: PROBLEMS WITH LEVERING-IN DEVICES IN
WESTINGHOUSE CIRCUIT BREAKERS

Subject DHP BREAKERS: LEVERING-IN DEVICE		Number ESBU-TB- 96-05-R0
System(s) BALANCE OF PLANT SWITCHGEAR USING TYPE DHP MAGNETIC AIR CIRCUIT BREAKERS		Date 06/19/96
Affected Plants CAE, CBE, CCE, CDE, GCLN1, BDAV1, CSTL1, CSTL2, CYW, ANG, GHAT1, GHAT2, KPR, B3M11, GSUS1, GSUS2, KRK, SCE, GCH1, GCH2, GWNP2		S.O.(s)
References Westinghouse Instruction Books I.B. 32-253-2 and I.B. 32-253-4A & 4B, "Instructions for Procel-line Type DHP Magnetic Air Circuit Breakers"	Affects Safety Yes <input checked="" type="checkbox"/> Related Equipment No <input type="checkbox"/>	Sheet 1 of 7

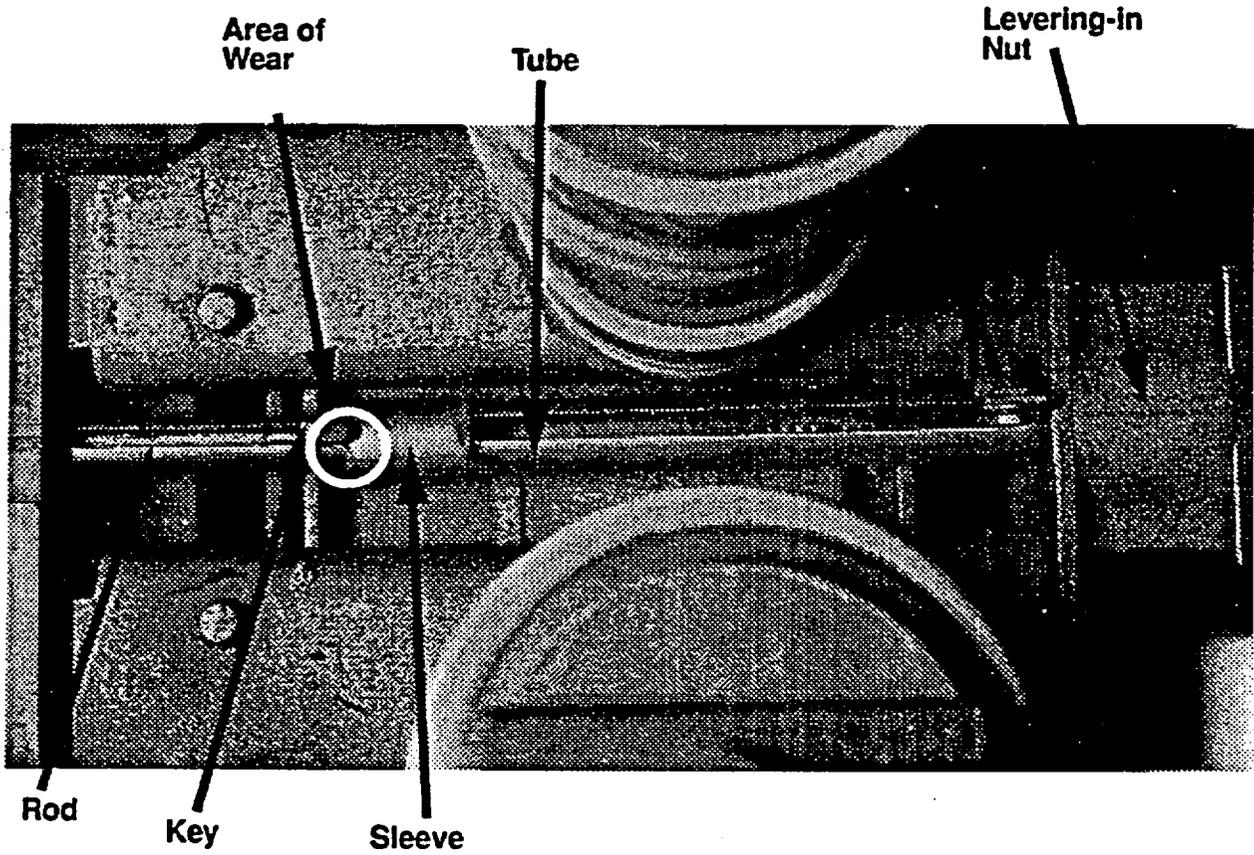
Figure 1. Levering-In Device Prior 1982

The root cause of the failure was a worn levering shaft key and a worn and cracked guide tube. The mating surfaces between the shaft key and the guide tube were worn and permitted the levering-in device to spin free while the breaker was still about a quarter inch from being fully engaged on the bus.

The spin free of the crank could occur prematurely if the levering-in device is worn at the mating pieces of the shaft and tube. Refer to Figures 1 & 2 for the two versions of the levering-in devices and the area of wear. The earlier version has a key welded in one side of the shaft and the later version has a pin through the shaft that protrudes on both sides. The key/pin interfaces with the slot in the tube and as the crank is turned the key/pin travels along this slot to the end of the tube. At the end of the tube the key/pin reaches the tapered part of the sleeve on the tube and no longer engages with the slot and the crank becomes spin free stopping travel of the breaker. When this area at the end of the tube and the key/pin become worn, the crank can go spin free before the breaker has traveled all the way to the proper OPERATE/ENGAGED position.

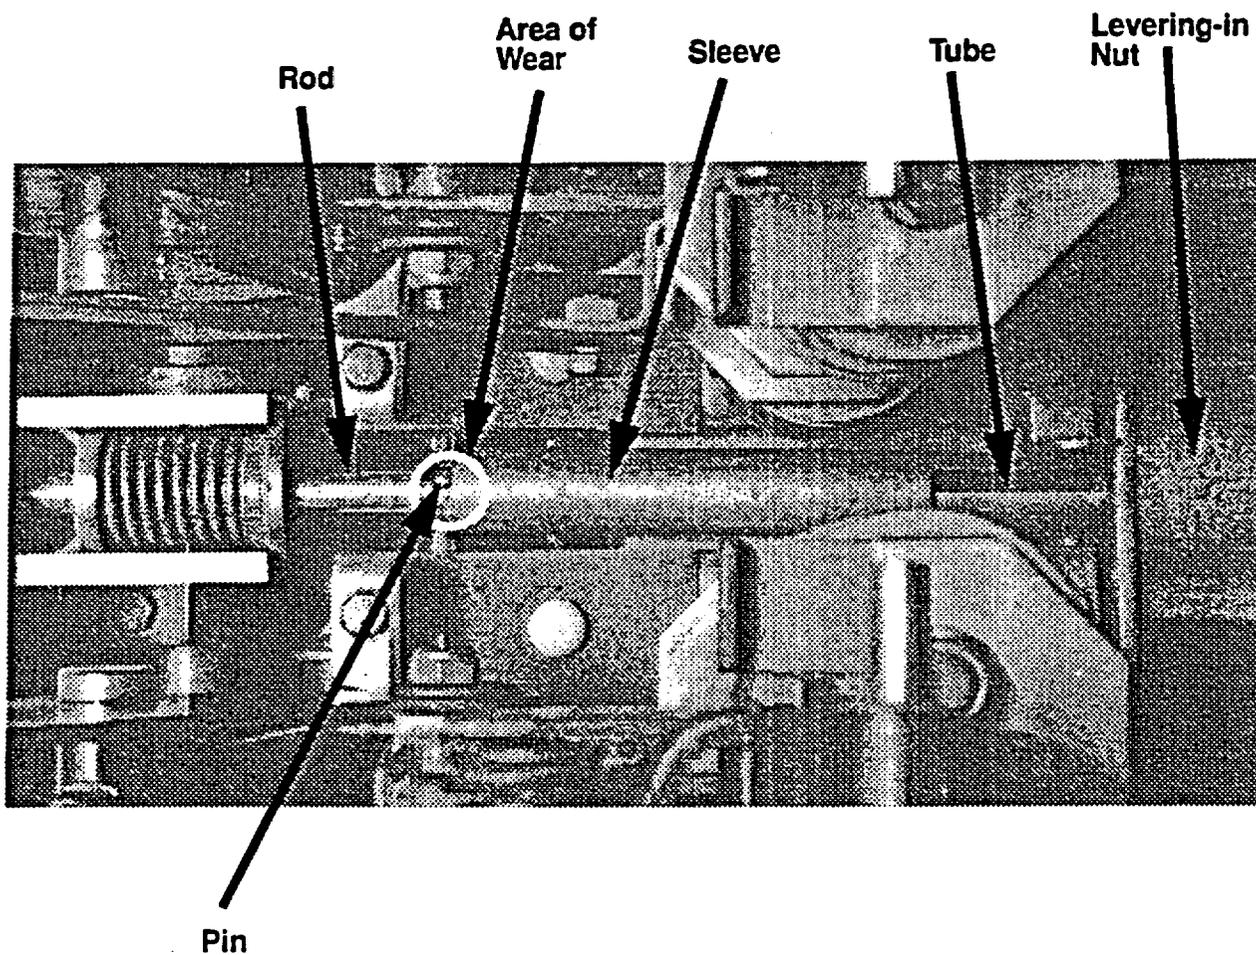
Figure 2. Levering-in Device After 1982

Westinghouse redesigned the levering-in device in 1982 to extend its service life. Figures 1 and 2 in the attached Westinghouse bulletin show the original and redesigned device installed in the breaker. Figure 6 is a sketch illustrating the difference in the guide tubes and levering shafts of the two designs. Interface between licensees and vendors in accordance with Generic Letter 83-28, "Required Actions Based on Generic Implications of Salem ATWS Events," issued July 8, 1983, can help ensure that information on safety-related components is complete and up to date.

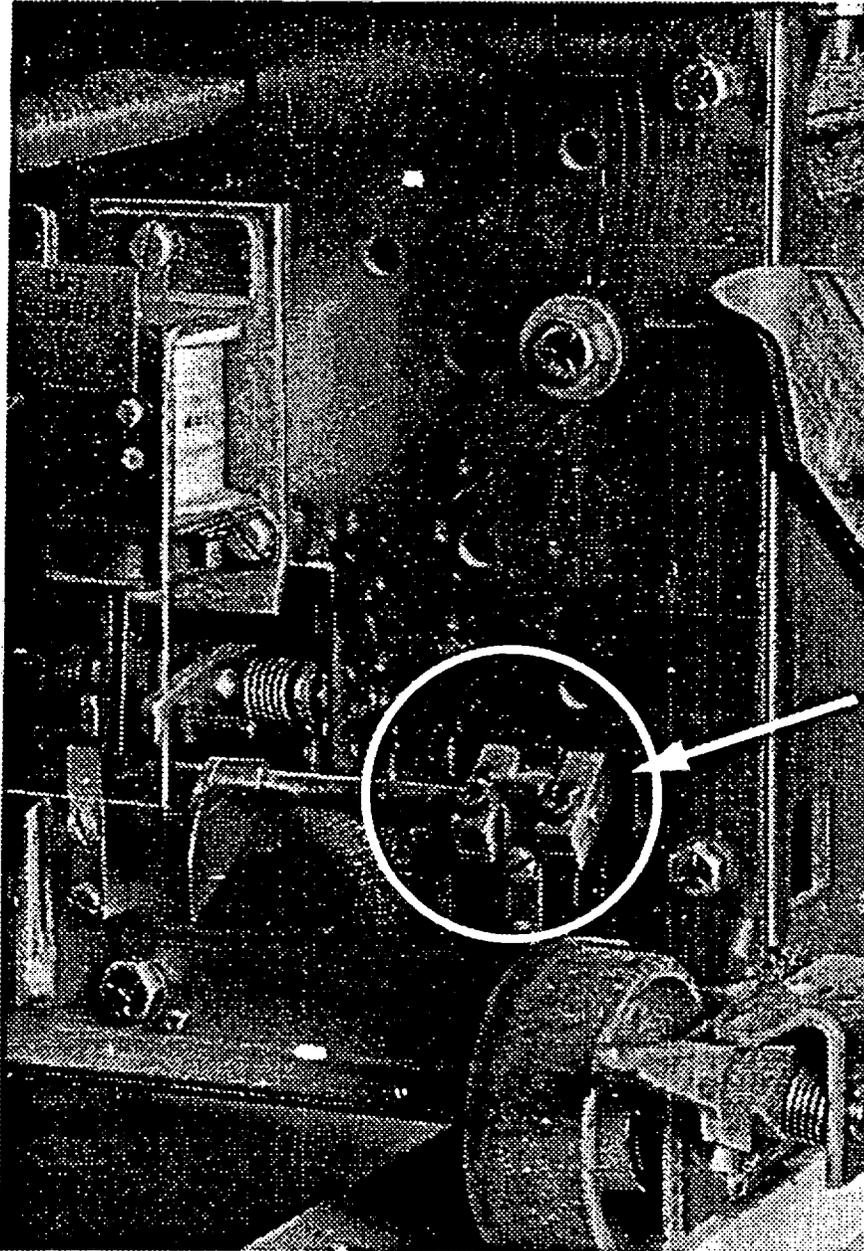
Figure 3. Breaker Front Panel

Note Position
of Tripping
& Closing Linkage

2. **Lever the breaker from the TEST position to the fully OPERATE/ENGAGED position. Note the relative position of the tripping and closing linkage on the front panel. They should be in the same position noted in the TEST position. If not, remove the breaker and perform complete examination of the levering-in device and floor trippers as they may need replaced.**
- B. The levering-in device on the DHP breakers is designed per ANSI/IEEE standard C37.20.2 for inserting and withdrawing the breaker from the TEST to the OPERATE/ENGAGED position 100 times. Because the breakers at nuclear plants have been subjected to numerous levering operations over the constructing and testing phases of the plant, it would be prudent to include the inspection and lubrication of the levering-in device in the preventative maintenance procedures.**

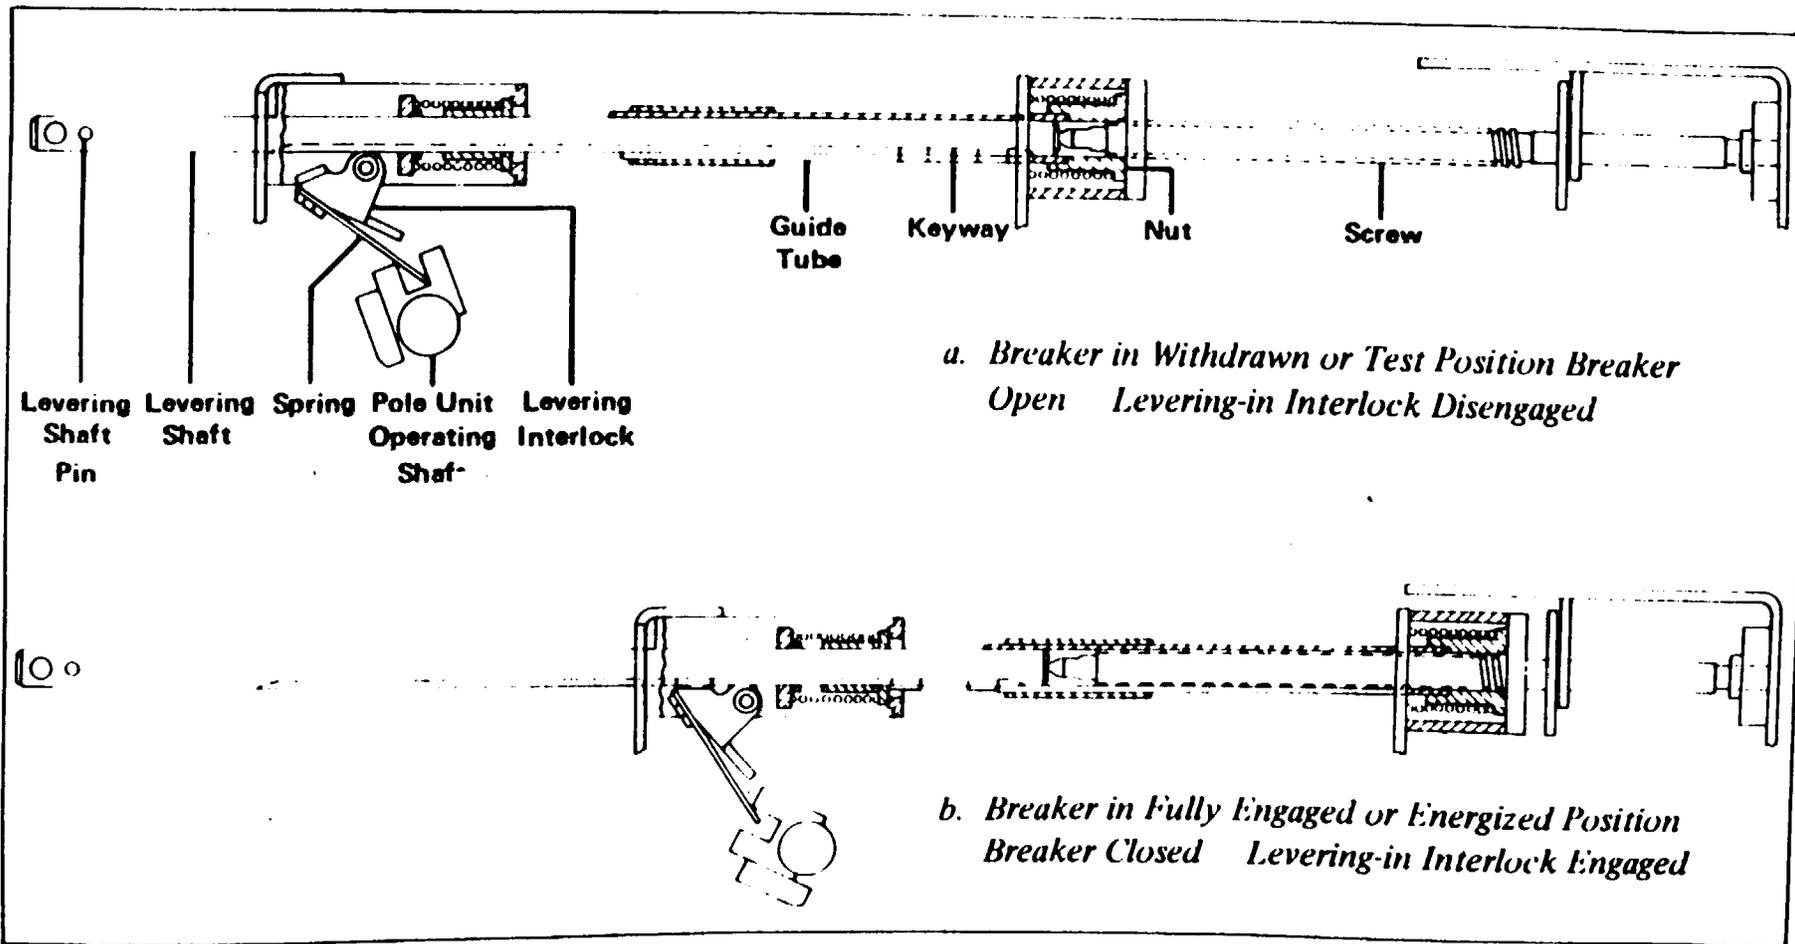
Figure 5 - Schematic of Levering-in Device and Interlock

When installing a Model DHP breaker, a plant equipment operator first pushes it into a cell in the switchgear until the rail latch catches and stops further movement toward the rear of the cell. At this point the breaker is in the TEST position and the levering-in device is not yet engaged. By pressing down on the rail latch, the operator can push the breaker another small increment until the levering nut at the rear of the breaker contacts the levering screw in the cell. The operator then attaches a manual crank to the levering shaft at the front of the breaker and turns the crank. Turning the crank causes the levering nut to traverse the levering screw, drawing the breaker into the cell until the breaker stops moving toward the rear of the cell and the crank and levering shaft spin free, indicating that the breaker is fully engaged. Figure 5 is a schematic diagram of the levering-in device.
