UNITED STATES
NUCLEAR REGULATORY COMMISSION
OFFICE OF NUCLEAR REACTOR REGULATION
WASHINGTON, DC 20555-0001

April 22, 1996

**NRC INFORMATION NOTICE 96-23: FIRES IN EMERGENCY DIESEL GENERATOR EXCITERS
DURING OPERATION FOLLOWING UNDETECTED FUSE
BLOWING**

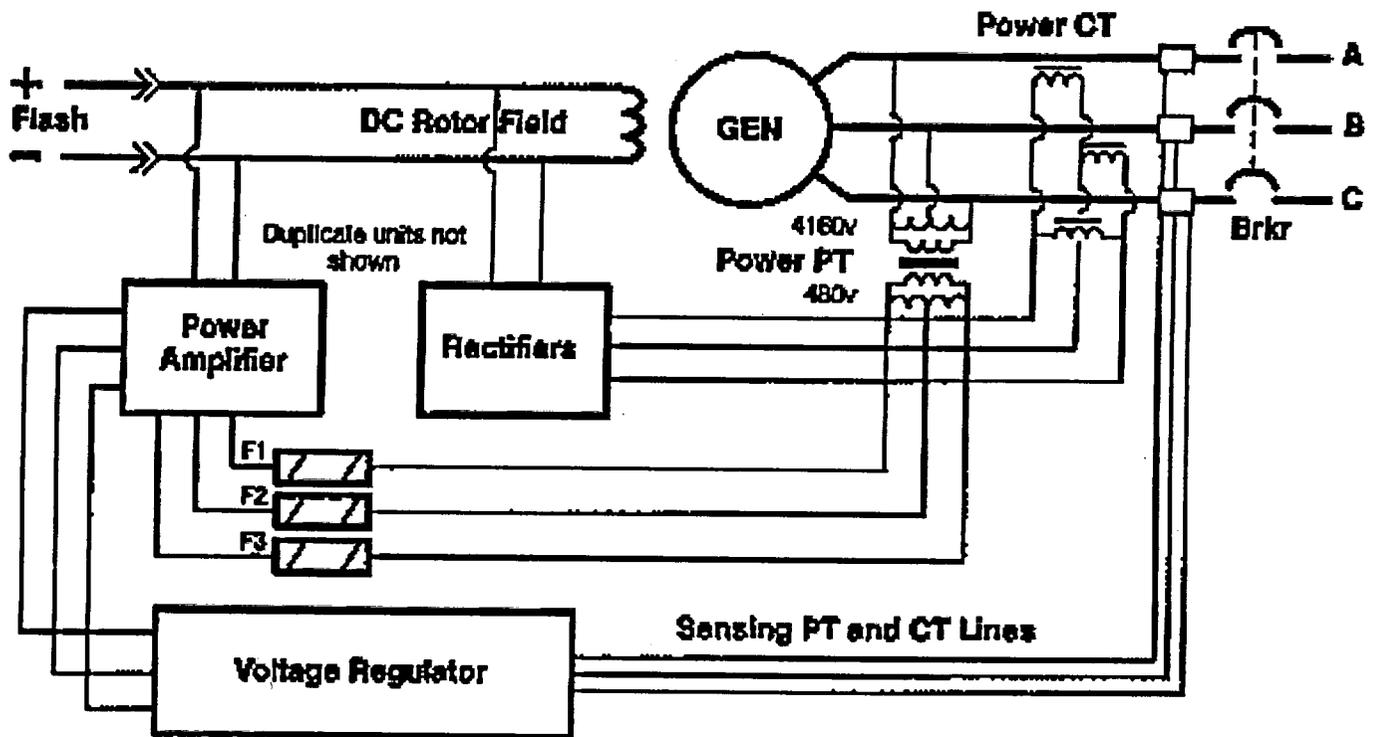
Figure 1: Emergency Diesel Generator Static Exciter-Voltage Regulator Simplified Functional Block Diagram

Engine shutdown without exciter shutdown caused a potential transformer secondary fuse to blow in each case as follows: The exciters at Wolf Creek (and Callaway) are type WNR manufactured by the Applied Products Division of Westinghouse Electric Corporation (Westinghouse). Figure 1 of Attachment 1 to this notice is a simplified functional block diagram of the affected static exciter-voltage regulator design. The potential transformers that caught fire (designated "PT" in Attachment 1) are Model 26616, delta-connected, 3-phase, step down 4160-Vac to 480-Vac, 45-kVA, 60-hz transformers, manufactured by the NWL Transformer Company in Bordentown, New Jersey. The primary windings of the PT are connected to the 4160-Vac, 3-phase generator output busses. The PT secondary windings supply a portion of the generator DC field excitation through power amplifiers. A major portion of the generator field excitation with the generator under load is supplied by current transformers (designated "CT" in Attachment 1) from the generator output through rectifiers. However, with a generator unloaded and its output breaker open, only a minimal amount of excitation is provided by the current transformers; most of it being provided by the potential transformers.

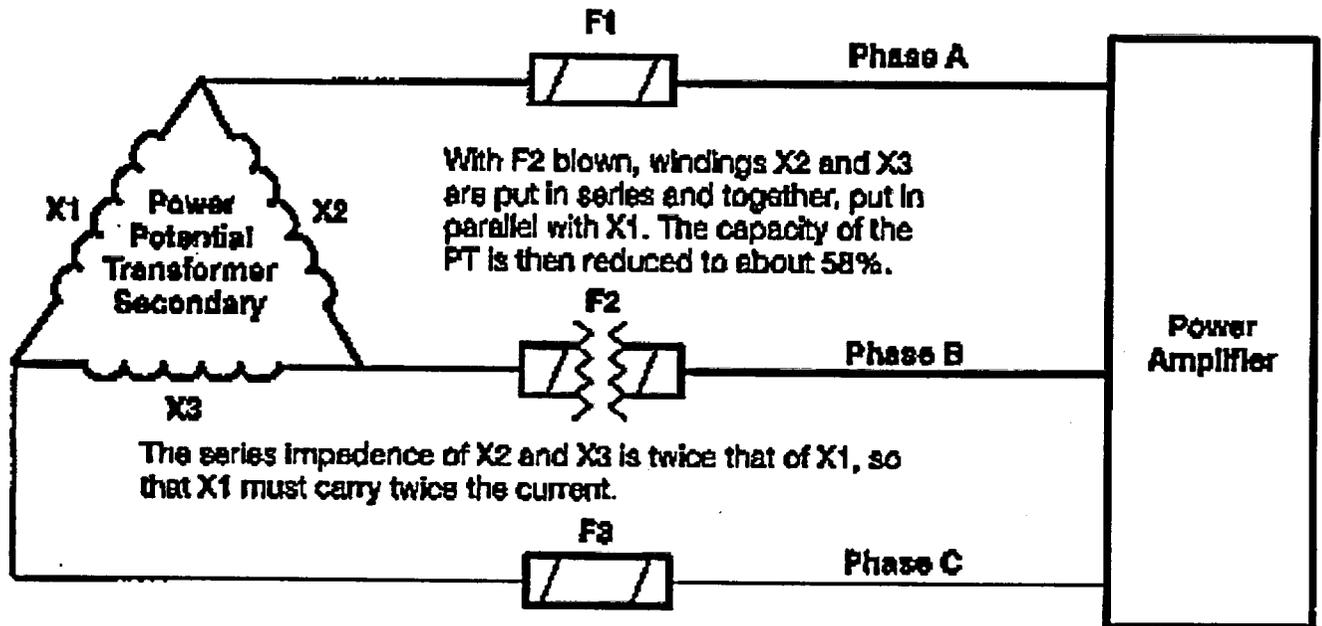
Figure 2: Effect on Potential Transformer Secondary Windings of Single-Phasing Due to Blown Fuse

The blown fuse in the exciter for EDG-A was a power amplifier fuse in the phase C line of the secondary branch circuit supplying one of the power amplifiers. The blown fuse in the exciter for EDG-B was the corresponding fuse in its phase B line. The licensee determined that the fuses had blown in each case as the result of manual engine shutdown without exciter shutdown. This had occurred with the generators unloaded (output breakers open) at the end of the EDG test run preceding the prolonged high-power runs during which the exciter caught fire. The blown fuses were not detected at the time because these fuses had no blown-fuse indication. The fires occurred in both cases after about an hour of sustained operation above full power. Because there was no blown-fuse indication, the normal full and above full-power runs for routine testing were conducted subsequently without knowing that the fuses had blown and "single phased" the potential transformers.

Single-phasing the secondary windings of the delta-connected potential transformers, as a result of the blown fuses, left them at about 58 percent of rated capacity with one phase winding carrying two-thirds of the total load. The other two windings were effectively put in series with each other; together they were now in parallel with the first winding, but with twice the total impedance and hence, only one-third total load. This effect is illustrated in Figure 2 of Attachment 1 to this notice. Subsequent operation with the undetected blown fuse for about 1 hour at or above full load severely overloaded the affected windings. It is expected that prolonged operation at any power level significantly above the reduced capacity of the single-phased potential transformers would eventually cause damage. However, even with the imbalanced load, total excitation current demand from the potential transformer, being within expected limits, was not sufficient to blow either or both of the other two fuses. Operation continued until the overloaded windings overheated and suffered progressive insulation breakdown, internal short circuiting of the windings, and the resultant fire.

The licensee has installed blown fuse indication on the EDG exciter cabinets. Prior to the installation of the blown fuse indication, the licensee established procedures and trained operators to verify the condition of the potential transformer secondary fuses following all EDG shutdowns, particularly those in which there are indications (such as no exciter shutdown light) that the exciter was not turned off automatically. Procedures and training also covered the conditions under which the exciter shutdown pushbutton is to be actuated and under which the alternate power amplifier is to be selected to maintain operability, e.g., in case an EDG demand signal is received during the fuse verification, or in case a fuse should blow during operation with or without an attendant fault or overload condition.

In other designs, such as newer Basler equipment, underfrequency protection is often available that will independently shut down the exciter upon loss of the prime mover. The licensee has installed volts-per-hertz protection to avoid the conditions in question. However, EDG exciter systems of other designs that remain on, either through a system design flaw or malfunction, after engine mechanical shutdown may behave in a similar manner.
