UNITED STATES
NUCLEAR REGULATORY COMMISSION
OFFICE OF NUCLEAR REACTOR REGULATION
WASHINGTON, D.C. 20555-0001

December 11, 1995

**NRC INFORMATION NOTICE 95-56: SHIELDING DEFICIENCY IN SPENT FUEL
TRANSFER CANAL AT A BOILING-WATER REACTOR**

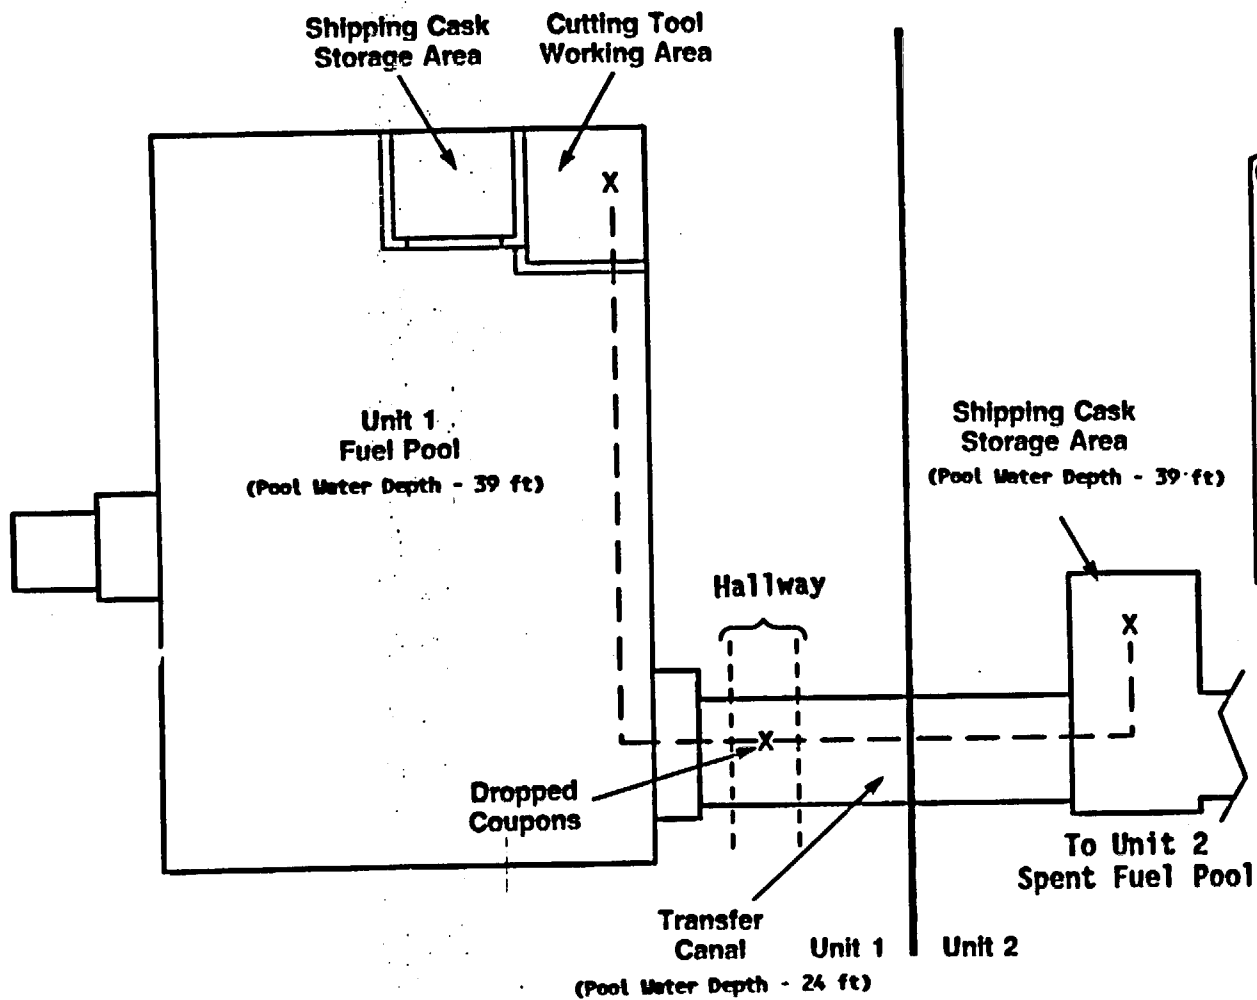
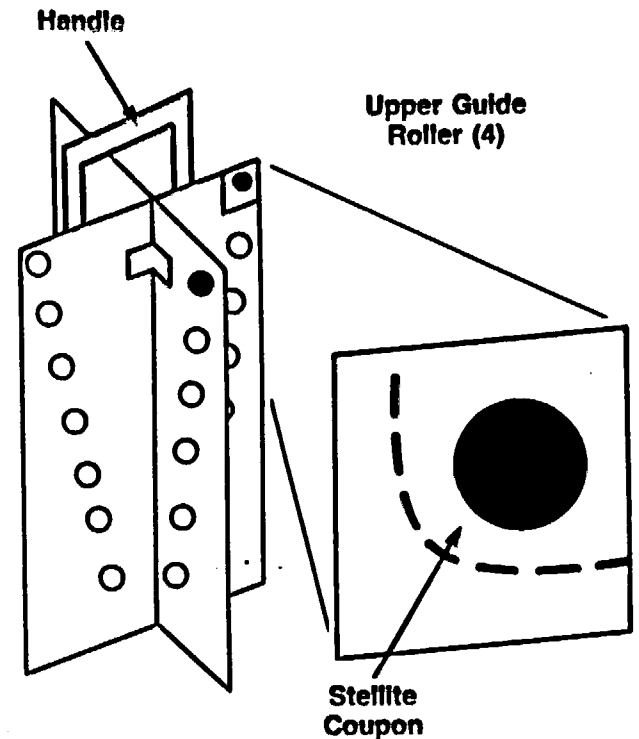
Underwater Operations Event in the Spent Fuel Pool at Hatch

On November 11, 1994, contractors were conducting underwater operations in the Unit 1 spent fuel pool in the cutting tool working area at the Edwin I. Hatch Nuclear Plant (Inspection Report 50-321/95-01 and 50-366/95-01 [Accession Number 9502140081])--cutting coupons out of spent control rod blades containing the upper guide roller bearings (see Attachment 1). The highly activated Stellite bearings (some measured as high as 160 sievert [16,000 rem] per hour at 30 centimeters [12 inches] under water) were being collected adjacent to the Unit 1 work area. Periodically, the coupons containing the upper guide roller bearings were transferred from the collection bucket to a cask liner in the shipping cask storage area in the Unit 2 spent fuel pool. When the workers could not find the tool to open the liner, they decided to transfer the coupons in the collection bucket (about half full, with 160 coupons) into another bucket for temporary storage, so that the cutting process could continue. To facilitate the task, the offload was performed in the transfer canal since the canal was much shallower than the fuel pools. During the transfer, some of the coupons fell to the bottom of the transfer canal. Since the transfer canal was designed and routinely used as a transit area for highly activated material, including spent fuel, the workers were not concerned about dropping the coupons and saw no need to notify the unit shift foreman or the control room of the incident. They recovered the coupons from the bottom of the canal and placed them in the storage bucket resting on the canal floor.

Stellite Coupon Movement

Top of Typical Control Rod

Coupon Is About 1.25" on Edge.
Stellite Ball Is About 3/8" Dia.

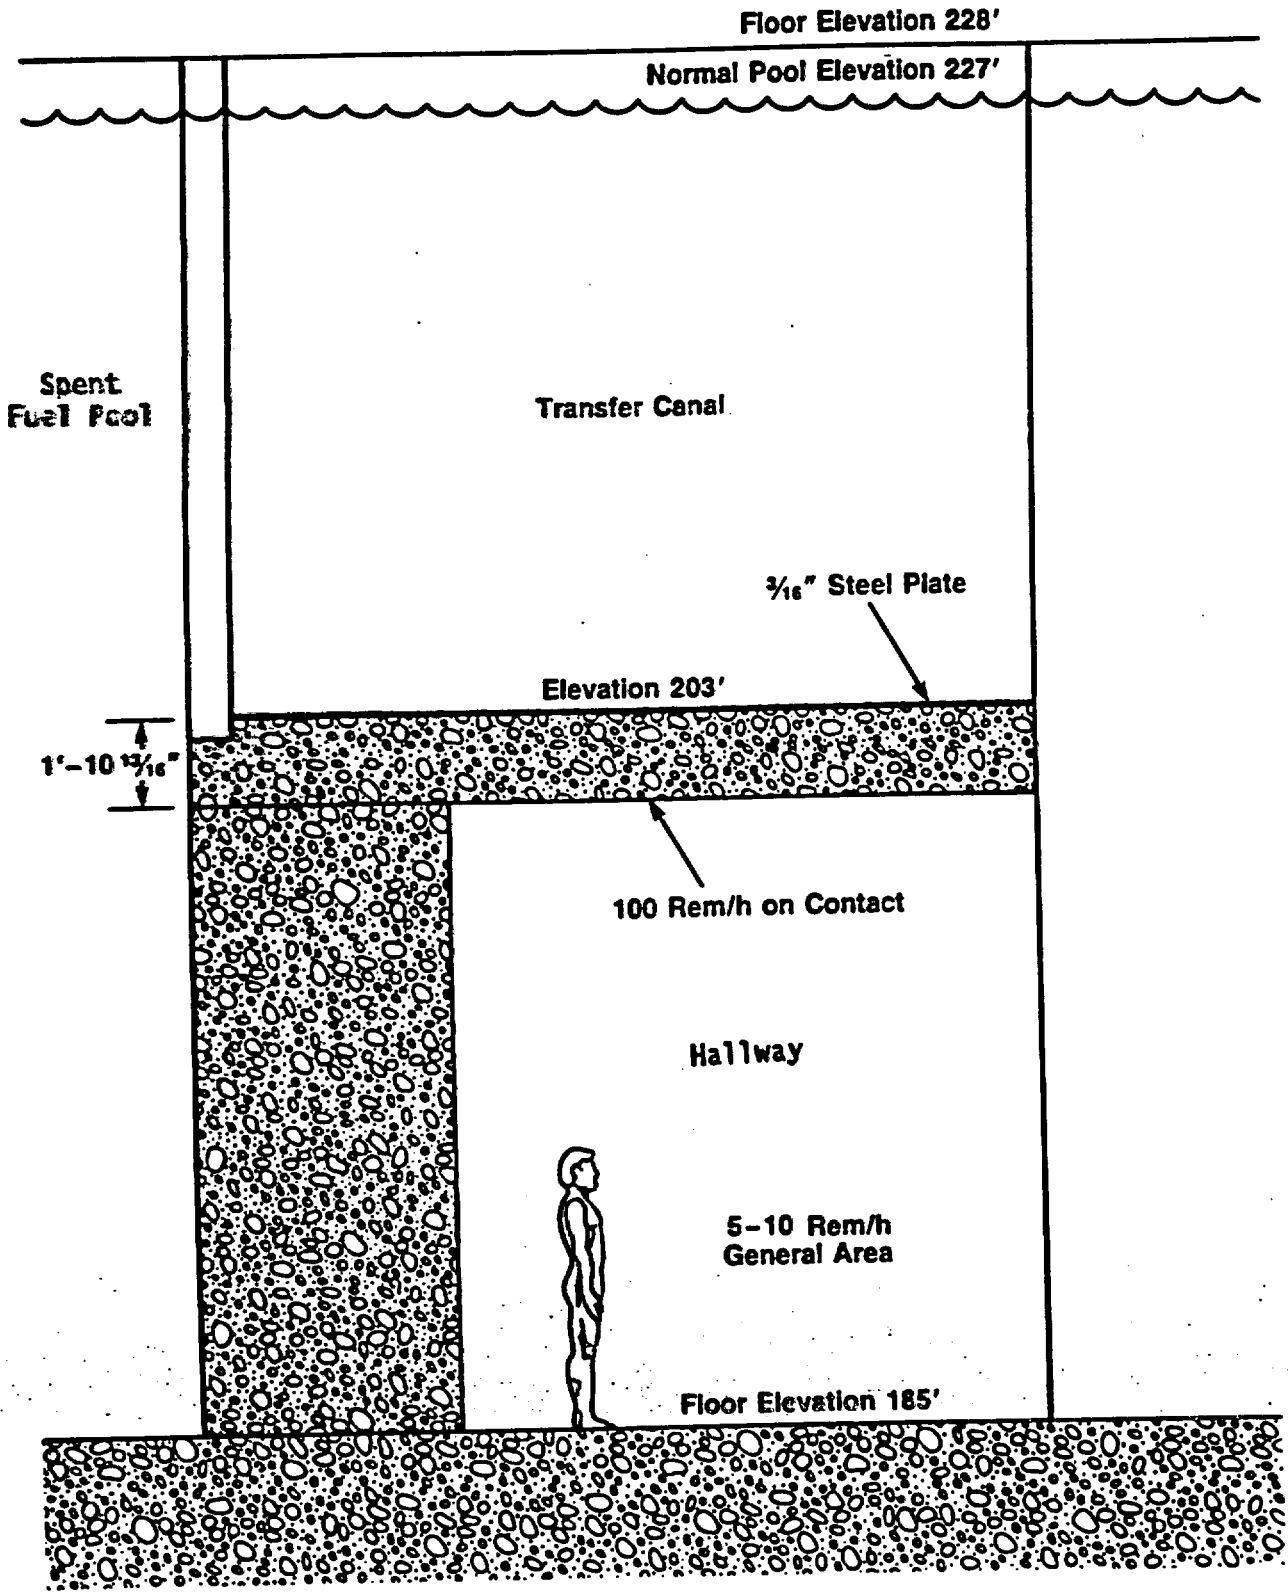
Unexpected High Radiation Area at Hatch

About 30 minutes after the coupons were dropped, a plant equipment operator was walking through the Unit 1 (56.4-meter [185-foot] elevation) hallway directly under the transfer canal (see Attachment 2), when his digital alarm dosimeter alarmed on high dose rate (set at 0.5 msievert [50 mrem] per hour). The plant equipment operator left the area promptly and notified a health physics supervisor, who sent a health physics technician to the area. When the health physics technician also found the elevated radiation levels described above, he secured the area, investigated for the source of the high radiation levels, and informed shift management. The licensee measured radiation levels of up to 1 sievert [100 rem] per hour on contact with the hallway ceiling directly below the bottom of the canal, and 0.05 to 0.1 sievert [5 to 10 rem] per hour in the general area of the hallway. The plant equipment operator received a dose equivalent of about 0.1 msievert [10 mrem] from the event. The licensee has always required that all personnel entering the radiological controlled area be issued dosimeters. Before alarm dosimeters were required, all workers entering the radiologically controlled area were issued personal dosimeters (non-alarm), so any doses to workers from this shielding deficiency would have been detected and accounted for as part of the routine dosimetry program.

A portion of the shielding directly under the transfer canal at Hatch Nuclear Plant is inadequate to prevent unacceptable external dose rates in the hallway below, should a highly activated component be placed near, or in contact with, the canal floor (with attendant loss of water shielding). Therefore, even with a successful bucket-to-bucket transfer (no dropped coupons), with the loaded bucket stored and resting on the canal floor, the hallway radiation levels would have been essentially the same as for the actual event.

In response to the event, Hatch Nuclear Plant management instituted procedural controls to prohibit the use of the transfer canal until doors had been installed, in order to exclude worker access to the affected hallway. Before the transfer gates are allowed to be lifted (allowing use of the transfer canal), the doors at each end of hallway under the canal are locked, and access to the hallway is controlled as a very high radiation area, as defined in 10 CFR 20.1602, "Control of Access to Very High Radiation Areas."
