UNITED STATES
NUCLEAR REGULATORY COMMISSION
OFFICE OF NUCLEAR REACTOR REGULATION
WASHINGTON, D.C. 20555

March 22, 1995

NRC INFORMATION NOTICE 95-19: FAILURE OF REACTOR TRIP BREAKER TO OPEN BECAUSE OF CUTOFF SWITCH MATERIAL LODGED IN THE TRIP LATCH MECHANISM

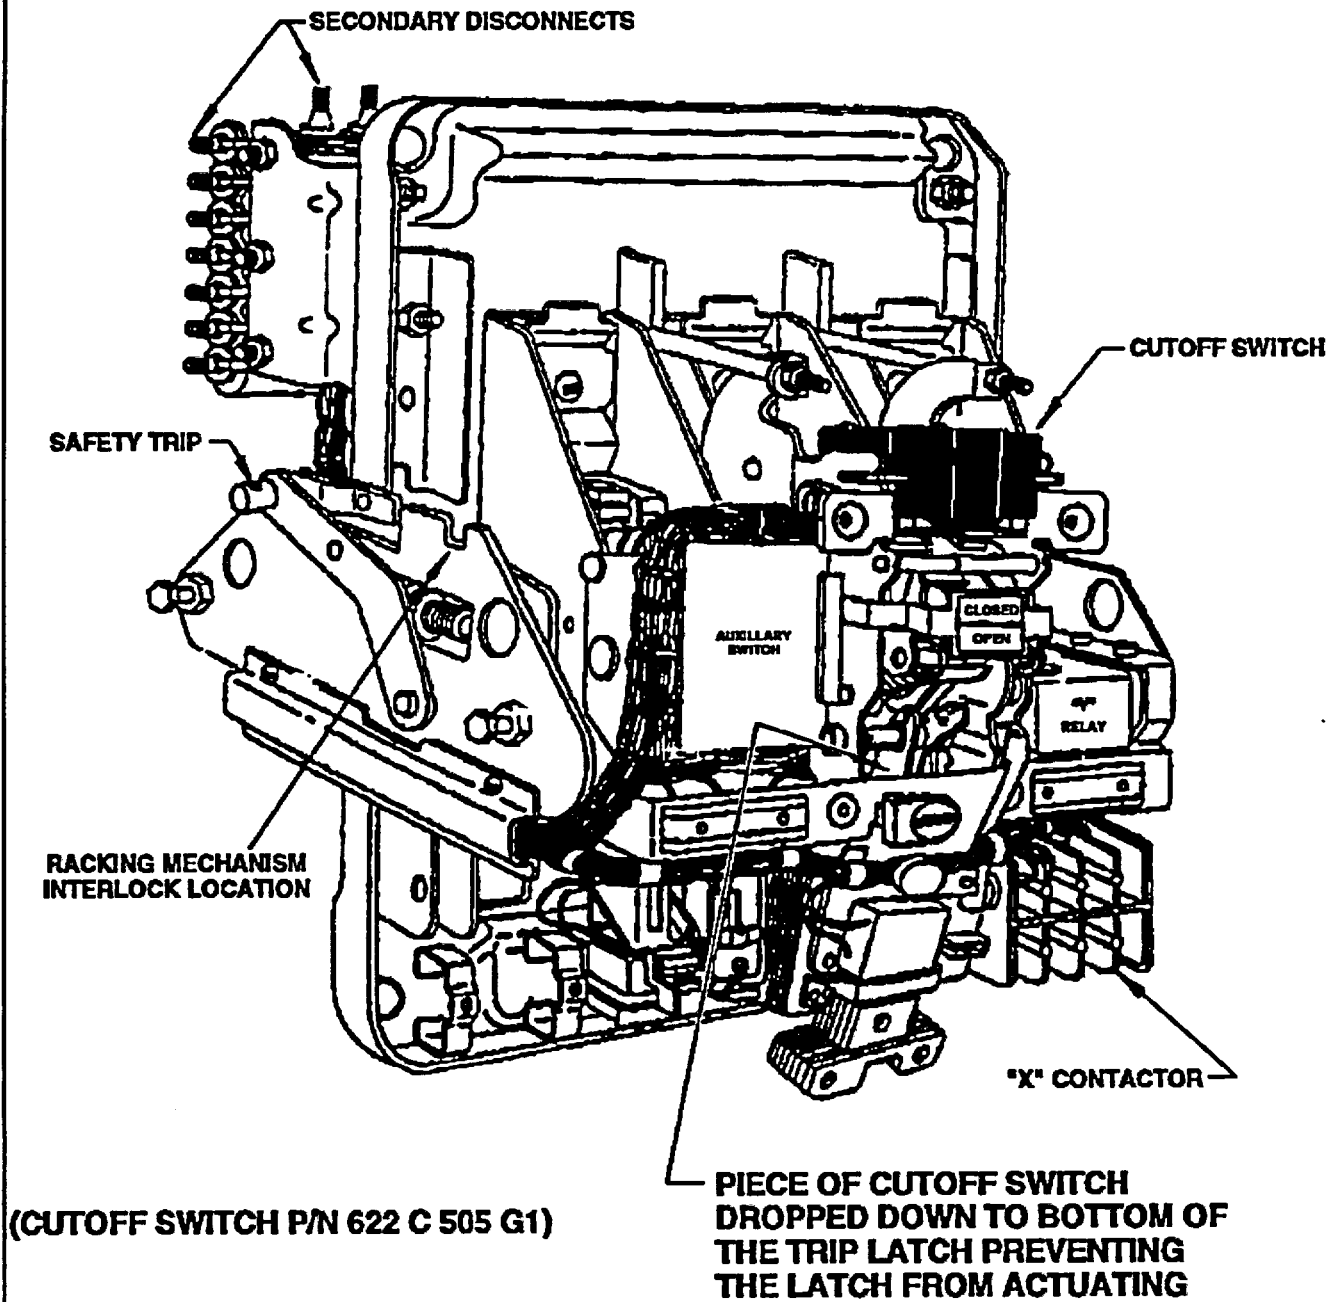
**FIGURE 1
AK-2 BREAKER FRONT VIEW**

The investigation of the problem revealed that a 6-mm-square [1/4-inch-square] piece of phenolic material had jammed the circuit breaker trip latch mechanism, preventing its operation. This piece of phenolic material had broken off from the breaker cutoff switch (p/n 622 C 505 G1), which is part of the breaker antipump circuitry. The cutoff switch is mounted in the breaker assembly above the trip latch mechanism (Figure 1). A screw holding the cutoff switch had come loose, allowing two halves of the switch to separate, become misaligned, and break during the previous circuit breaker operation.

The licensee inspected the remaining Unit 2 trip circuit breakers as well as the similar motor generator set output breakers. No additional loose screws were found on the cutoff switch mountings. The licensee has incorporated the inspection of the cutoff switch phenolic block and screw into the maintenance procedures for Units 1 and 2.
