UNITED STATES
NUCLEAR REGULATORY COMMISSION
OFFICE OF NUCLEAR REACTOR REGULATION
WASHINGTON, D.C. 20555-0001

December 1, 1995

NRC INFORMATION NOTICE 95-53: FAILURES OF MAIN STEAM ISOLATION VALVES AS A RESULT OF STICKING SOLENOID PILOT VALVES

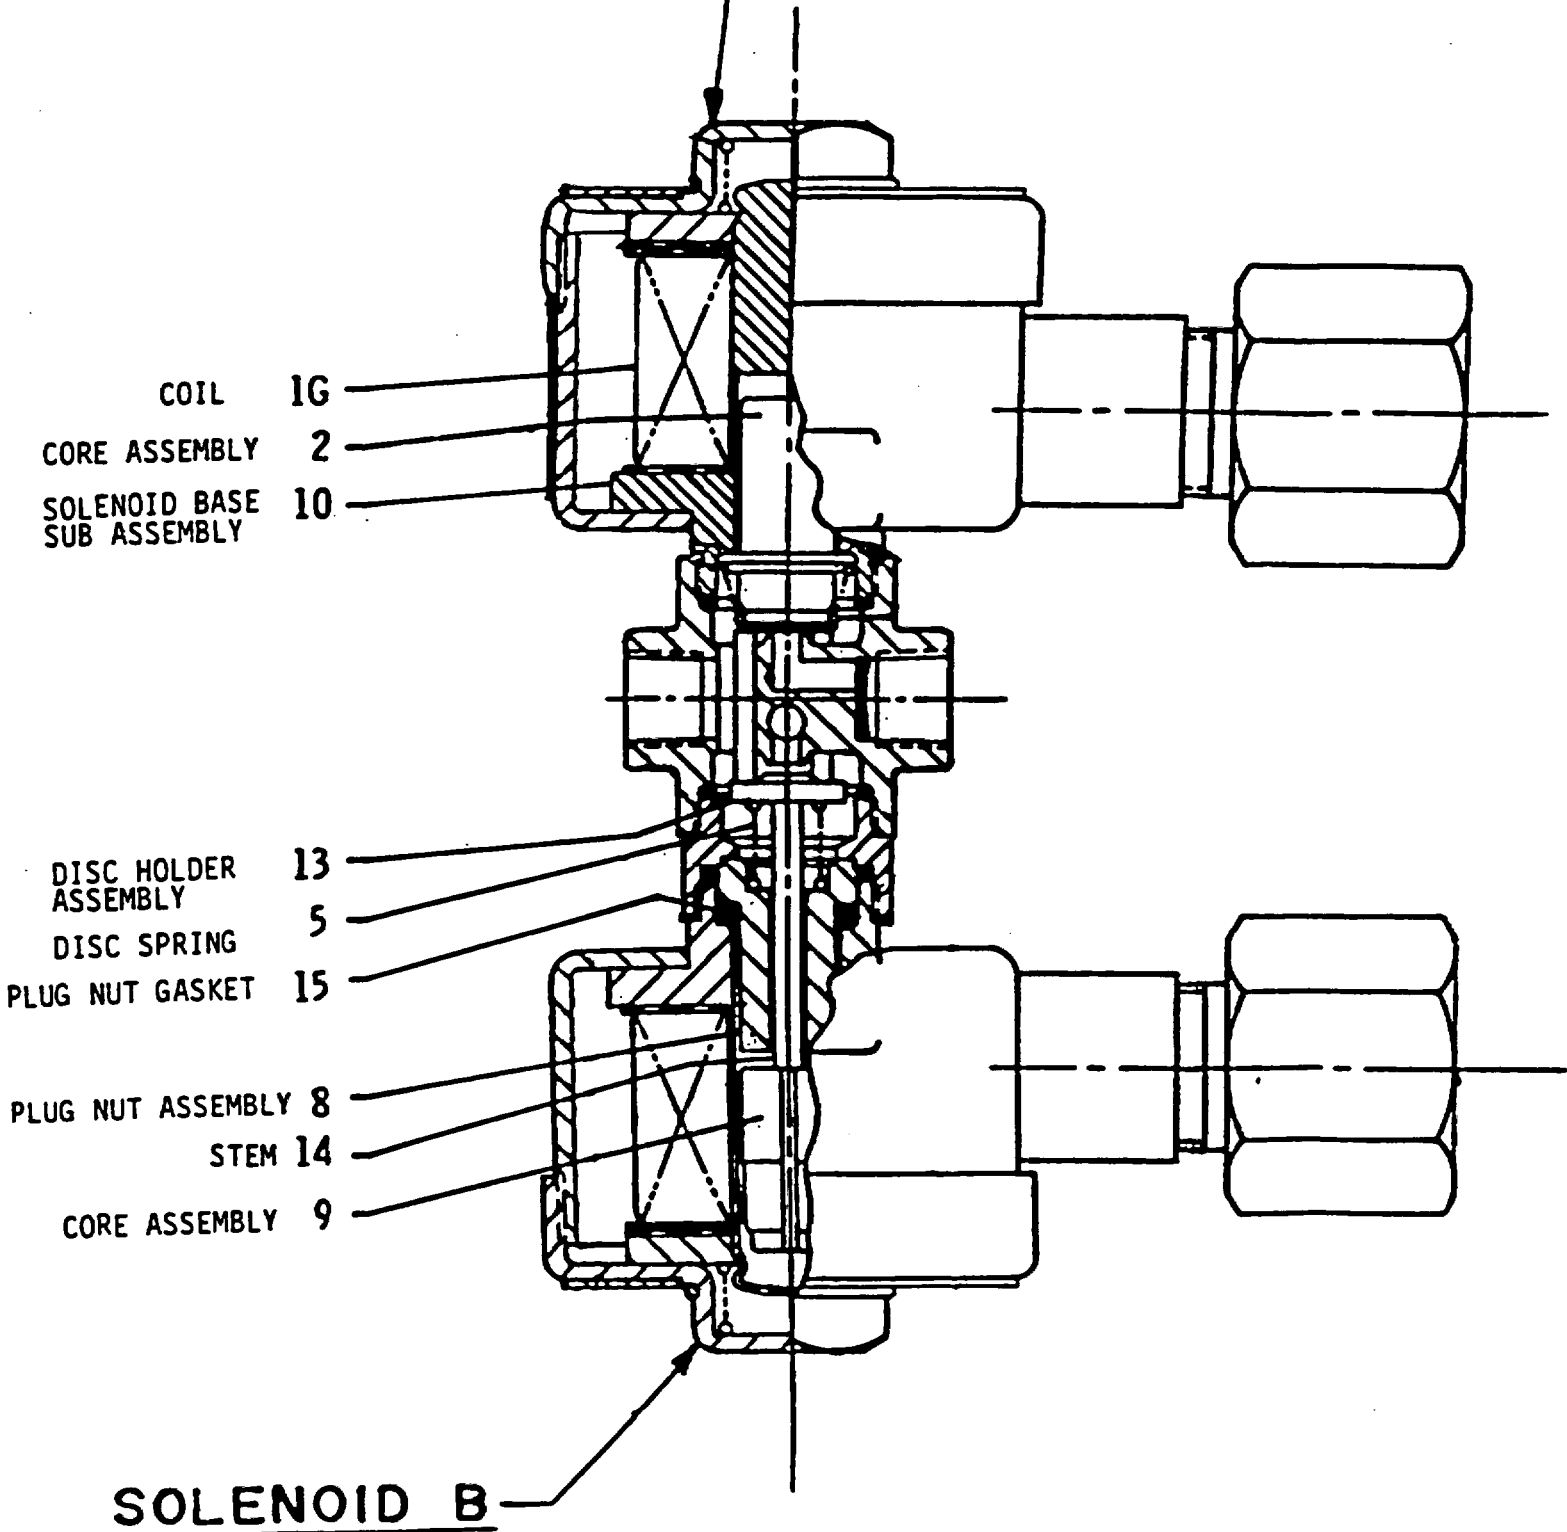
Figure 1 - ASCO NP8323 3-Way Pilot Solenoid Valve

Commonwealth Edison (ComEd), the licensee for LaSalle County Station, initiated an investigation and determined that the ASCO solenoid valves had failed to operate because the core (item 9 in Figure 1) and the plugnut (item 8) had stuck together. The root cause of the sticking of the two pieces appeared to be the presence of a lubricant (Nyogel 775A) and a thread sealant (Loctite PST 550 or Neolube 100), which had formed an adhesive film between

the core and the plugnut (see NRC Inspection Reports 50-373 & 50-374/95003, 4, 5, and 9 covering inspections at LaSalle between February and July 1995, and 99900369/95-01 which provides details of an NRC vendor inspection at ASCO on March 13-14, 1995).

Neither ComEd, ASCO, General Electric (GE), nor the NRC inspectors were able to conclusively determine how the lubricant or thread sealant got on the core and the plugnut. The thread sealant cures only under anaerobic conditions. If the thread sealant was improperly installed on any of the connecting pipe fittings, or not allowed to cure for 24 hours before air was blown through the pneumatic actuator, some of the uncured thread sealant could migrate through the system. Additionally, on the basis of NRC staff observations of the ASCO assembly techniques and discussions with ASCO personnel, it was concluded that the ASCO NP8323 assembly and testing methods could have allowed inadvertently applied lubricant (Nyogel 775A) to be transferred to the core and/or plugnut during fabrication or operational testing activities.

Extensive testing was performed by both ComEd and ASCO in an attempt to determine the root cause of the sticking SOVs. ComEd concluded that the Nyogel 775A lubricant used during assembly at the factory was applied in sufficient quantity to deposit a film on the core and plugnut interface. Although the Nyogel 775A alone would not cause the SOV to stick, the licensee believes that the Nyogel film acted as a collection point for microscopic amounts of uncured thread sealant that migrated through the pneumatic actuators, and over time enough thread sealant accumulated to cause the SOVs to stick. The licensee noted that all three of the installed valves that failed were found to have Nyogel present at the core and plugnut interface.

GE and ASCO determined from their testing that Nyogel 775A lubricant would not develop sufficient adhesive force between the core and the plugnut to cause them to stick. However, their testing showed that uncured thread sealant applied to the core and plugnut interface could cause the core and the plugnut to stick together and prevent operation of the SOV.

Long-term corrective measures taken by LaSalle personnel included better control of the use of thread sealant and the replacement of ASCO NP8323 solenoid valves with valves made by a different manufacturer (Valcor). Four of the eight Unit 2 MSIV solenoid valves were replaced with the new valves. The remaining four MSIV solenoid valves had the same model ASCO valves reinstalled. Before installation, the licensee returned the valves to ASCO for inspection and cleaning. During inspection at the factory before the valves were cleaned, some lubricant was found on the plugnut of one of the returned valves. To ensure only clean valves would be used, new valves were assembled without using internal lubricants and returned to LaSalle.
