UNITED STATES
NUCLEAR REGULATORY COMMISSION
OFFICE OF NUCLEAR REACTOR REGULATION
WASHINGTON, D.C. 20555

March 10, 1995

NRC INFORMATION NOTICE 95-17: REACTOR VESSEL TOP GUIDE AND CORE PLATE CRACKING

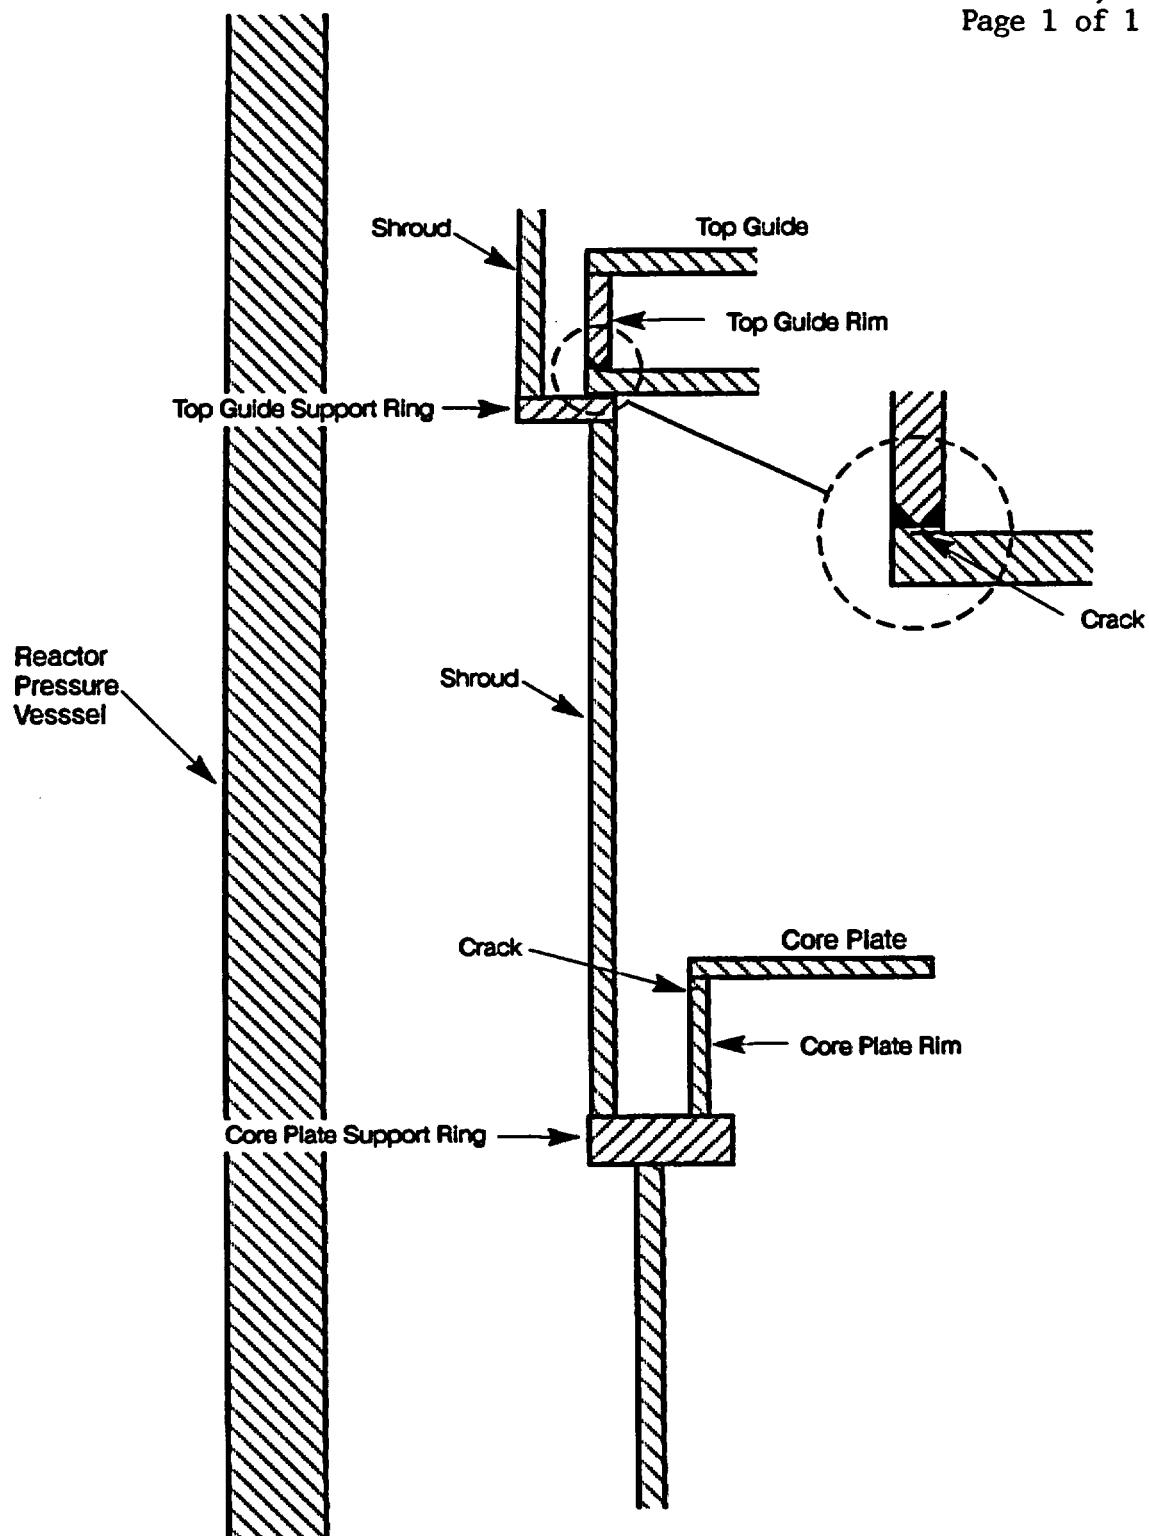
Figure 1. Location of Cracking in Top Guide and Core Plate

During the 1994 inservice inspection of the Wuergassen BWR in Germany, significant cracking was visually observed in the reactor vessel top guide and core plate. The cracks were circumferentially oriented along the weld regions and were located in the rim areas of the top guide and the core plate (see figure in Attachment 1). The top guide and the core plate were made of niobium stabilized austenitic stainless steel (SS) (equivalent to American Iron and Steel Institute Type 347 SS) and were post-weld heat treated during fabrication. The Type 347 SS material had a relatively high carbon content and a minimum niobium-to-carbon ratio. Samples of this material had passed a standard sensitization test. Significant cracking was also found in the core shroud, which was made of the same material. The root cause of the observed cracking is still under evaluation.

Early in 1991, minor cracking not associated with a weld was observed in a cross beam of the top guide in a domestic BWR (Oyster Creek). Subsequent monitoring and assessment of the cracking showed that the structural integrity of the top guide was maintained. The cracking observed in the overseas BWR is considered significant because it was the first time cracking was found in the ring weld regions of the reactor vessel top guide and core plate.
