UNITED STATES
NUCLEAR REGULATORY COMMISSION
OFFICE OF NUCLEAR REACTOR REGULATION
WASHINGTON, D.C. 20555

March 10, 1995

NRC INFORMATION NOTICE 95-17: REACTOR VESSEL TOP GUIDE AND CORE PLATE
CRACKING

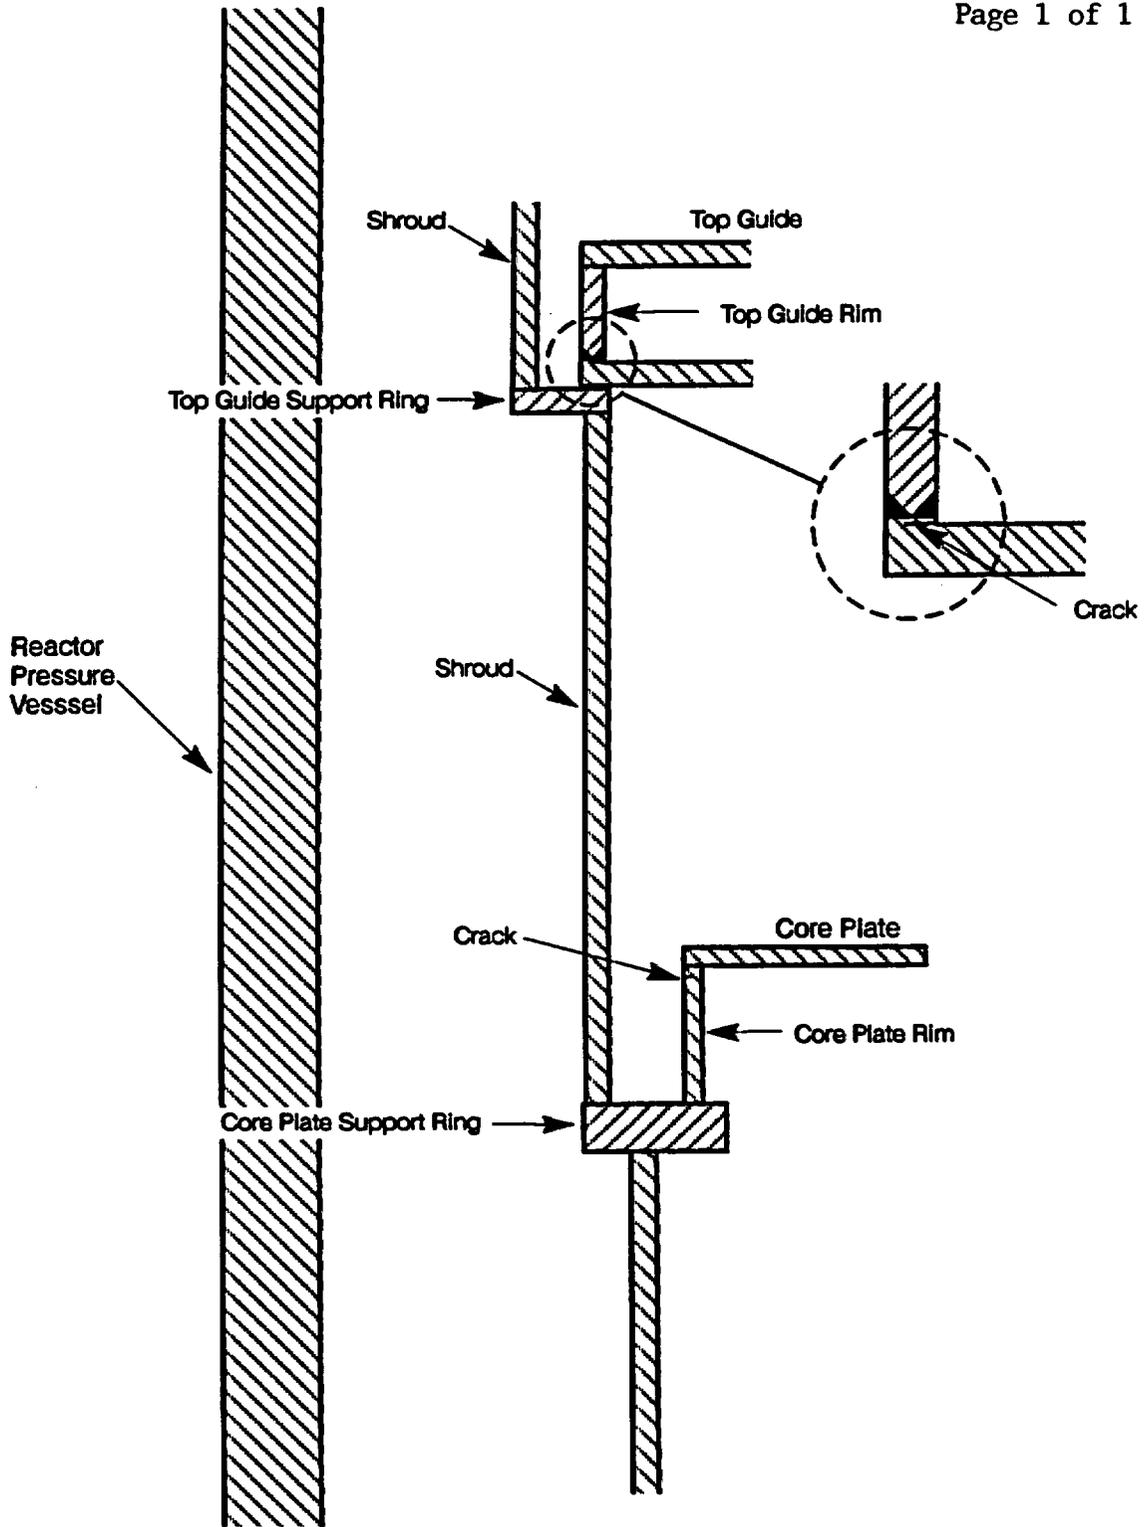
Figure 1. Location of Cracking in Top Guide and Core Plate

During the 1994 inservice inspection of the Wuergassen BWR in Germany, significant cracking was visually observed in the reactor vessel top guide and core plate. The cracks were circumferentially oriented along the weld regions and were located in the rim areas of the top guide and the core plate (see figure in Attachment 1). The top guide and the core plate were made of niobium stabilized austenitic stainless steel (SS) (equivalent to American Iron and Steel Institute Type 347 SS) and were post-weld heat treated during fabrication. The Type 347 SS material had a relatively high carbon content and a minimum niobium-to-carbon ratio. Samples of this material had passed a standard sensitization test. Significant cracking was also found in the core shroud, which was made of the same material. The root cause of the observed cracking is still under evaluation.

Early in 1991, minor cracking not associated with a weld was observed in a cross beam of the top guide in a domestic BWR (Oyster Creek). Subsequent monitoring and assessment of the cracking showed that the structural integrity of the top guide was maintained. The cracking observed in the overseas BWR is considered significant because it was the first time cracking was found in the ring weld regions of the reactor vessel top guide and core plate.
