UNITED STATES
NUCLEAR REGULATORY COMMISSION
OFFICE OF NUCLEAR REACTOR REGULATION
WASHINGTON, D.C. 20555

August 25, 1995

NRC INFORMATION NOTICE 95-34: AIR ACTUATOR AND SUPPLY AIR REGULATOR PROBLEMS
IN COPES-VULCAN PRESSURIZER POWER-OPERATED
RELIEF VALVES

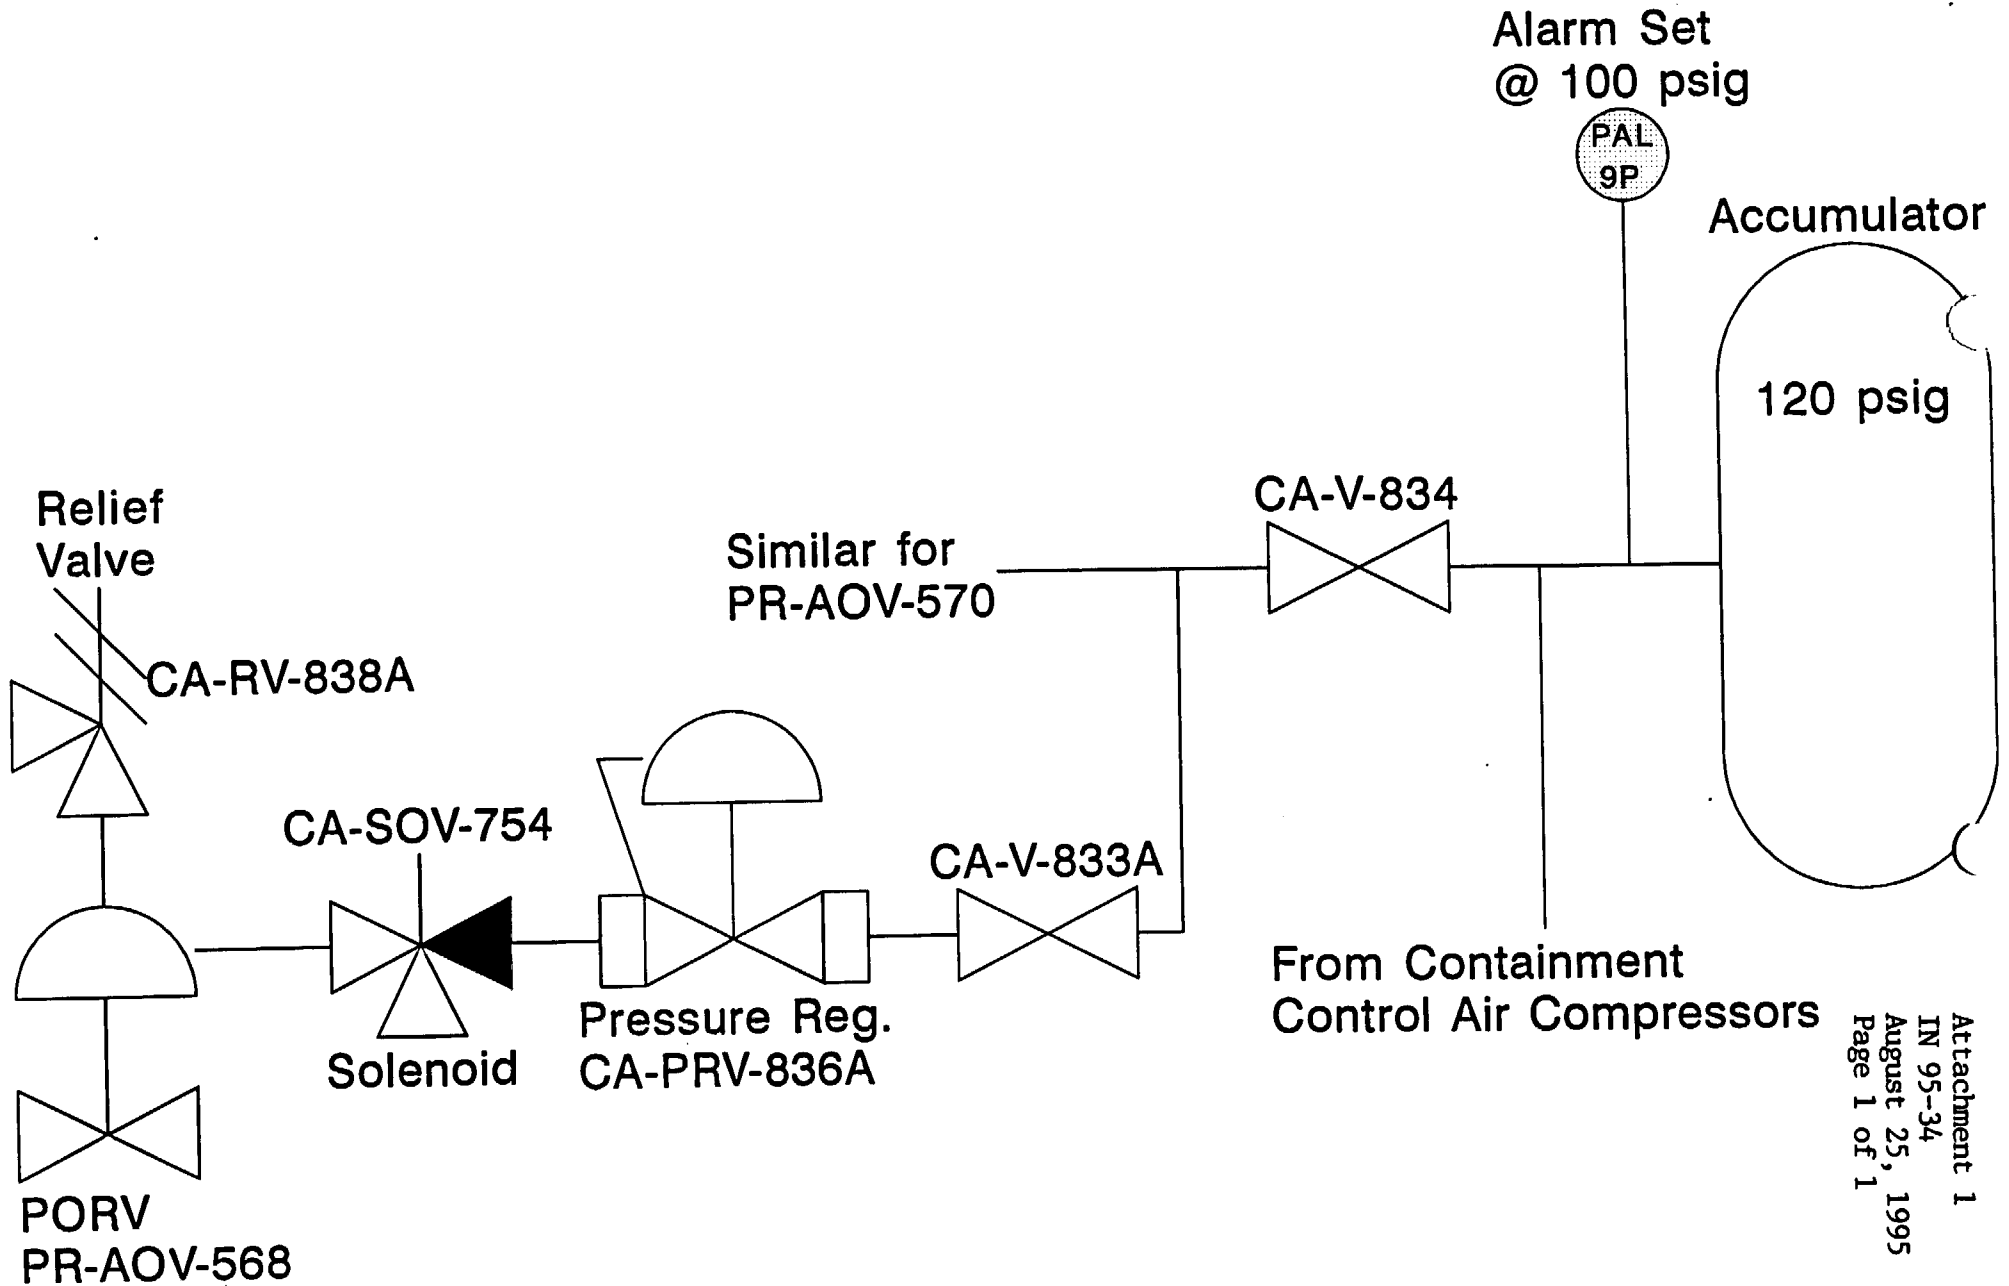
PORV Actuation System

The Haddam Neck PORVs are 2-inch nominal size, air-operated plug valves manufactured by Copes-Vulcan (Model D-100-160). The portion of the control air system that supplies air to the PORVs serves a safety-related function. It is isolated from the remainder of the control air system by two safety-related check valves. It also includes a 405 liter [107-gallon] emergency air accumulator to support PORV operation in the event of a loss of the normal control air supply. Each of the air supply lines leading to the PORVs (see Attachment 1) is equipped with a pressure regulator that reduces the air pressure being supplied from 931 kPa [120 psig] to 690 kPa [85 psig]. An air relief valve on each PORV actuator will protect it from overpressurization if the supply line regulator fails open. These relief valves are set to open at 793 kPa [100 psig], which is the maximum design pressure of the PORV diaphragms.

Several causes of the air pressure regulator setpoint drift have been postulated: one is that moisture intrusion from the control air system can cause corrosion of the regulating mechanism, and the other is that the drift may be configuration related. At Haddam Neck, the air regulating valve is upstream of the (normally closed) solenoid operated valve, meaning that the air regulating valve is constantly subjected to system pressure. The air regulating valve vendor has indicated that this configuration may cause setpoint drift.
