UNITED STATES
NUCLEAR REGULATORY COMMISSION
OFFICE OF NUCLEAR REACTOR REGULATION
WASHINGTON, D.C. 20555-0001

May 26, 1994

NRC INFORMATION NOTICE 94-40: FAILURE OF A ROD CONTROL CLUSTER ASSEMBLY TO FULLY INSERT FOLLOWING A REACTOR TRIP AT BRAIDWOOD UNIT 2

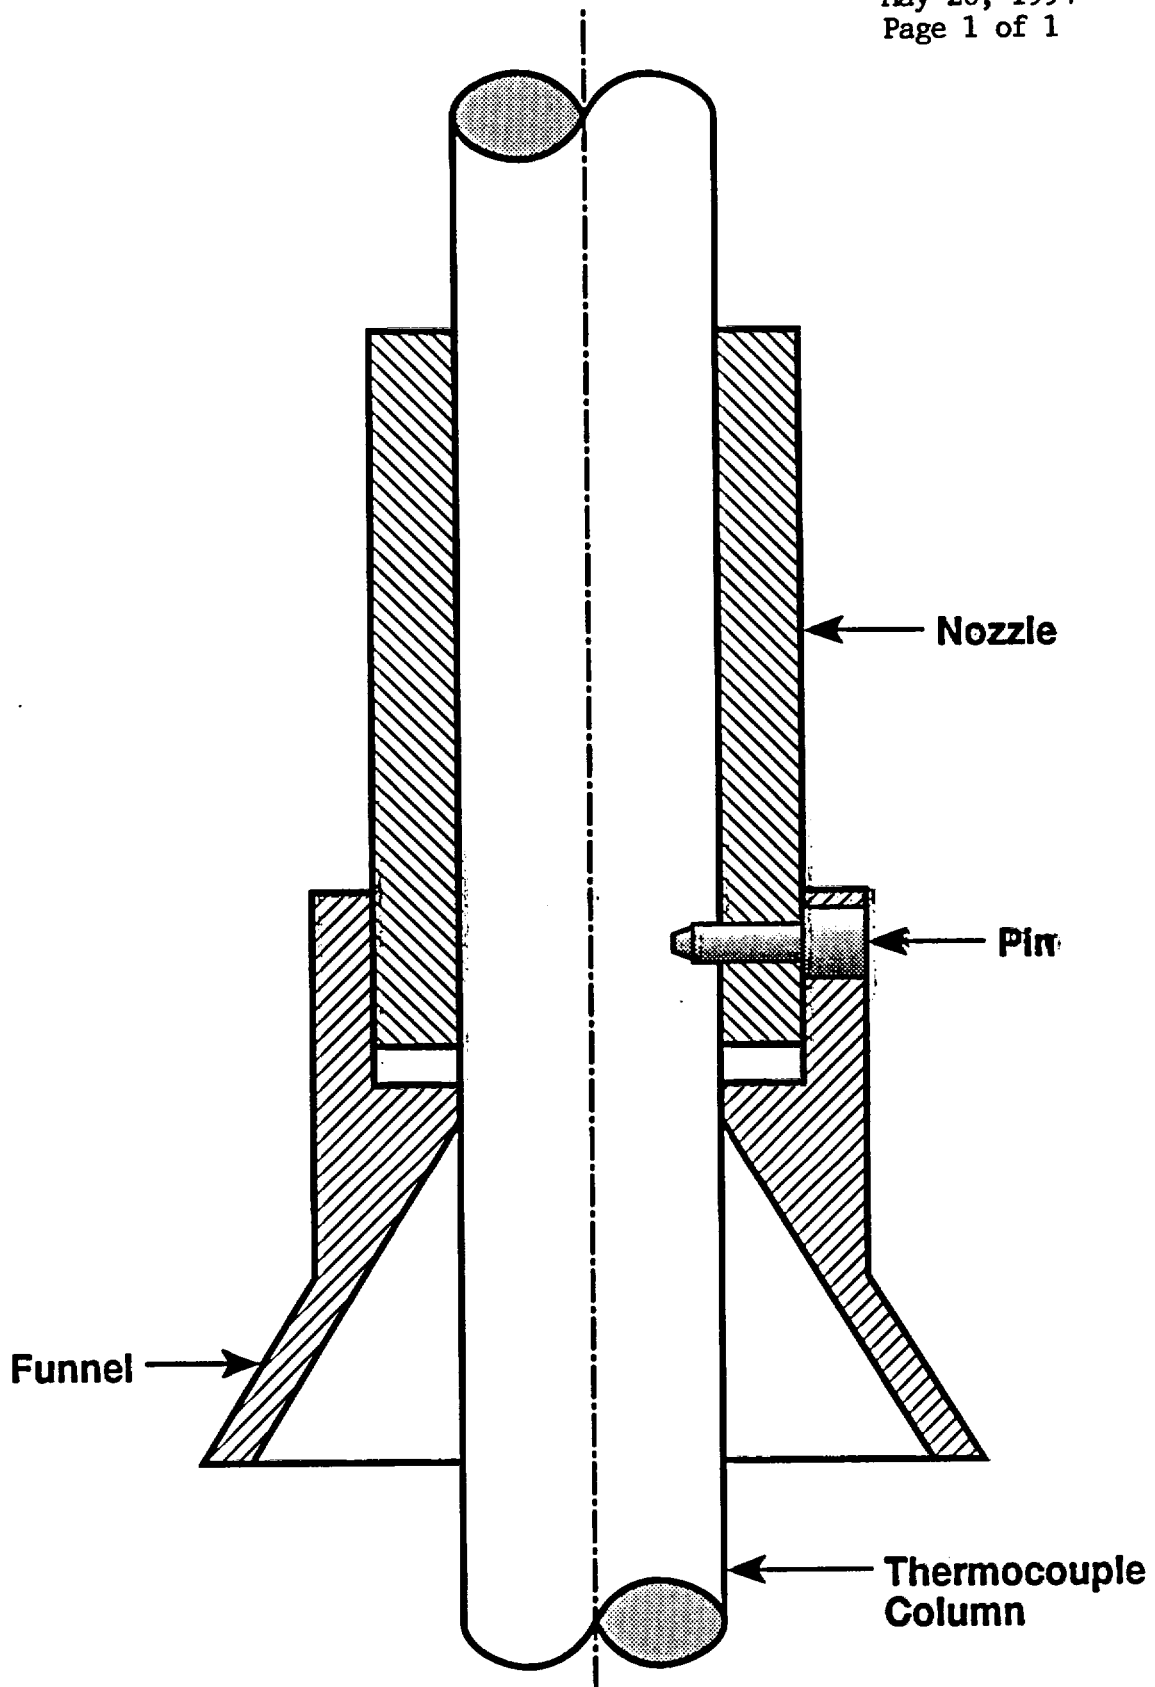
Figure 1 – In-Core Thermocouple Column

The vessel head has five in-core column nozzles and each nozzle has a funnel to aid in-core column and vessel head alignment during assembly. Each in-core thermocouple column reactor vessel head nozzle funnel is threaded onto the nozzle and pinned to prevent the funnel from rotating (see Figure 1). The design calls for the two pins per funnel, installed during original construction, to be secured by a cap weld. However, the cap weld for the pin that fell into the core upper internals appeared to be missing or may have failed. The funnel pin caps were welded on site by Nuclear Installation Services Corporation (NISCO). Additional inspections found that the pin adjacent to the missing pin was loose and that a pin from another funnel was missing. The second missing pin was recovered from the top surface of the reactor upper internal components.

The failure or lack of the weld was an intermediate cause of the stuck rod control cluster assembly. Because the pin was apparently not welded, it worked loose from the nozzle/funnel assembly, dropped into the guide tube access hole for control rod K-2, and came to rest in a position where it prevented the rod control cluster assembly from inserting past step 210. The most probable root cause of the failure of control rod K-2 to fully insert is improper installation or other personnel error; the pin cap appeared not to be welded, as required by design drawings, and the condition remained undetected during subsequent inspections.

The licensee performed initial acid etching that suggested that the loose funnel pins had never been welded. The licensee is having additional tests performed on the affected pins to more narrowly define the root cause, such as lack of sufficient weld material, failure of the weld, or missing weld.

The licensee reworked all Unit 2 in-core thermocouple column nozzle funnels by adding welds in three places around the top of the funnel to nozzle interface circumference. In addition, all of the original cap welds were reinforced to preclude their failure, should the root cause subsequently be determined to be weld failure.
