UNITED STATES
NUCLEAR REGULATORY COMMISSION
OFFICE OF NUCLEAR REACTOR REGULATION
WASHINGTON, D.C. 20555

September 26, 1994

NRC INFORMATION NOTICE 94-67: PROBLEM WITH HENRY PRATT MOTOR-OPERATED BUTTERFLY VALVES

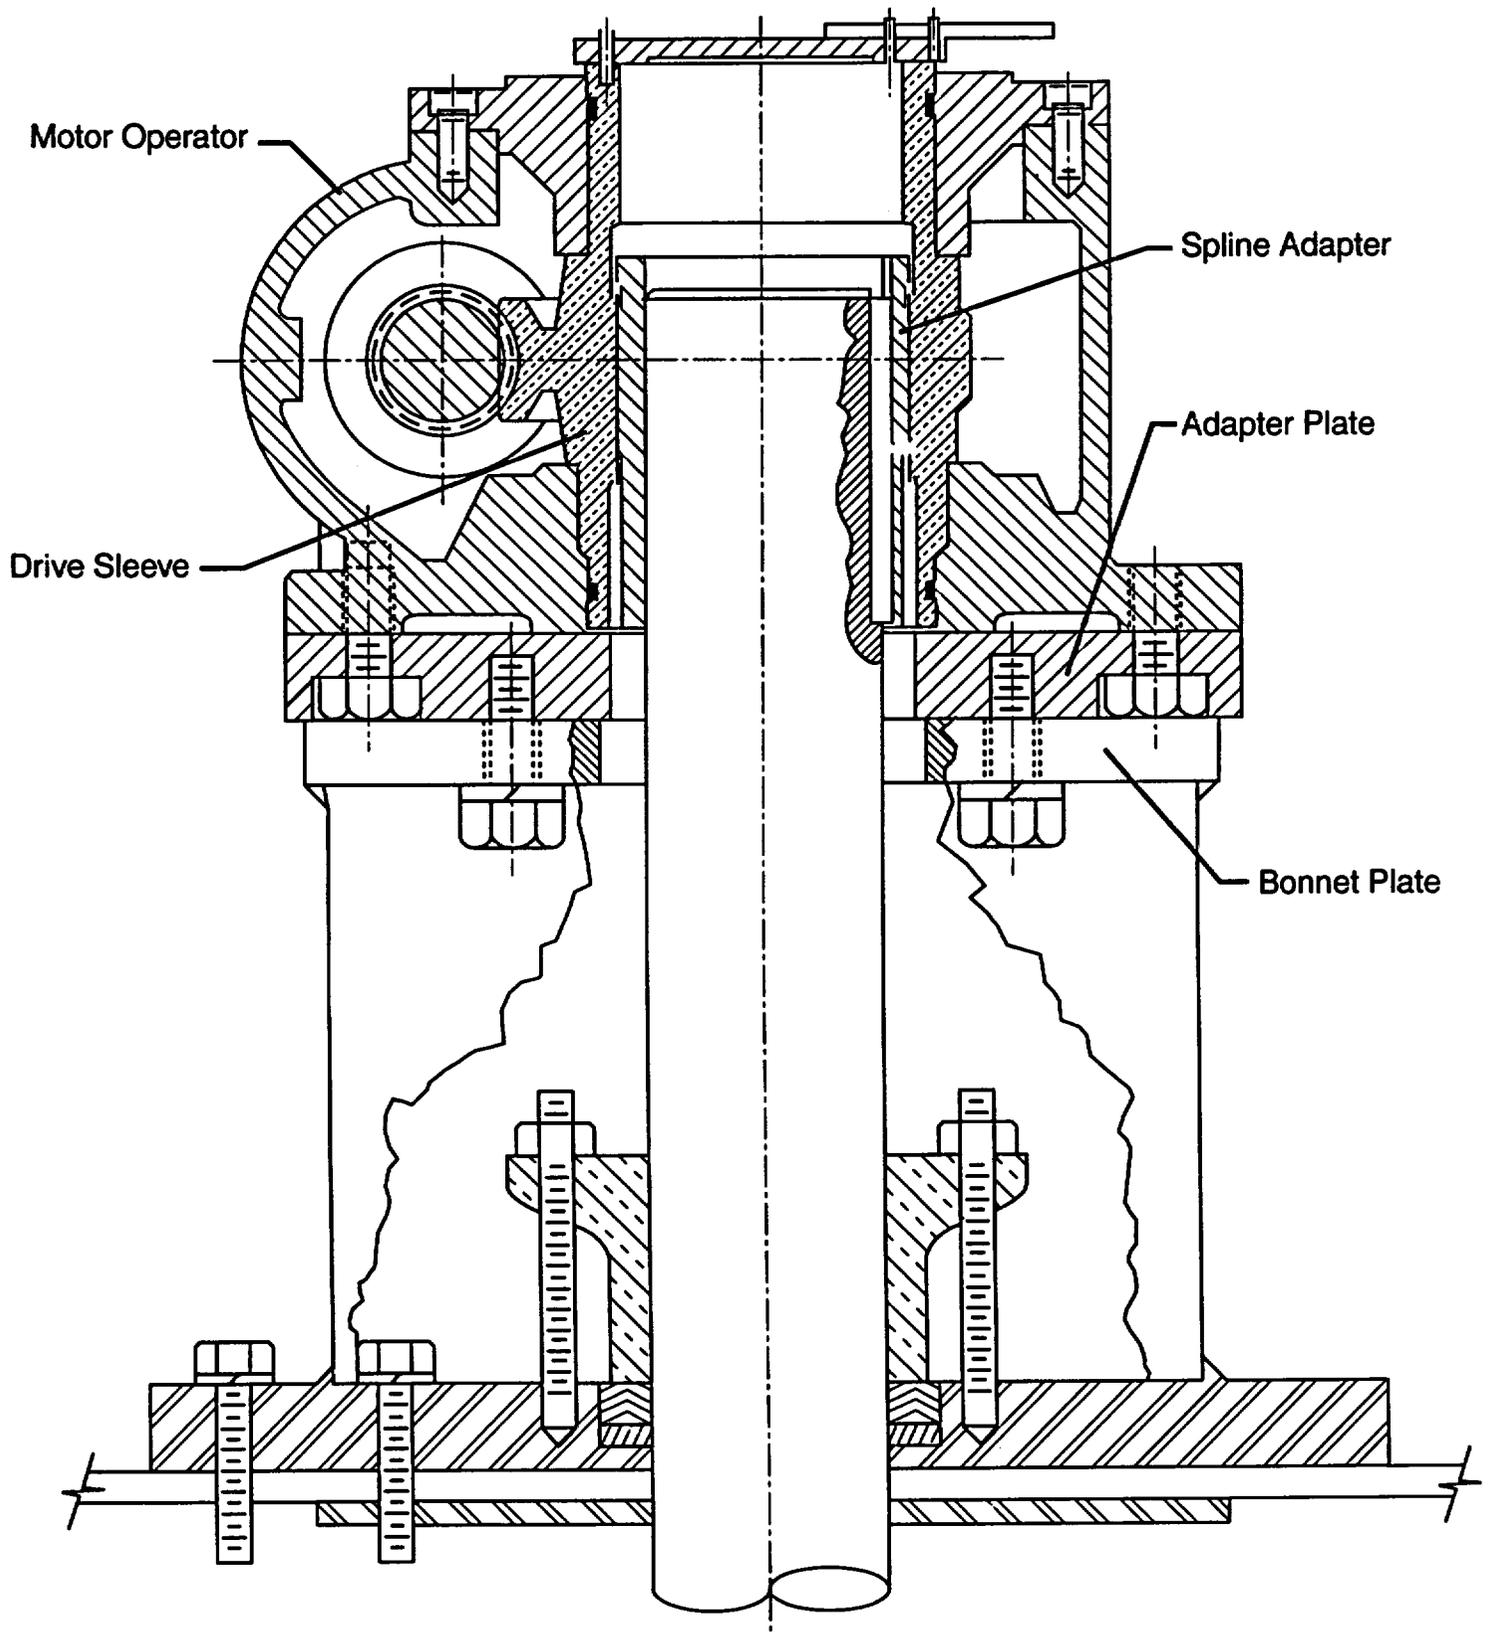
Figure 1

On October 17, 1993, the Duquesne Light Company conducted a full flow surveillance test on a recirculation spray pump at Beaver Valley Power Station, Unit 2. The pump did not establish adequate flow or discharge pressure during the test. The licensee found that the pump suction valve was shut, though the annunciator in the control room indicated it fully open. As the result of the investigation, the licensee found that the valve operator had decoupled from the valve stem, allowing the operator to move independently of the valve. Two of the three other recirculation pump suction valves were starting to decouple because the valve spline adapters separated from the operator drive sleeves.

The recirculation spray pump suction valves at Beaver Valley Unit 2 are 12 inch nominal size Henry Pratt 1400 series butterfly valves with Limitorque HBC-1 operators. The drive sleeve on a Limitorque HBC valve operator rotates a spline adapter. The spline adapter is keyed to the valve stem, but the key does not prevent the adapter from moving down the valve stem toward the valve.

If the spline adapter slips down the valve stem, it will disconnect from the drive sleeve. On a Henry Pratt valve, the spline adapter is held in position by an adapter plate, which is designed to permit passage of the valve stem, but not the spline adapter. Additionally, the valve bonnet plate, which is located below the adapter plate, is designed the same way. The adapter plates and bonnet plates were designed and manufactured by Henry Pratt.

Duquesne Light Company found that the center holes in the valve bonnet plates and adapter plates were about 1.3 cm [0.5 inches] larger (in diameter) than the corresponding design dimensions. This was sufficient to allow the spline adapters to slip down the valve stem during operation of the valve. This is shown in Figure 1.

Henry Pratt Butterfly Valve
with Limitorque Motor Operator

The licensee checked all 54 Henry Pratt butterfly valves at the Beaver Valley Nuclear Power Station for proper adapter plate and bonnet plate dimensions. No problems were noted beyond the recirculation pump suction valves. The licensee placed temporary spline adapter retaining clamps on the recirculation spray pump suction valves pending permanent modification.
