UNITED STATES  
NUCLEAR REGULATORY COMMISSION  
OFFICE OF NUCLEAR REACTOR REGULATION  
WASHINGTON, D.C. 20555

September 26, 1994

**NRC INFORMATION NOTICE 94-67: PROBLEM WITH HENRY PRATT MOTOR-OPERATED BUTTERFLY VALVES**

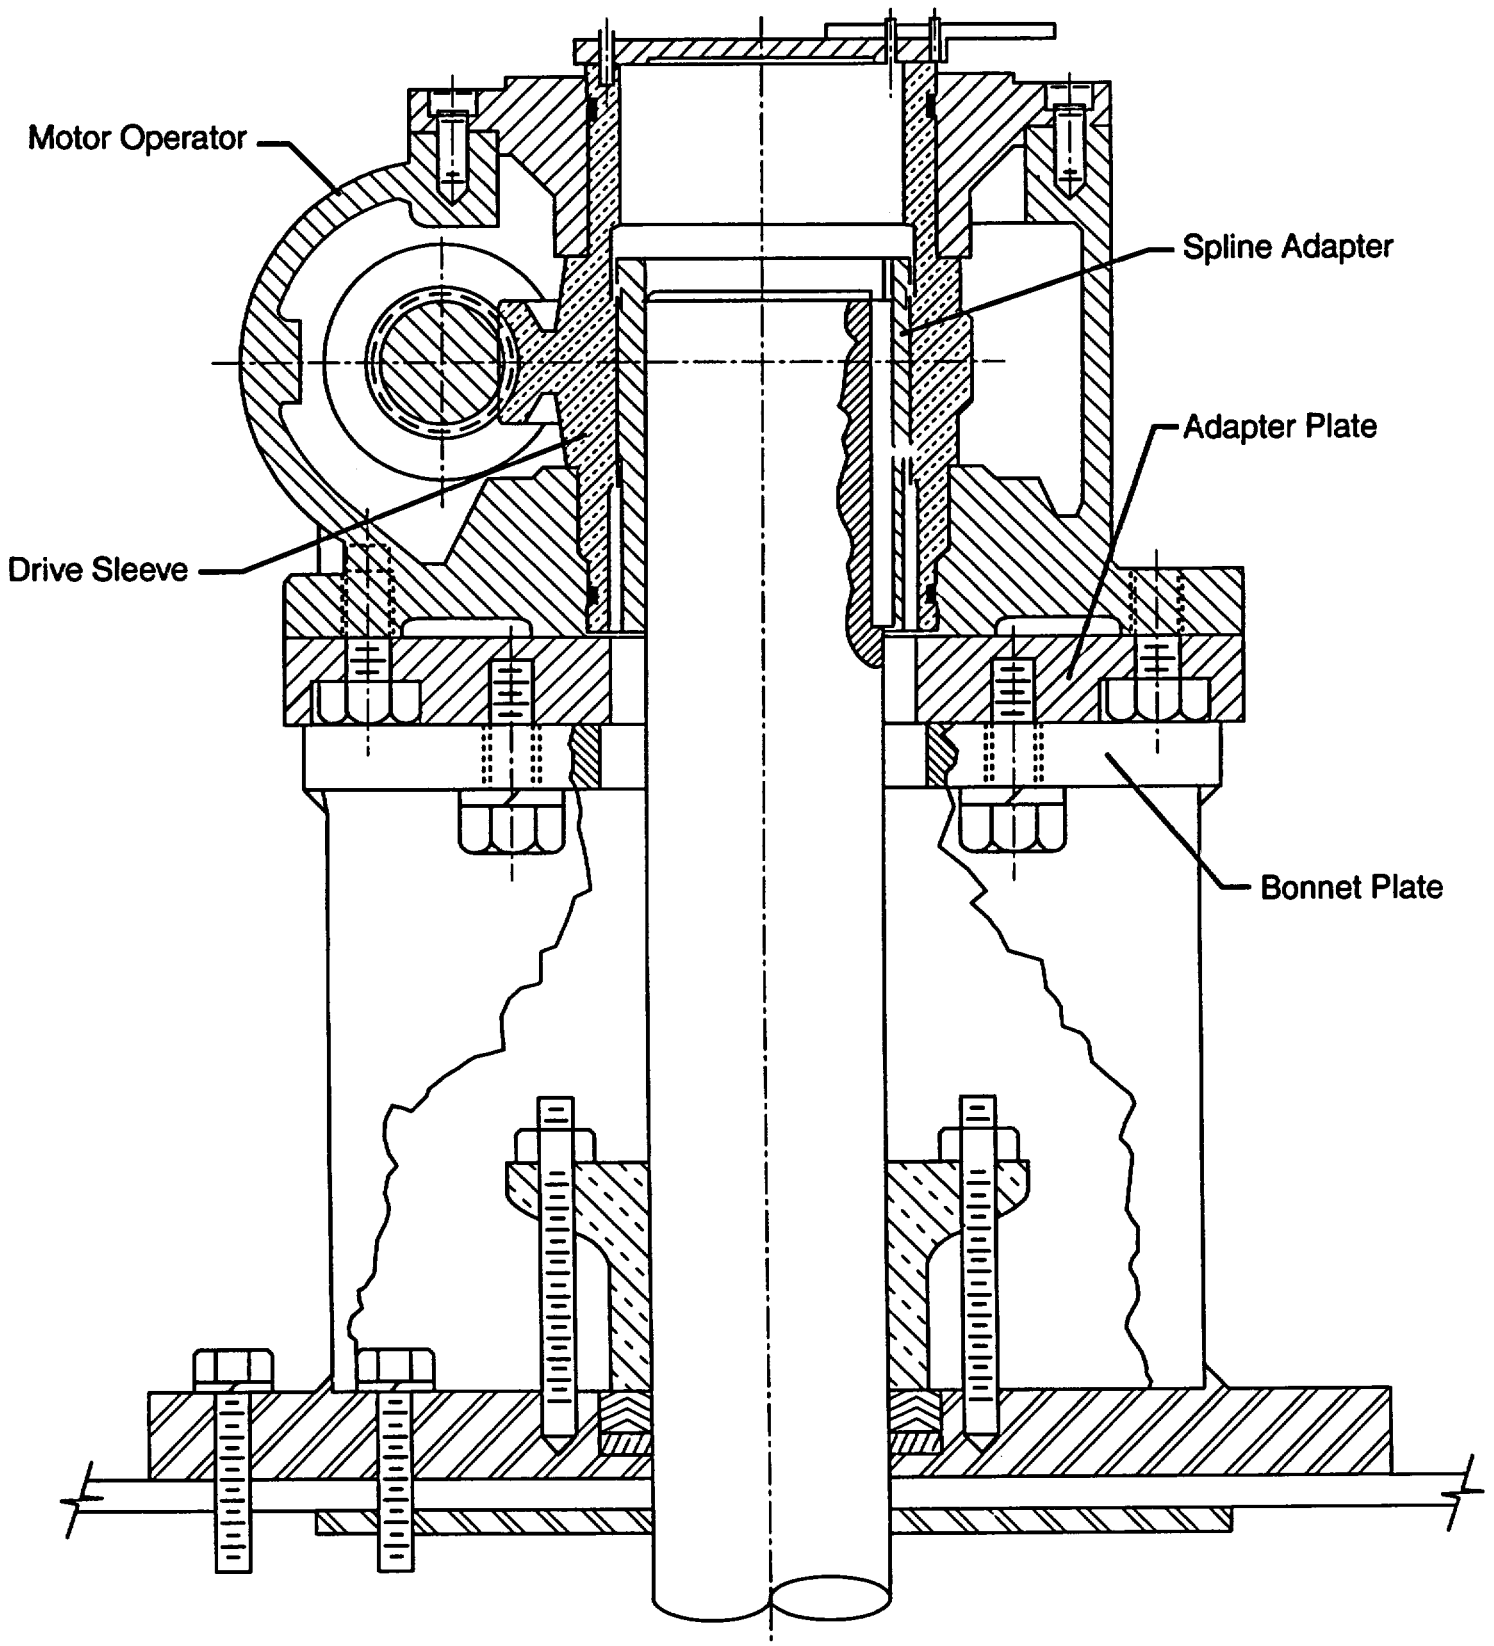
Figure 1

The recirculation spray pump suction valves at Beaver Valley Unit 2 are 12 inch nominal size Henry Pratt 1400 series butterfly valves with Limitorque HBC-1 operators. The drive sleeve on a Limitorque HBC valve operator rotates a spline adapter. The spline adapter is keyed to the valve stem, but the key does not prevent the adapter from moving down the valve stem toward the valve.

If the spline adapter slips down the valve stem, it will disconnect from the drive sleeve. On a Henry Pratt valve, the spline adapter is held in position by an adapter plate, which is designed to permit passage of the valve stem, but not the spline adapter. Additionally, the valve bonnet plate, which is located below the adapter plate, is designed the same way. The adapter plates and bonnet plates were designed and manufactured by Henry Pratt.

Duquesne Light Company found that the center holes in the valve bonnet plates and adapter plates were about 1.3 cm [0.5 inches] larger (in diameter) than the corresponding design dimensions. This was sufficient to allow the spline adapters to slip down the valve stem during operation of the valve. This is shown in Figure 1.

Henry Pratt Butterfly Valve  
with Limitorque Motor Operator

The licensee checked all 54 Henry Pratt butterfly valves at the Beaver Valley Nuclear Power Station for proper adapter plate and bonnet plate dimensions. No problems were noted beyond the recirculation pump suction valves. The licensee placed temporary spline adapter retaining clamps on the recirculation spray pump suction valves pending permanent modification.
