UNITED STATES  
NUCLEAR REGULATORY COMMISSION  
OFFICE OF NUCLEAR REACTOR REGULATION  
WASHINGTON, D.C. 20555

August 1, 1994

NRC INFORMATION NOTICE 94-54: FAILURES OF GENERAL ELECTRIC MAGNE-BLAST  
CIRCUIT BREAKERS TO LATCH CLOSED

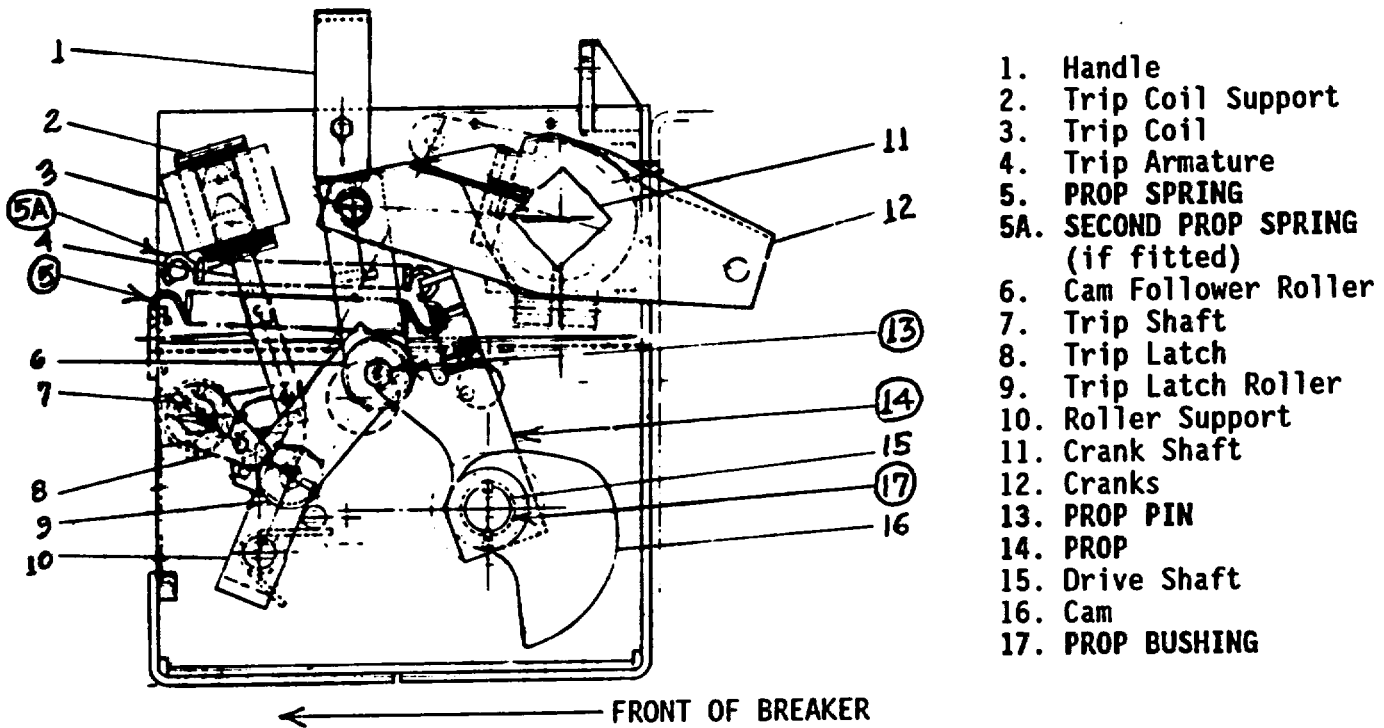
Figure 1 (Adapted From Figure 7 of GE Instruction Book GEI-88761)

The cause of the failures to latch cited in the body of the Information Notice is related to a component of the Type ML-13 breaker operating mechanism called the prop (see Attachment 2). The breaker will fail to latch closed when the prop does not travel forward fast enough (relative to the motion of the closing linkage) to be in the proper position under the prop pin of the closing linkage as it rises above then descends onto the prop during the closing cycle (whether manually or electrically initiated). Absent a trip condition upon closing, the prop is permitted (by the rotation of the main cam) to be pulled forward under the prop pin by the prop reset spring (or springs when two are fitted). If the slower speed of the prop relative to the pin is such that the pin passes down in front of the prop instead of landing on top of it (called latching) as it is supposed to, the linkage will "collapse" causing the moving contact arms to immediately drop down to the open position. This condition or action is also called the trip-free condition because it occurs in the same manner as if a trip signal were present at the breaker tripping mechanism when the breaker attempts to close, thus preventing the prop from moving forward and latching.

The breaker manufacturer, in GE Service Advice Letter (SAL) No. 073-348.1, issued in December 1990, recommended replacement of the main (lower) prop spring with an improved spring (called the "gold" prop spring because of the color of its cadmium plating). NRC Information Notice 90-41, "Potential Failure of General Electric Magne-Blast Circuit Breakers and AK Circuit Breakers," also addressed this problem. The gold prop spring has been fitted in breakers built since 1971, due to fatigue failures reported in the original spring. Although SAL 073-348.1 did describe the dual prop spring configuration, it did not address the addition of a second prop spring. See Attachment 2.

Normal prop wipe can be confirmed with the breaker in its cubicle and closed (in test position if necessary) in most installations by visual inspection (using an inspection mirror and light) without having to get too close to energized components or hazardous mechanism parts if the switchgear cabinet door can be opened with appropriate safety precautions. Pending issuance of a service advice letter (SAL) by the manufacturer on this problem or a safety communication by GE NE, Attachment 2 illustrates an inspection hole in the right side of the mechanism frame through which the prop and prop pin position may be viewed. While the fully forward prop position (to the stop) is the desired condition (maximum wipe), the absence of failures to latch along with consistent and greater than minimum allowed prop wipe is, according to GE, indicative of continued reliable latching. However, because minimum prop wipe is not a published design specification, and because certain other factors (e.g., opening spring adjustment) may influence latching reliability, GE has requested that any licensee experiencing Magne-Blast breaker latching problems or noticing changed, inconsistent or apparently abnormally low prop wipe, particularly following overhaul or repair including prop bushing replacement, contact GE NE PDS at (610) 992-6049.
