UNITED STATES
NUCLEAR REGULATORY COMMISSION
OFFICE OF NUCLEAR REACTOR REGULATION
WASHINGTON, D.C. 20555

December 17, 1993

**NRC INFORMATION NOTICE 93-97: FAILURES OF YOKES INSTALLED ON WALWORTH GATE
AND GLOBE VALVES**

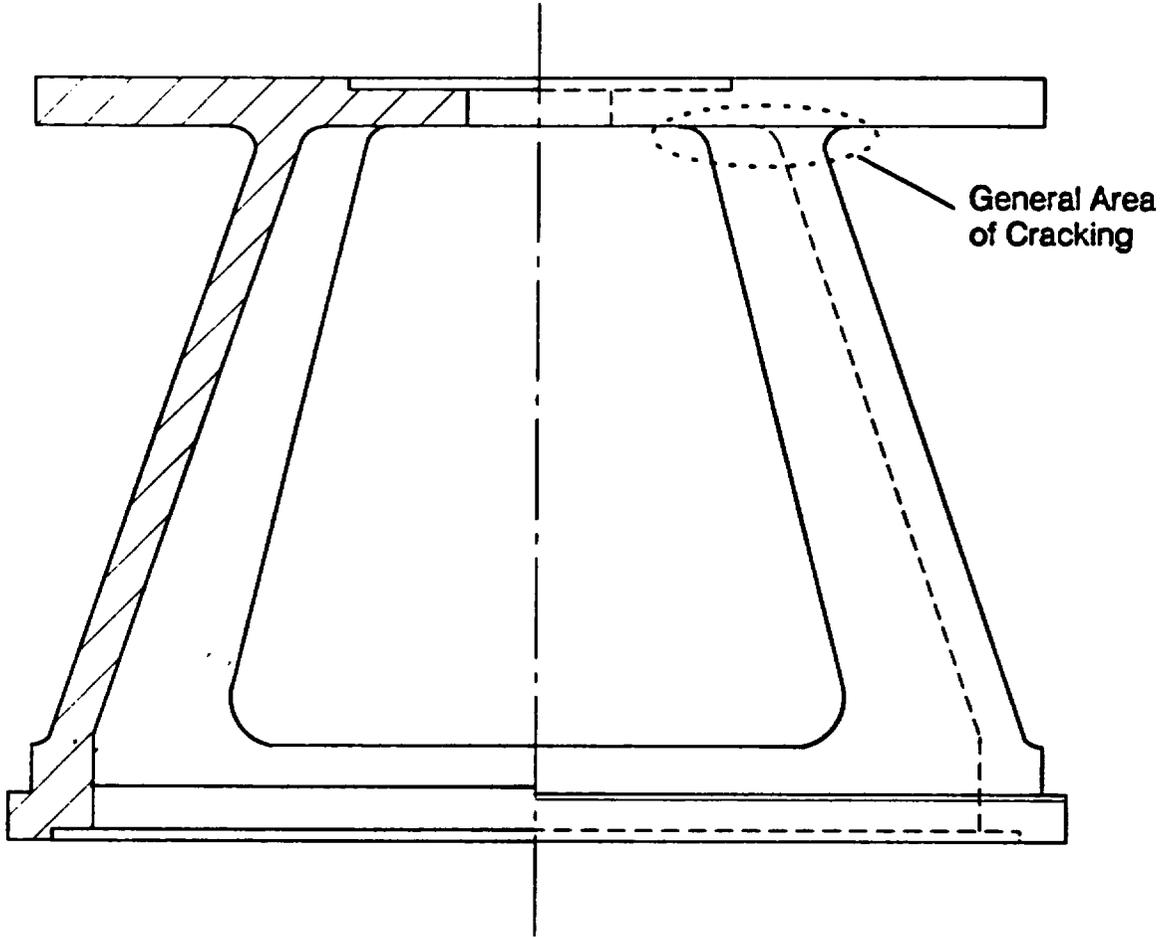
Typical Walworth Valve Yoke

On October 1, 1993, during a refueling outage, the licensee of Peach Bottom Atomic Power Station, Unit 3, notified the NRC resident inspector that it had discovered cracks in the yokes of several valves manufactured by Walworth. The cracks appeared to have originated in the transition between the plate and yoke arms. Attachment 1 is a sketch of a typical Walworth valve yoke showing the general location of the majority of the cracks.

The licensee found cracks in 9 of 62 Walworth valves of the pressure seal design with semicircular yoke legs. The licensee also inspected valves of other designs and confirmed that the cracking was limited to this type of

valve. All of the cracked valves were safety-related components. The sizes of the cracked valves ranged from 4 inches to 24 inches.

The licensee determined that the cracking appeared to be due to a combination of three factors: (1) a yoke design which concentrated stress in the area of the cracks, (2) insufficient bolt torque, which increased the stress, and (3) existing casting defects. The licensee also stated that the failure mode appeared to be fatigue.

For valve yoke designs similar to those of the Walworth valves at Peach Bottom, the force delivered by the motor actuator may bend the support plate slightly and cause cracks to develop or propagate at the junction of the plate and yoke arms. Loose bolts will induce greater stresses in the yoke mounting flange area, which could greatly reduce the fatigue life of the yoke. This problem could result in common-mode failures affecting both redundant and diverse safety systems.

The licensee repaired the cracks by welding in accordance with the American Society of Mechanical Engineers Boiler and Pressure Vessel Code. When reinstalling yokes on valves that were disassembled for repair, the licensee torqued the valve operator mounting fasteners with sufficient preload to reduce joint flexing during valve operation.
