UNITED STATES
NUCLEAR REGULATORY COMMISSION
OFFICE OF NUCLEAR REACTOR REGULATION
WASHINGTON, D.C. 20555

December 17, 1993

NRC INFORMATION NOTICE 93-101: JET PUMP HOLD-DOWN BEAM FAILURE

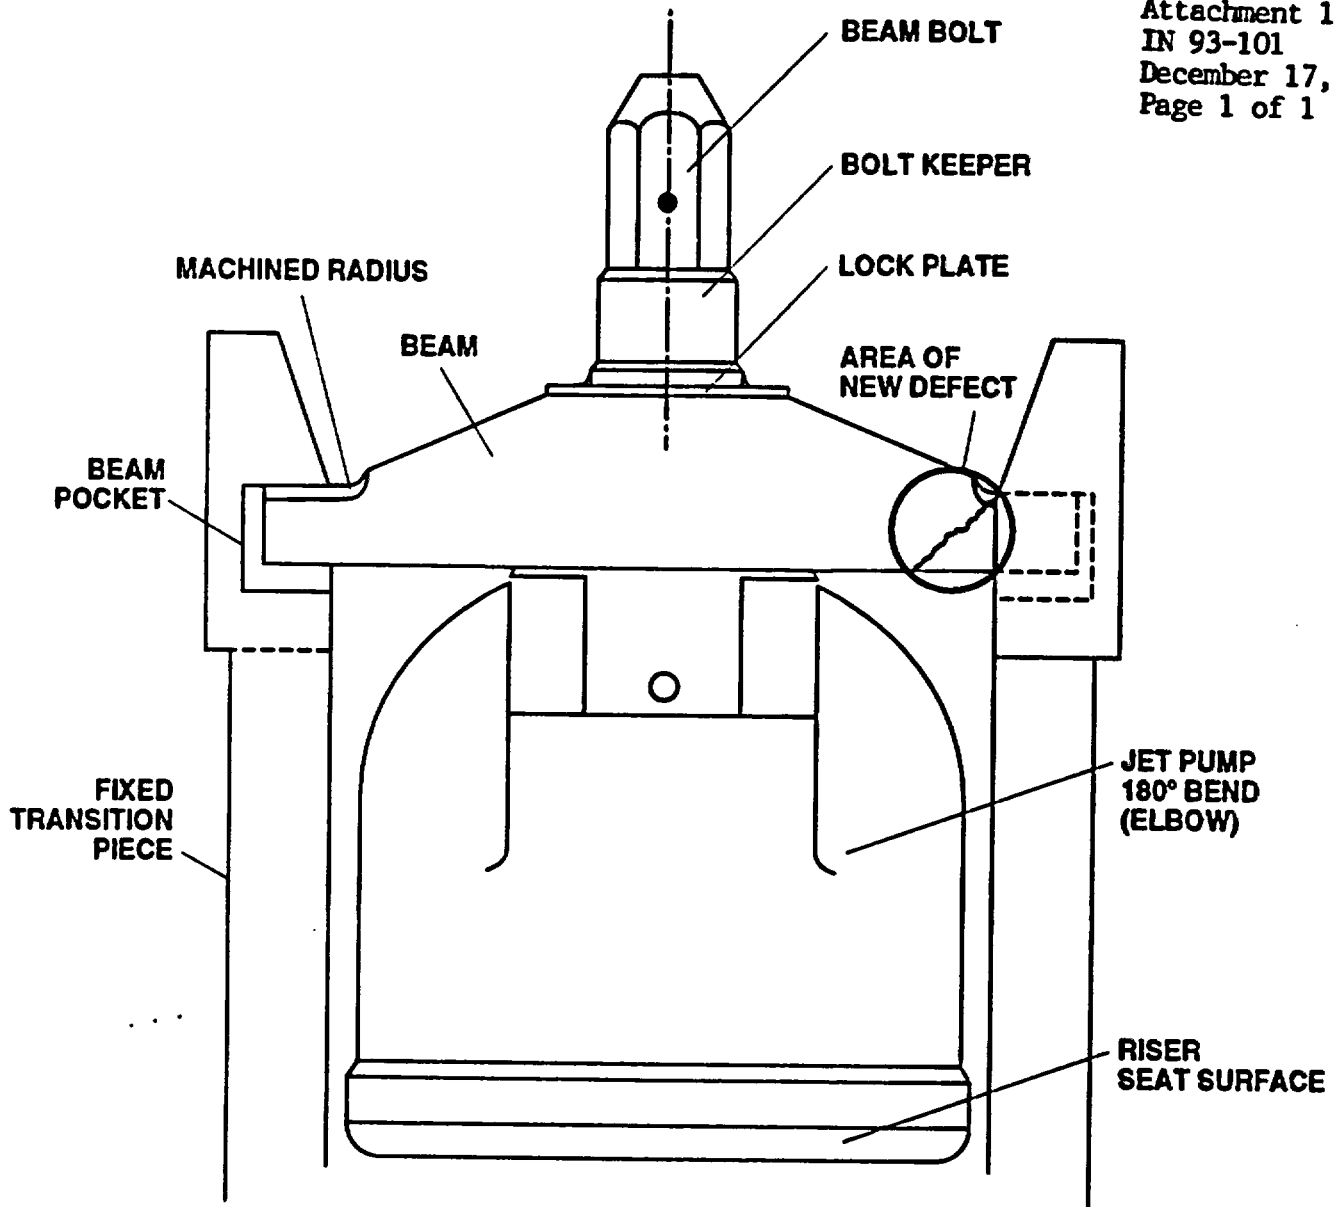
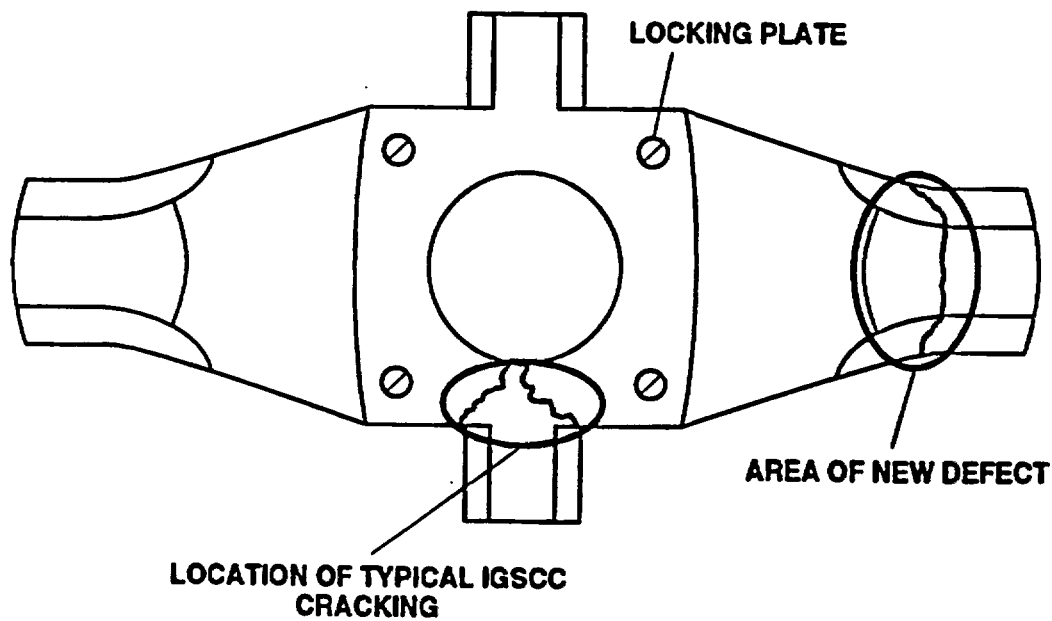
Jet Pump Beam Failure Location

The jet pump hold-down beam failure at the Grand Gulf power station in September 1993 is unlike previous failures in that the hold-down beam for jet pump 10 failed in the transition area between the main body of the beam and the beam end as shown in Attachment 1. There have not been any previous reports of failures in this location. One beam end failed completely, causing the beam to come out of the transition piece, removing the restraint on the jet pump elbow and leading to the disassembly of jet pump 10. There is one hold-down beam for each jet pump assembly. Visual examination of the failed beam showed a crack face covering more than 270° of the cross-section of the intact beam end; the other beam end had cracked in the same location and was missing. The cracks began in an area where a radius machining cut had been made in the forging and led to failure in a location of the beam with a cross-section smaller than the areas that had been affected in previous cases. GE concluded that the probable cause of failure was an intergranular stress corrosion crack that propagated over 80 percent of the fracture surface. Fatigue striations covered the remaining 20 percent of the surface. GE stated that the loss of preload as a result of the intergranular stress corrosion may have induced the fatigue failure.

The licensee conducted ultrasonic examinations on the other inservice jet pump beams and found indications on jet pump 8 and jet pump 21 at the bolt hole area in the center of the hold-down beams. This cracking was consistent with that described in bulletin IEB 80-07. The licensee replaced all the jet pump beams with spare beams available on site.
