UNITED STATES
NUCLEAR REGULATORY COMMISSION
OFFICE OF NUCLEAR REACTOR REGULATION
WASHINGTON, D.C. 20555

February 8, 1994

NRC INFORMATION NOTICE 94-11: TURBINE OVERSPEED AND REACTOR COOLDOWN
DURING SHUTDOWN EVOLUTION

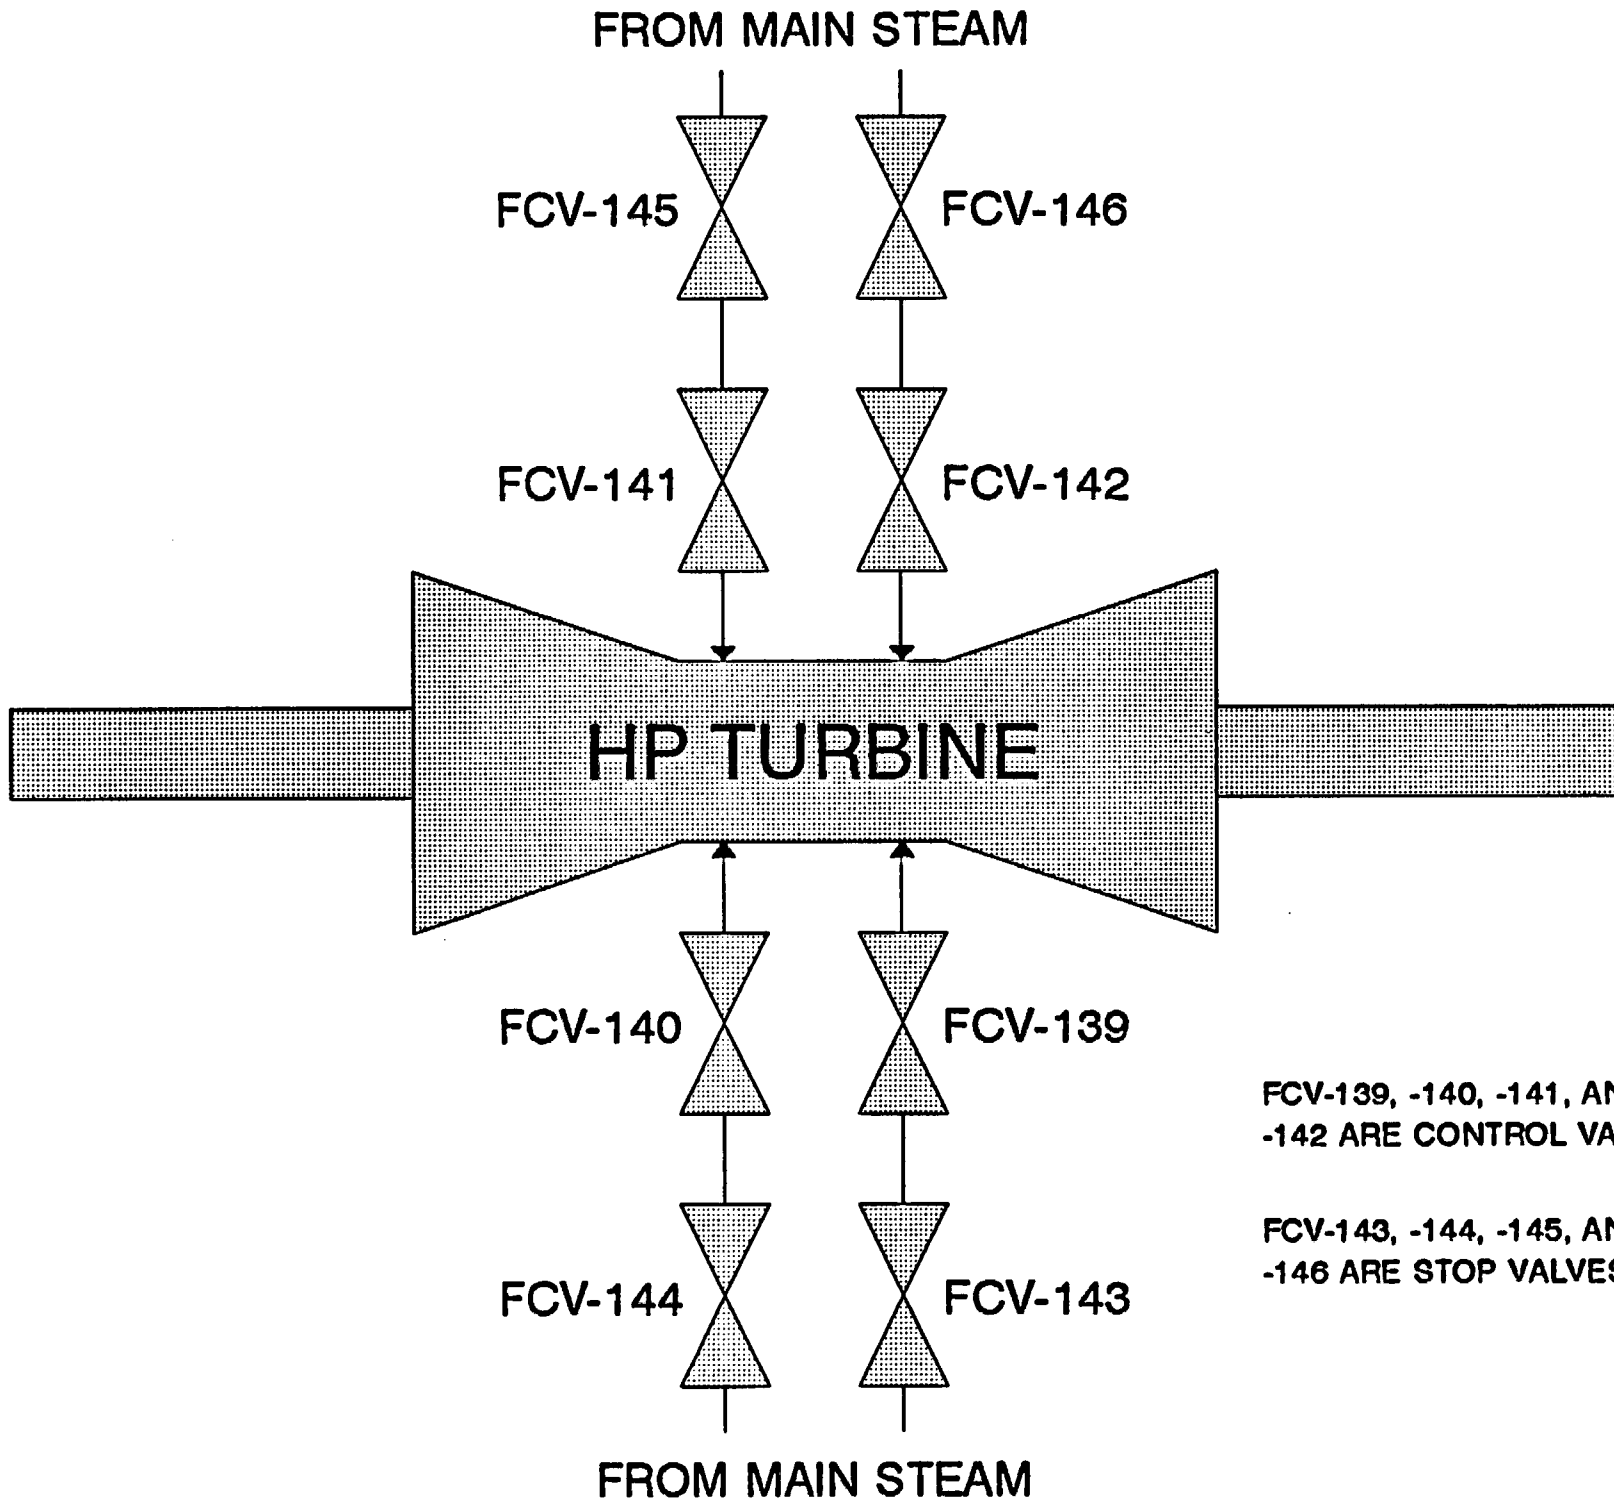
During reactor operations at Diablo Canyon, turbine speed is regulated by the positions of four governor valves (see Attachment 1) which are controlled by the P2000 computer. When the turbine is tripped, pressure switch PS-22B (Low Auto Stop Oil Pressure) is designed to provide a contact closure signal to the P2000 computer. This signal is used by the P2000 computer to reset the main turbine speed reference signal to 0 rpm. To prevent excessive cooldown following a plant shutdown, the licensee re-latches the main turbine while the stop valve equalizing valves are closed. Re-latching the turbine in this manner closes the stop valve trip pilot valves, which isolates a steam leakage path to the condenser.

FCV-139, -140, -141, AND
-142 ARE CONTROL VALVES

FCV-143, -144, -145, AND
-146 ARE STOP VALVES
