UNITED STATES
NUCLEAR REGULATORY COMMISSION
OFFICE OF NUCLEAR REACTOR REGULATION
WASHINGTON, D.C. 20555

June 17, 1994

NRC INFORMATION NOTICE 94-45: POTENTIAL COMMON-MODE FAILURE MECHANISM FOR
LARGE VERTICAL PUMPS

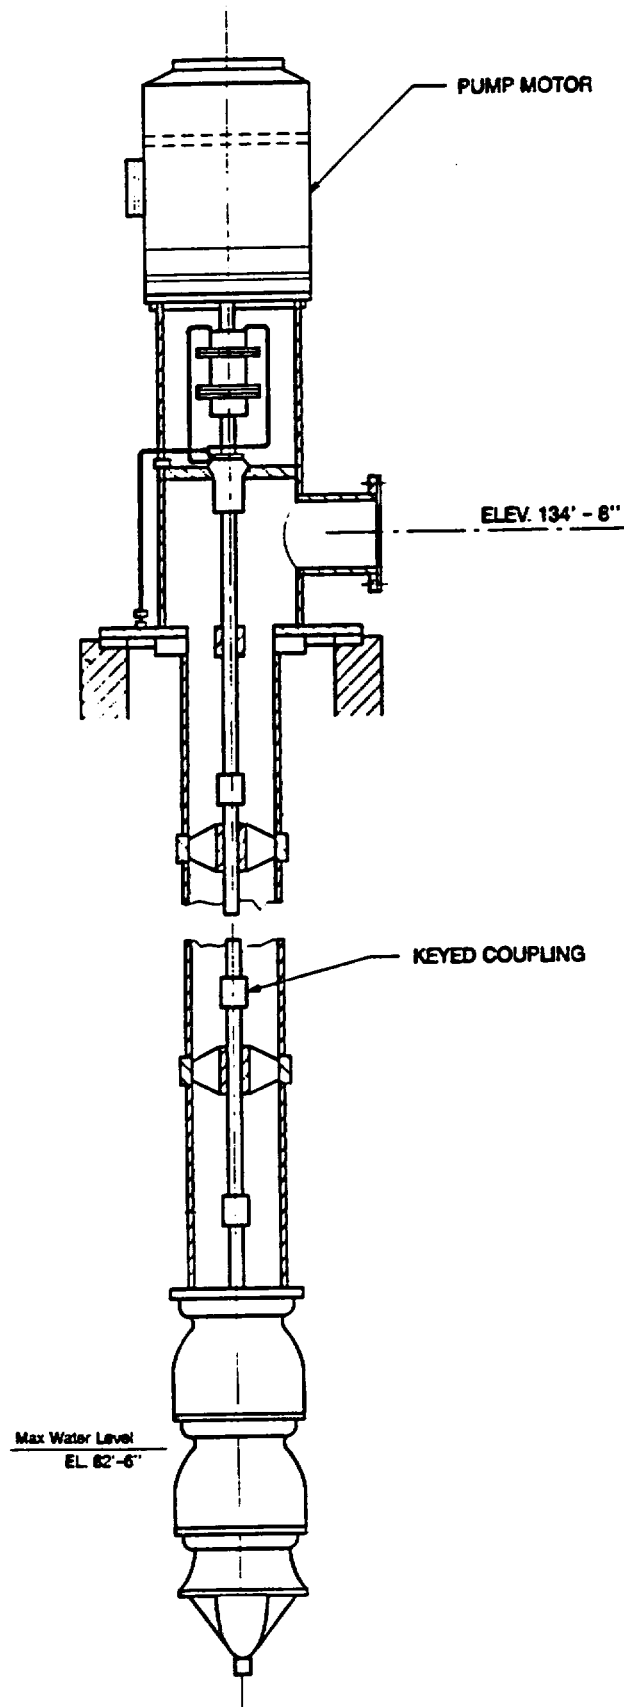
Figure 1 Grand Gulf Standby Service Water Pump

On March 3, 1994, while performing vibration tests on standby service water pump "B," Grand Gulf personnel noted that vibration levels at all monitored points were higher than the reference values. Additional testing exhibited a rapidly degrading trend in pump vibration performance. The pump was declared inoperable and disassembled for inspection.

The pump is a two-stage vertical line shaft pump with the pump impellers coupled to the pump motor via a segmented vertical line shaft, approximately 18 meters [60 feet] long (see Figure 1). Six couplings (see Figure 2) are used to connect the shaft segments. The pumps are located in large cooling towers that contain water which is chemically treated to reduce biofouling. The pumps are run weekly for 24 hours to permit addition and circulation of the chemicals.

Inspection of pump "B" revealed that the impellers had milled into the pump bowls, extensively damaging the impellers and the bowls. The licensee estimated that more than 2.54 cm [1 inch] of material had been worn away from the impellers and bowls. Subsequent disassembly and inspection of the "A" standby service water pump also showed corrosion of the coupling fasteners, but there was only minor damage to the impellers and bowls.

The standby service water pumps are tested in accordance with the licensee's inservice testing program. Neither pump indicated any degradation in developed head, flow, or vibration during quarterly inservice testing performed previously. Vibration measurements are taken near the motor bearing housing because the pump bearings are submerged. Vibration measurements taken at this location may not identify this type of failure mechanism until significant damage has occurred. In addition, the motor did not indicate any increase in running current during testing.

This style of coupling is used by several manufacturers of vertical line shaft pumps. The event at Grand Gulf indicates that current testing of vertical line shaft pump hydraulic and mechanical performance may not identify, before damage occurs, interference between the pump impellers and bowls caused by a change in shaft length. Current manufacturer's recommendations do not require "as-found" measurements of pump lift to be taken and evaluated whenever the pump is uncoupled from the motor. The licensee of the Grand Gulf Station has now added this inspection to its inservice testing program. In addition, after the pumps were rebuilt subsequent to this event, measurements of as-found total float between the impellers and the bowls were taken by the licensee. The measurements were taken by lifting the shaft until the upper part of the impeller contacted the bowl, then measuring the change when the impeller was lowered and allowed to rest on the bottom of the bowl. This measurement was taken after the pump was installed, and is to be used to evaluate measurements taken during the service life of the pump.

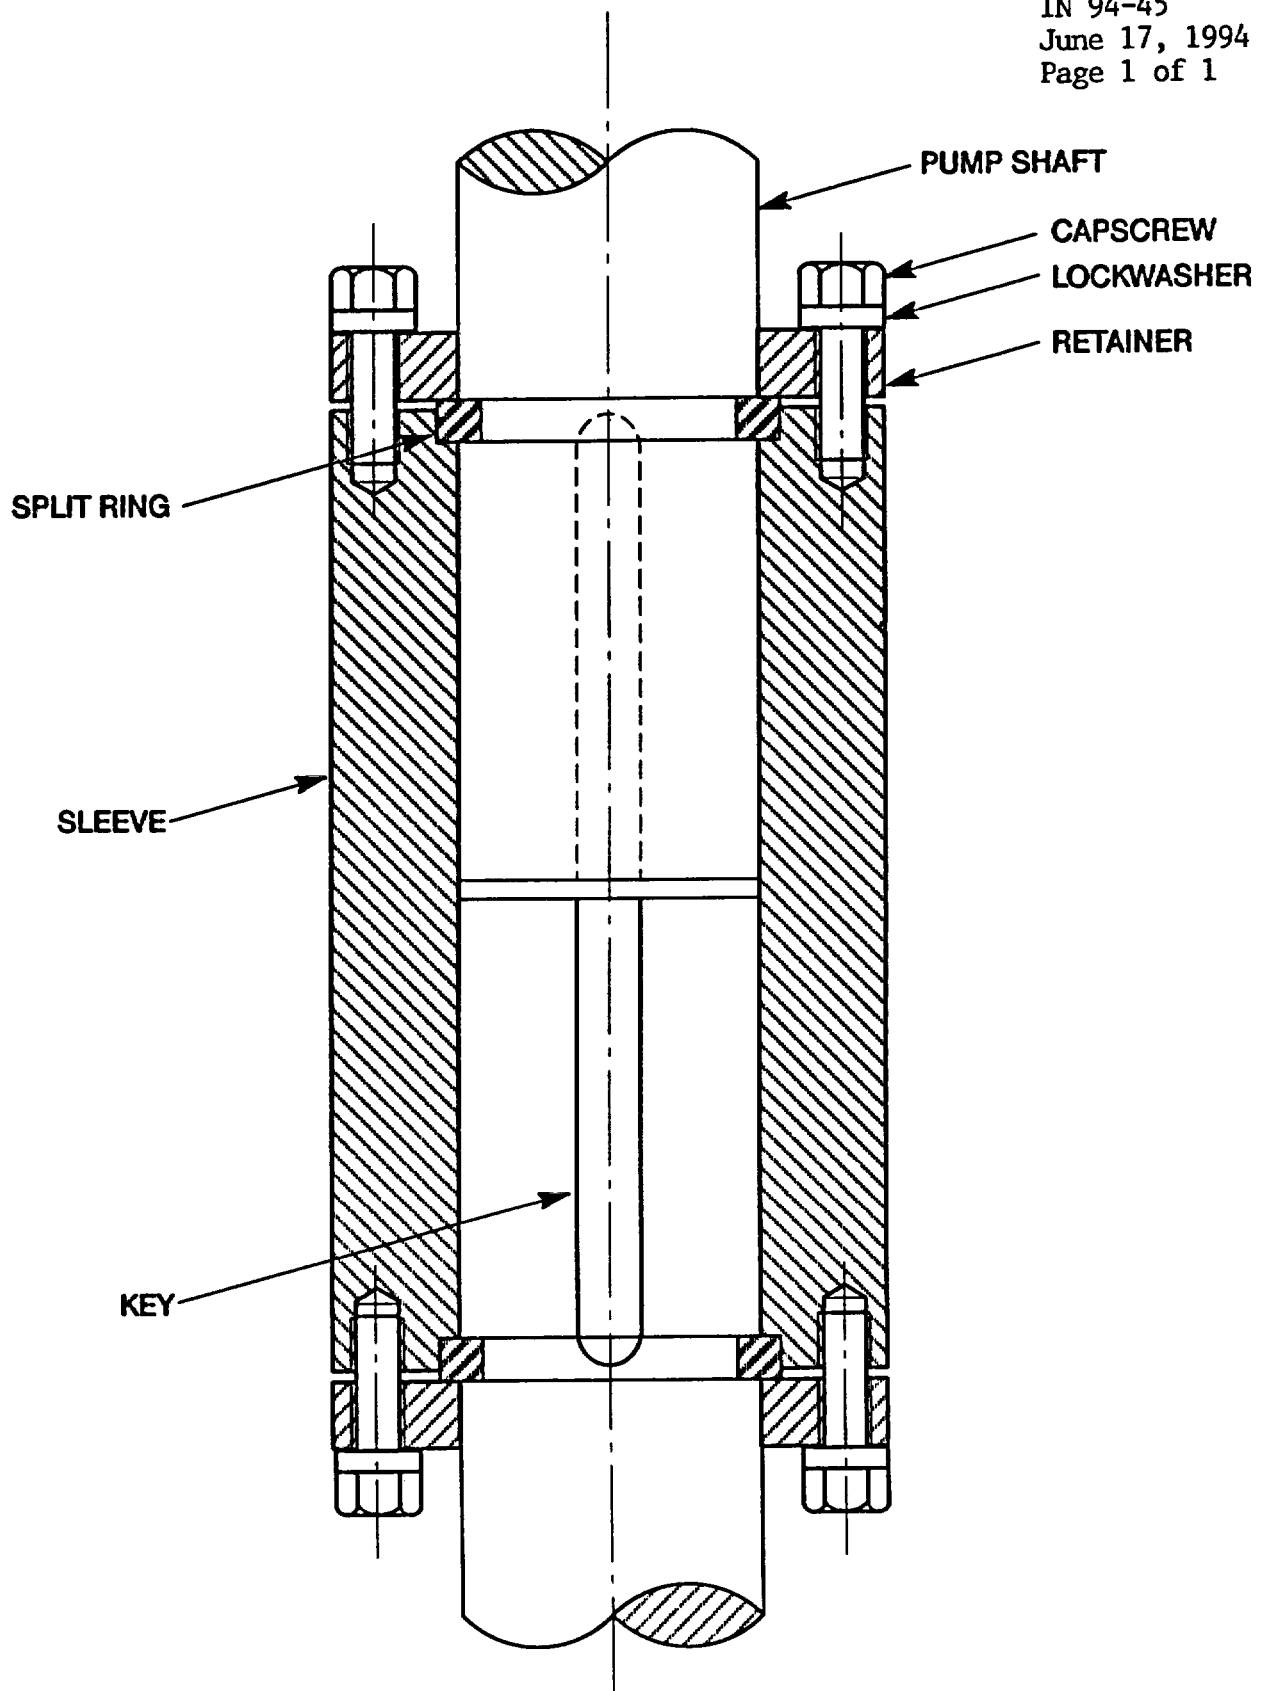
Figure 2 Standby Service Water Pump Coupling (Typical of 6)

Disassembly showed extensive corrosion of the carbon steel bolts and lockwashers used in the pump shaft coupling assemblies. Some lockwashers were missing and were assumed to have corroded away completely. The corrosion allowed each retainer to move away from its contact surface on the sleeve. This allowed the gaps between the pump shaft sections to increase. This process increased the effective shaft length which reduced the clearance between the pump impellers and the bottom of the bowls.

Dissimilar materials used in the coupling assembly may have contributed to this event. The retainer bolts and lockwashers were made of carbon steel; the pump shafts and remaining coupling components were made of stainless steel.
