UNITED STATES  
NUCLEAR REGULATORY COMMISSION  
OFFICE OF NUCLEAR REACTOR REGULATION  
WASHINGTON D.C. 20555

January 7, 1994

NRC INFORMATION NOTICE 94-01: TURBINE BLADE FAILURES CAUSED BY TORSIONAL  
EXCITATION FROM ELECTRICAL SYSTEM DISTURBANCE

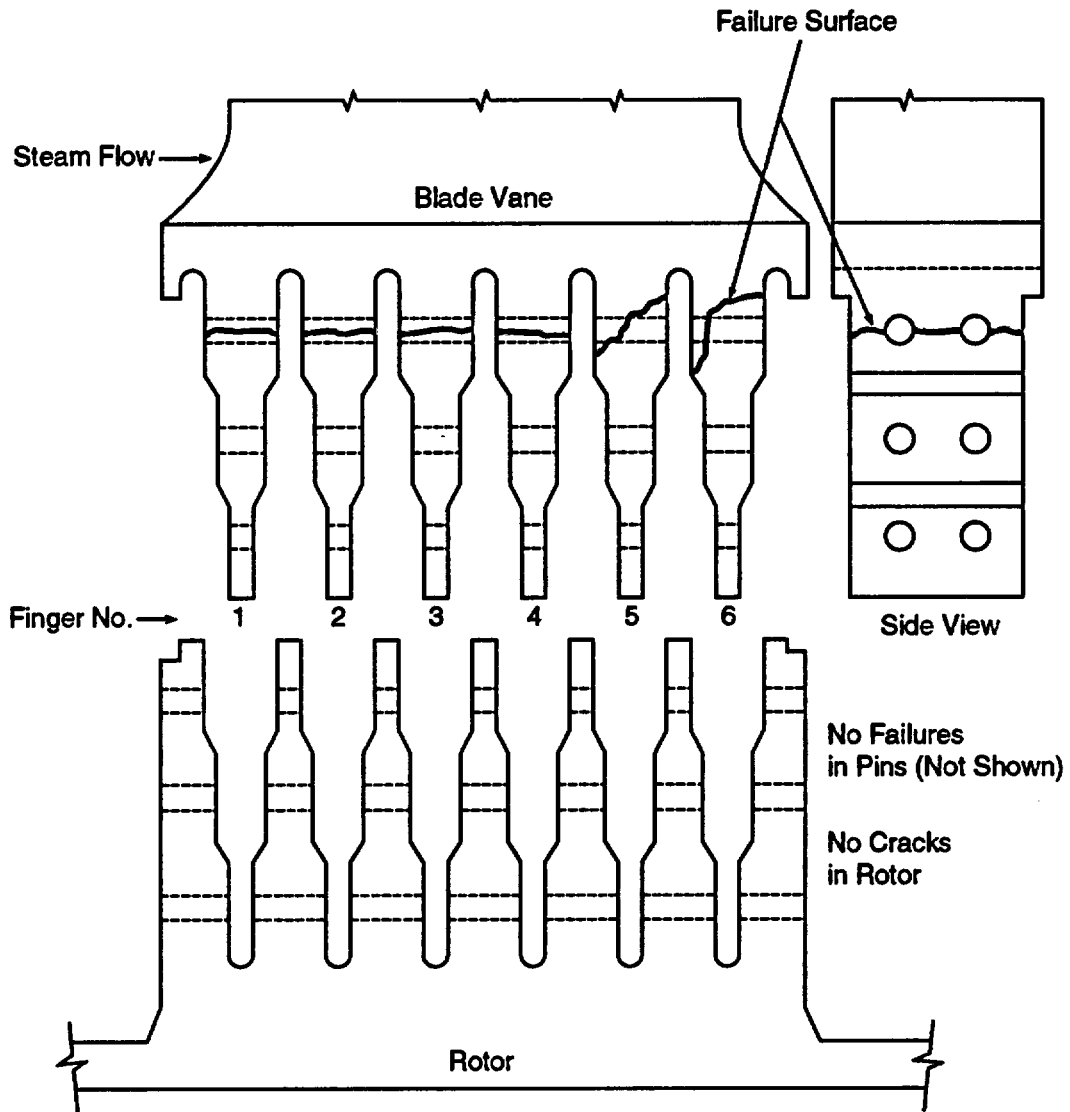
**Figure 1 The Finger Dovetail of a Typical Blade**

On July 12, 1993, at Susquehanna Unit 1, automatically shut down as a result of high turbine vibration, which was felt in the control room (Reference 1). The maximum amplitude recorded was about 0.038 cm [15 mils] at bearing No. 8. Two blades from the L-1 row on the governor end of the low-pressure C turbine separated from the rotor. The failed blades gouged diaphragms (stationary rotors) and damaged other blades in the L-0 and L-1 rows. Cracks were found at the roots of several blades in the L-1 row. The fragments of the blades damaged 50 to 100 condenser tubes.

Susquehanna Unit 1 uses General Electric low-pressure turbines, model number TB 170X592. Each turbine operates at 1800 revolutions per minute. The L-1 blades are about 96 cm [38 inches] long. The root (finger dovetails) of a blade consists of six plates, each plate being about 6 cm [2 1/2 inches] wide, 10 cm [4 inches] long, and 1 cm [3/8 inch] thick. Each plate has six pin holes arranged in three rows of two holes each. The blade is attached to the

rotor by pins staked in the holes. The failed blades were severed at the top rows of holes, as indicated in Figure 1.
