UNITED STATES
NUCLEAR REGULATORY COMMISSION
OFFICE OF NUCLEAR REACTOR REGULATION
WASHINGTON, D.C. 20555

September 30, 1993

NRC INFORMATION NOTICE 93-79: CORE SHROUD CRACKING AT BELTLINE REGION WELDS
IN BOILING-WATER REACTORS

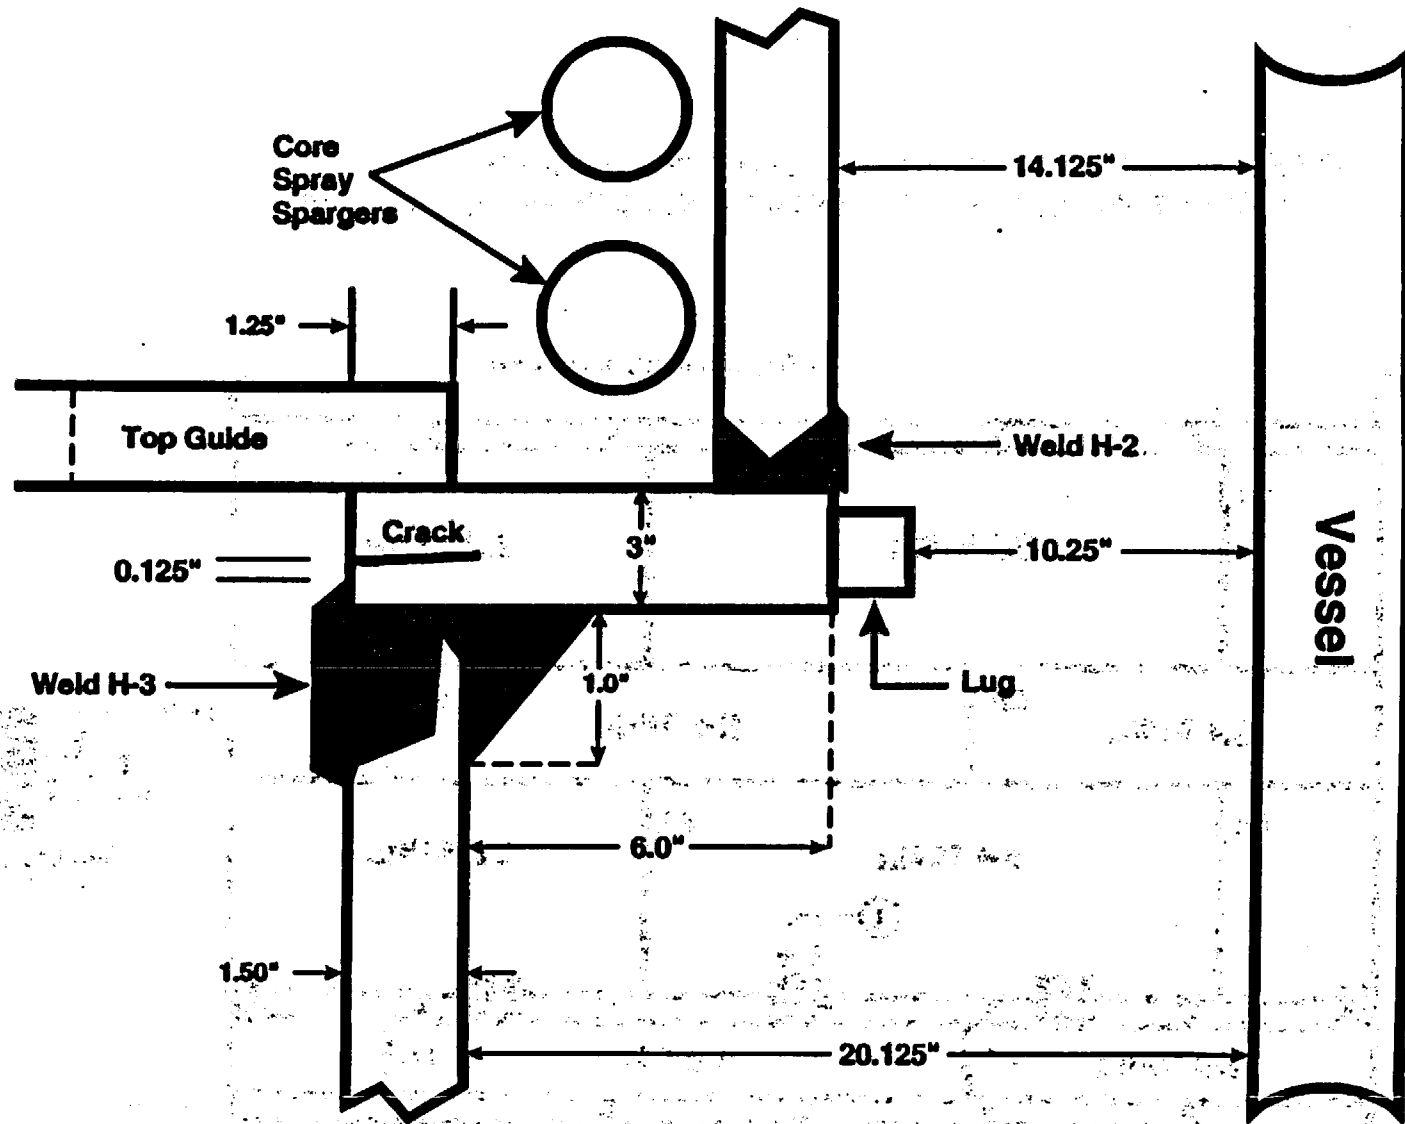
Figure 2. Details of Weld Locations H-2 and H-3 in the Brunswick Unit 1 Core Shroud (From CP&L)

The results from the boat samples indicated intergranular stress-corrosion cracking (IGSCC) as the mechanism. Preliminary results suggest that the crack in the HAZ of weld H-3 may be 3.8 centimeters [1.5 inches] or more in depth. The location of this crack is shown in Figure 2.

As a result of the shroud cracks being discovered on Unit 1, CP&L re-examined the results of the inspection performed during the 1991 refueling outage of Unit 2. The re-examination revealed three minor crack indications in the HAZ of weld H-2. The licensee concluded that the cracks do not pose a concern to normal operation of the reactor.
