UNITED STATES
NUCLEAR REGULATORY COMMISSION
OFFICE OF NUCLEAR REACTOR REGULATION
WASHINGTON, D.C. 20555

September 30, 1993

NRC INFORMATION NOTICE 93-79: CORE SHROUD CRACKING AT BELTLINE REGION WELDS
IN BOILING-WATER REACTORS

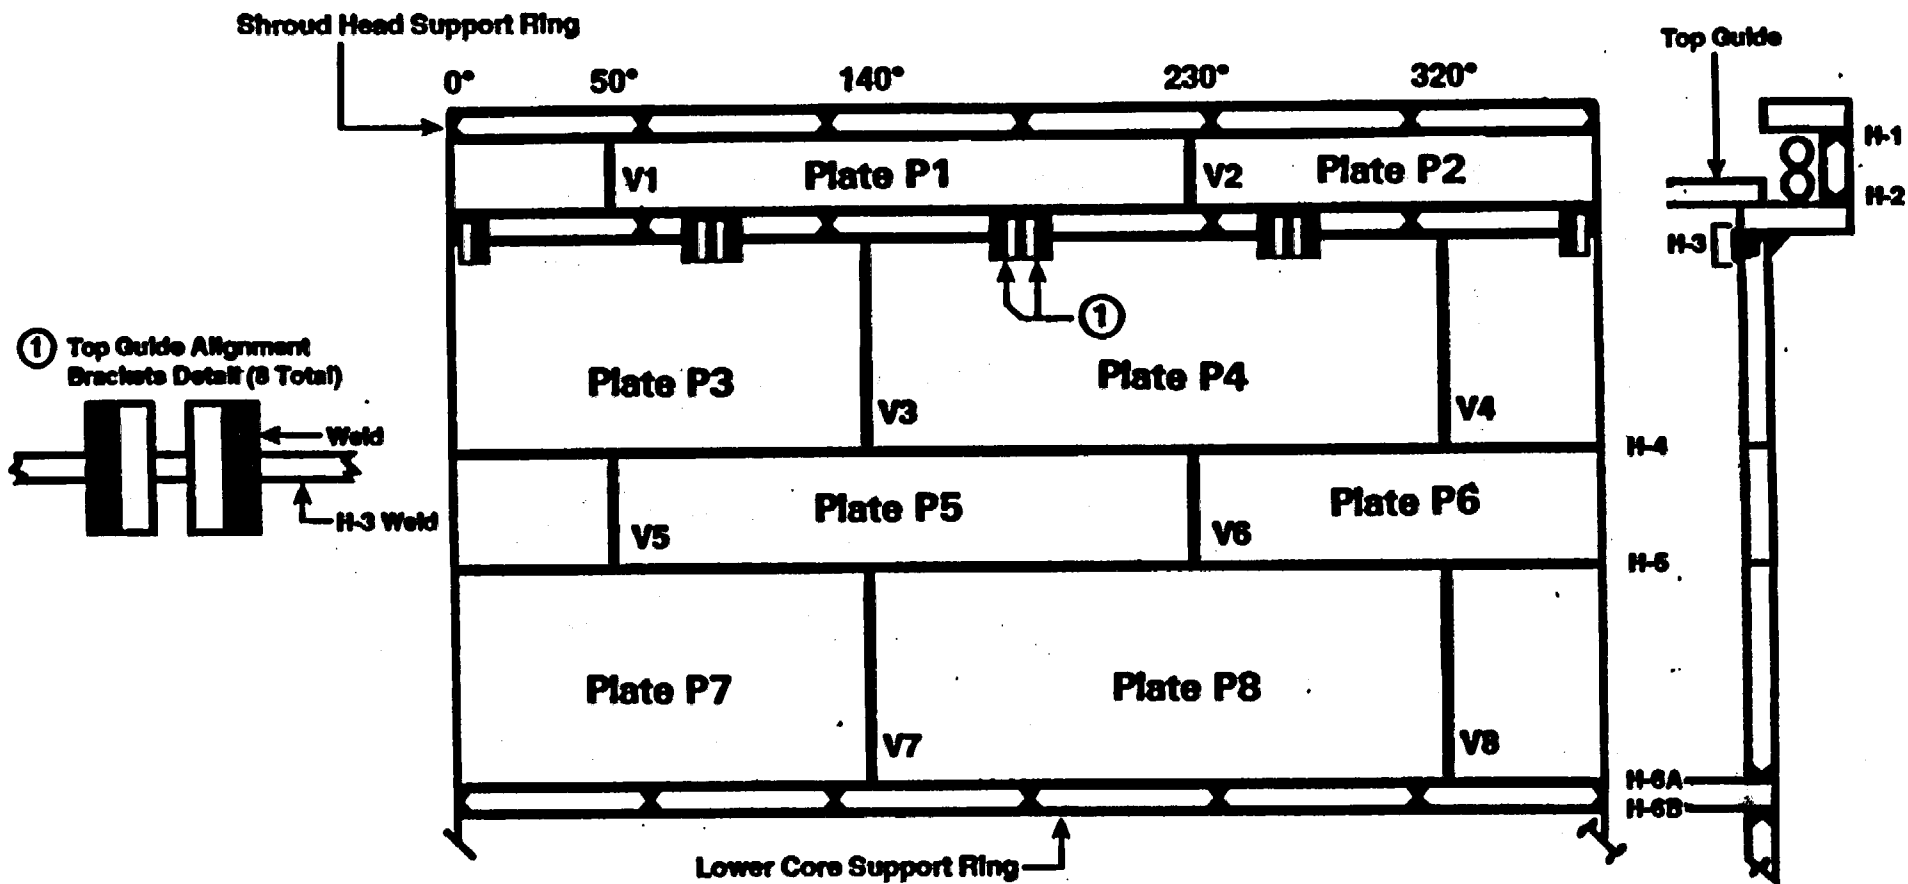
Figure 1. Weld and Plate Locations in the Beltline Region of the Brunswick Unit 1 Core Shroud (From CP&L)

Carolina Power and Light Company (CP&L), the licensee for Brunswick, found both circumferential and axial cracks in the shroud. The circumferential cracks were located in the inside shroud surface in the heat-affected zone (HAZ) of weld H-3 and extended 360° around the circumference of the shroud (see Figures 1 and 2). Weld H-3 is a horizontal weld which fuses the top guide support ring to the lower shroud. The first axial crack discovered was located on the outside shroud surface of weld H-4 in the lower shroud. CP&L performed additional visual testing (VT) and ultrasonic testing (UT) of the shroud and removed boat samples to evaluate the length and size of the cracks.

Additional VT inspections revealed more axial cracks at the inside surface of weld H-4 as well as cracks at welds H-1, H-2, and H-5 of the shroud. One of the additional cracks, a circumferential crack at weld H-5, appears to be approximately 76.2 centimeters [30 inches] in length. The majority of the cracks are located in the HAZ of the welds, although one crack was discovered in the central region of shroud plate P-6. The crack in P-6, however, may be associated with a possible weld repair of a surface defect in the plate after its fabrication at the mill.

CP&L plans to repair the Brunswick Unit 1 core shroud before the plant is brought back into service. CP&L intends to restore the strength of the shroud by adding stiffening braces around the top portion of the shroud. However, the licensee will continue to examine and evaluate the cracks in the core shroud.

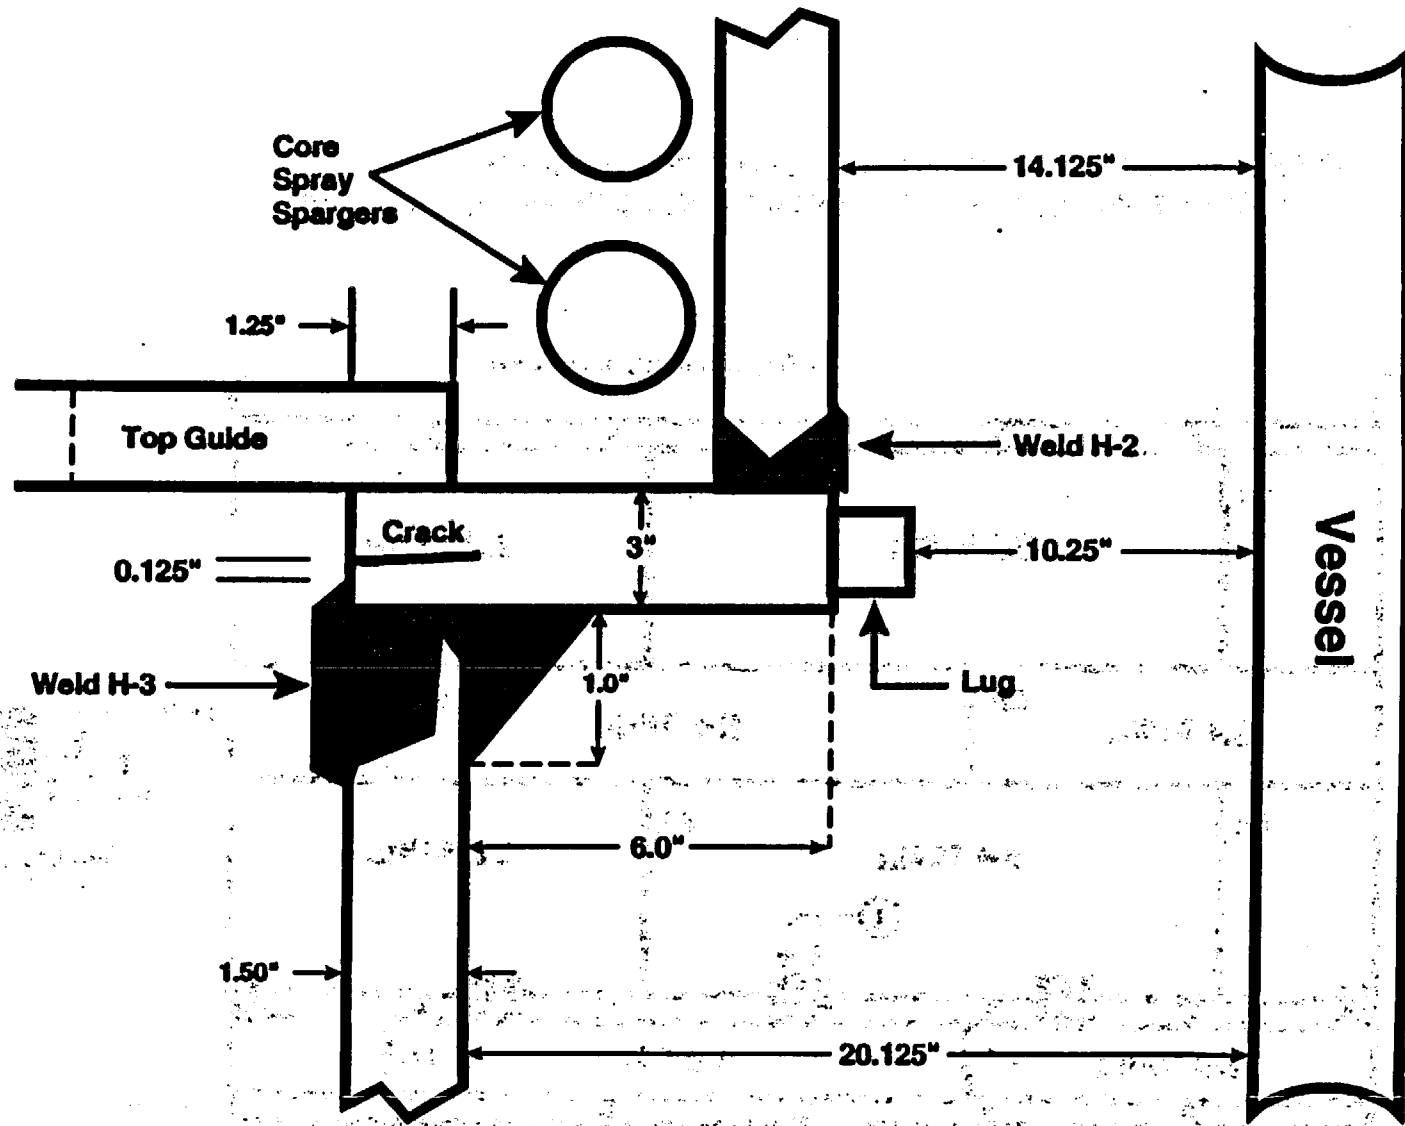
Figure 2. Details of Weld Locations H-2 and H-3 in the Brunswick Unit 1 Core Shroud (From CP&L)

The results from the boat samples indicated intergranular stress-corrosion cracking (IGSCC) as the mechanism. Preliminary results suggest that the crack in the HAZ of weld H-3 may be 3.8 centimeters [1.5 inches] or more in depth. The location of this crack is shown in Figure 2.

As a result of the shroud cracks being discovered on Unit 1, CP&L re-examined the results of the inspection performed during the 1991 refueling outage of Unit 2. The re-examination revealed three minor crack indications in the HAZ of weld H-2. The licensee concluded that the cracks do not pose a concern to normal operation of the reactor.
