UNITED STATES  
NUCLEAR REGULATORY COMMISSION  
OFFICE OF NUCLEAR REACTOR REGULATION  
WASHINGTON, D.C. 20555

December 3, 1993

NRC INFORMATION NOTICE 93-91: MISADJUSTMENT BETWEEN GENERAL ELECTRIC 4.16-KV  
CIRCUIT BREAKERS AND THEIR ASSOCIATED CUBICLES

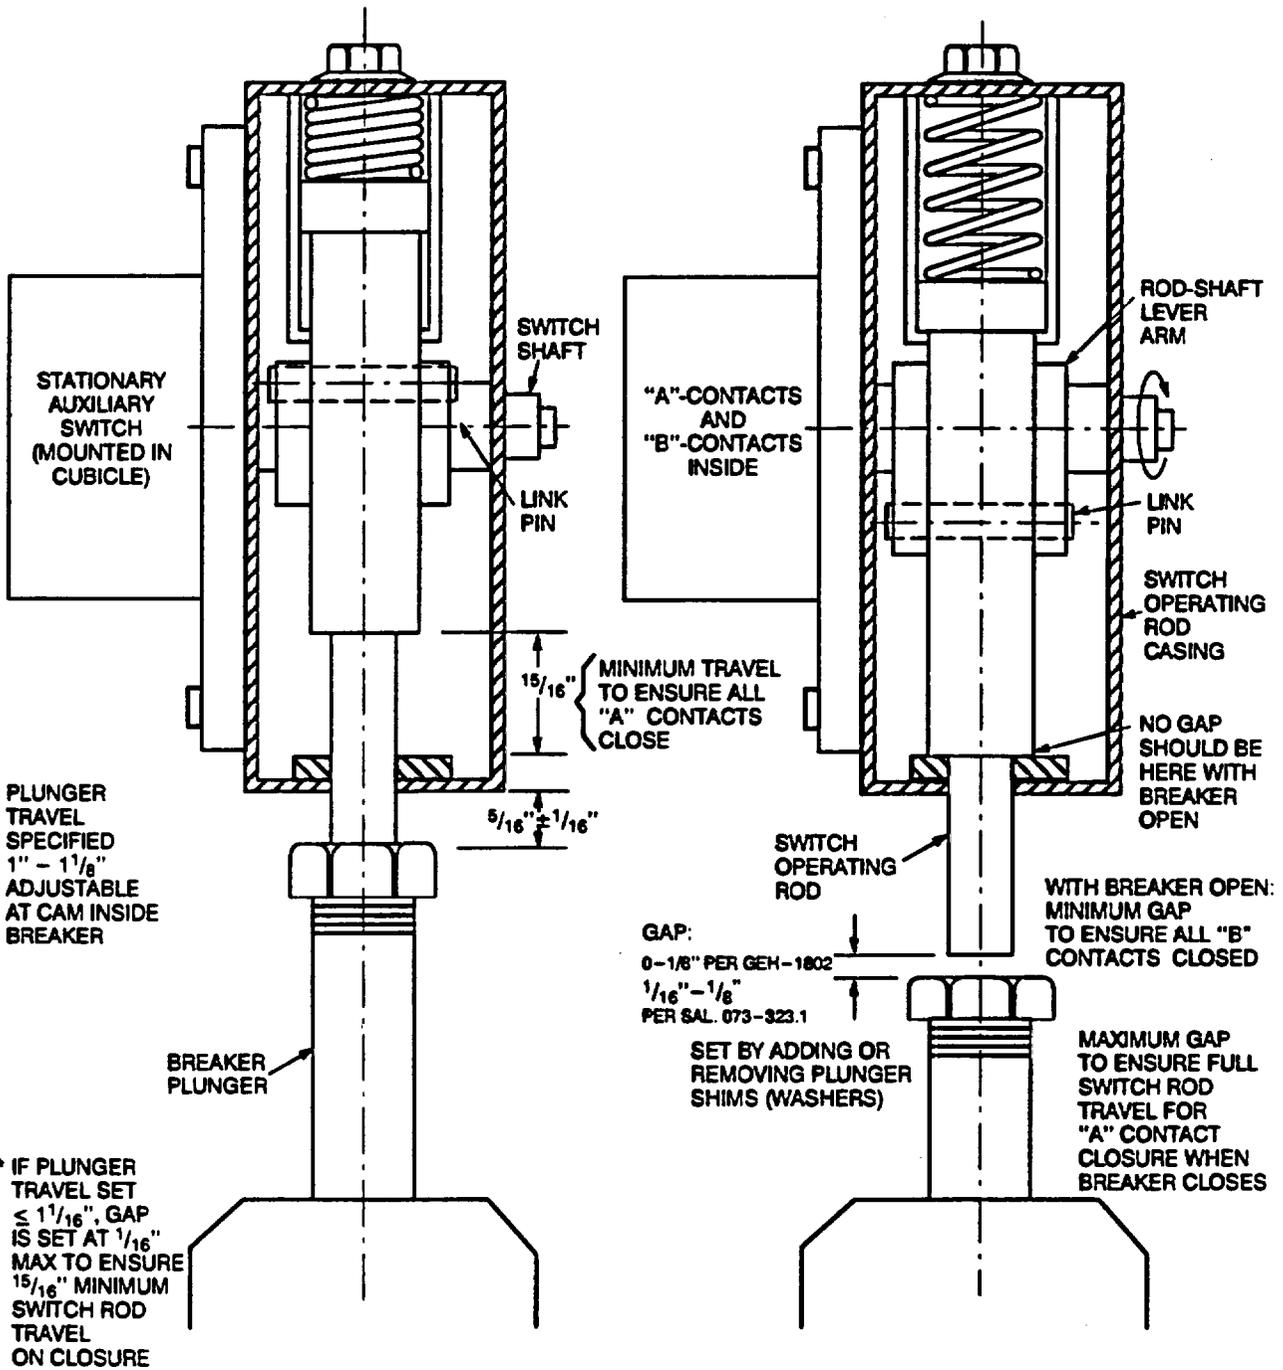
**MAGNE-BLAST CIRCUIT BREAKER PLUNGER - STATIONARY  
 AUXILIARY SWITCH ADJUSTMENTS (ADAPTED FROM GE  
 MVSD FIELD INSTALLATION DRAWING 0172C7558)**

Troubleshooting revealed that the auto-closing logic for the diesel generator output breaker was not being completed because a "b" contact from breaker 1A401 was open, indicating that the breaker was closed when the breaker was actually open. When the breaker 1A401 is open and in its fully elevated operating position in the cubicle, there is supposed to be a small gap or clearance between the breaker plunger and the stationary auxiliary switch

operating rod (see Attachment 1, Figure 2) to ensure positive closure of all "b" contacts in the stationary auxiliary switch. However, the plunger of breaker 1A401 was found to be actually pushing its stationary auxiliary switch operating rod up about 4.8 mm [3/16 inch] with the breaker open. This apparently occurred when the breaker was last elevated into its operating position which then opened one or more "b" contacts (including the one in the diesel generator breaker control circuit) from their normally closed position. The misalignment rendered the "B" diesel generator inoperable from July 21, 1993, to September 25, 1993, because it was not capable of automatically closing onto the 1A4 bus.

Further conversations between the licensee and GE determined that there are additional dimensional checks (not contained in either the breaker or switchgear technical manual) which would provide additional assurance of proper auxiliary contact operation after breaker maintenance. These additional dimensional checks for a closed breaker (see Attachment 1, Figure 1) are:

- 7.9 ± 1.6 mm [5/16 ± 1/16 inch] from the top of the circuit breaker plunger nut to the bottom of the auxiliary switch operating rod casing.
- All "a" contacts are closed with at least 23.8 mm [15/16 inch] travel of the operating rod.

NOTE: Total specified travel of the plunger is 27 ± 1.6 mm [1 1/16 ± 1/16 inch]. If the total plunger travel is set at the minimum specified value of 25.4 mm [1 inch] and the plunger-to-operating-rod gap is set at the maximum specified value of 3.2 mm [1/8 inch], the amount of travel of the operating rod would only be 22.2 mm [7/8 inch], or less than the required 23.8 mm [15/16 inch] necessary to fully ensure closure of the "a" auxiliary contacts when the breaker closes.

For an open breaker (see Attachment 1, Figure 2) the additional dimensional check is:

- The operating rod collar should rest on the operating rod casing, and the operating rod should not be displaced by the plunger of an open breaker.

Circuit Breakers Types AM-4.16 and AM-13.8"). In order to ensure a minimum gap for positive "b" contact closure, the manufacturer (now called the GE Specialty Breaker product department) provided additional guidance in its Service Advice Letter (SAL) 073-323.1, issued February 1, 1978, specifying a gap of 1.6 mm [1/16 inch] to 3.2 mm [1/8 inch]. This SAL also provides the recommended sequence of adjustments.
