UNITED STATES
NUCLEAR REGULATORY COMMISSION
OFFICE OF NUCLEAR REACTOR REGULATION
WASHINGTON, D.C. 20555

December 3, 1993

**NRC INFORMATION NOTICE 93-91: MISADJUSTMENT BETWEEN GENERAL ELECTRIC 4.16-KV
CIRCUIT BREAKERS AND THEIR ASSOCIATED CUBICLES**

**MAGNE-BLAST CIRCUIT BREAKER PLUNGER - STATIONARY
 AUXILIARY SWITCH ADJUSTMENTS (ADAPTED FROM GE
 MVSD FIELD INSTALLATION DRAWING 0172C7558)**

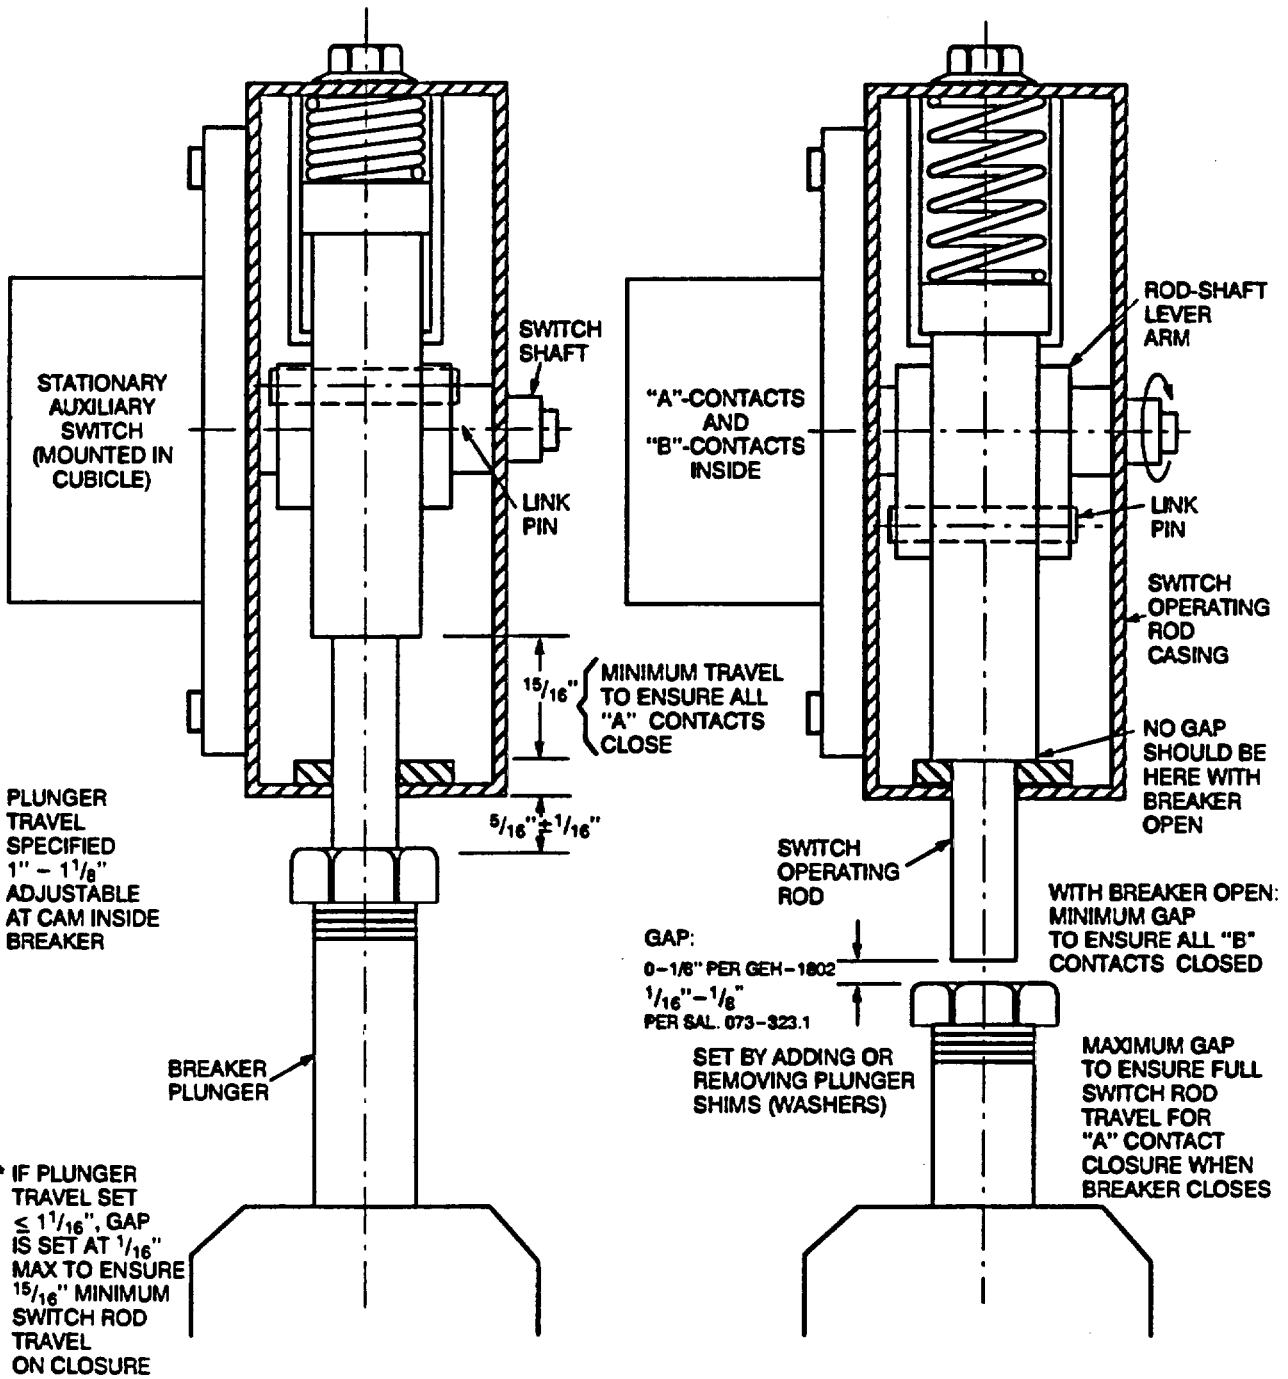
Troubleshooting revealed that the auto-closing logic for the diesel generator output breaker was not being completed because a "b" contact from breaker 1A401 was open, indicating that the breaker was closed when the breaker was actually open. When the breaker 1A401 is open and in its fully elevated operating position in the cubicle, there is supposed to be a small gap or clearance between the breaker plunger and the stationary auxiliary switch

operating rod (see Attachment 1, Figure 2) to ensure positive closure of all "b" contacts in the stationary auxiliary switch. However, the plunger of breaker 1A401 was found to be actually pushing its stationary auxiliary switch operating rod up about 4.8 mm [3/16 inch] with the breaker open. This apparently occurred when the breaker was last elevated into its operating position which then opened one or more "b" contacts (including the one in the diesel generator breaker control circuit) from their normally closed position. The misalignment rendered the "B" diesel generator inoperable from July 21, 1993, to September 25, 1993, because it was not capable of automatically closing onto the 1A4 bus.

Misadjustment between the stationary auxiliary switch and the breaker plunger on 4.16-kv breakers has the potential to cause multiple common-cause failures of many different logic functions that rely on these auxiliary switch contacts. The circuit breaker plunger to auxiliary switch operating rod adjustment may be affected by breaker maintenance, switchgear maintenance, differences in operating plunger height of interchangeable breakers, differences in breaker cubicles and breaker position switches, and non-repeatability in breaker height when racking in breakers.

Circuit Breakers Types AM-4.16 and AM-13.8"). In order to ensure a minimum gap for positive "b" contact closure, the manufacturer (now called the GE Specialty Breaker product department) provided additional guidance in its Service Advice Letter (SAL) 073-323.1, issued February 1, 1978, specifying a gap of 1.6 mm [1/16 inch] to 3.2 mm [1/8 inch]. This SAL also provides the recommended sequence of adjustments.

Further conversations between the licensee and GE determined that there are additional dimensional checks (not contained in either the breaker or switchgear technical manual) which would provide additional assurance of proper auxiliary contact operation after breaker maintenance. These additional dimensional checks for a closed breaker (see Attachment 1, Figure 1) are:

- 7.9 ± 1.6 mm [5/16 ± 1/16 inch] from the top of the circuit breaker plunger nut to the bottom of the auxiliary switch operating rod casing.
- All "a" contacts are closed with at least 23.8 mm [15/16 inch] travel of the operating rod.

NOTE: Total specified travel of the plunger is 27 ± 1.6 mm [1 1/16 ± 1/16 inch]. If the total plunger travel is set at the minimum specified value of 25.4 mm [1 inch] and the plunger-to-operating-rod gap is set at the maximum specified value of 3.2 mm [1/8 inch], the amount of travel of the operating rod would only be 22.2 mm [7/8 inch], or less than the required 23.8 mm [15/16 inch] necessary to fully ensure closure of the "a" auxiliary contacts when the breaker closes.

For an open breaker (see Attachment 1, Figure 2) the additional dimensional check is:

- The operating rod collar should rest on the operating rod casing, and the operating rod should not be displaced by the plunger of an open breaker.

Figure 1
 BREAKER CLOSED

Figure 2
 BREAKER OPEN

GE stated that it will issue a SAL to clarify the instructions and dimensions contained in the previous publications. Meanwhile, licensee inquiries on this subject may be directed to GE Nuclear Energy Power Delivery Services in King of Prussia, Pennsylvania (Phone: 215-992-6049/Fax: 215-992-6191.)
